Artikel: Dynamic test of a pedestrian bridge as part of safety assessment
Autor: Clemente, Paolo / Buffarini, Giacomo
DOI: <https://doi.org/10.5169/seals-62873>

Dynamic Test of a Pedestrian Bridge as Part of Safety Assessment

The results of the dynamic tests carried out on the approach pedestrian bridge to Civita di Bagnoregio, Italy, are shown. The structural elements were in bad conditions due to the carbonation of concrete. The results of the experimental campaign allowed to state that the structural behaviour of the bridge was quite similar to that we could expect. Under ambient vibrations the structure behaved as a whole, formed by the piers linked at their tops by means of the beams.

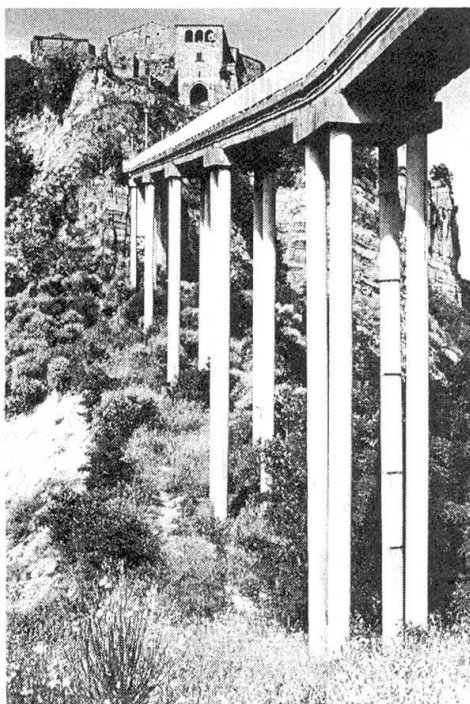
Fig. 1 Piers 1 to 5

The approach pedestrian bridge to Civita di Bagnoregio is composed by 14 spans, which are simply supported on the piers. These are spaced by about 19.00 m. Starting from Civita we first find a 20% steep slope, which interests five spans. The heights of the piers from pier 1 to pier 5 vary from 11 to 15 m, pier 4 being the highest. The viaduct between pier 5 and pier 9 is almost horizontal while in the last part, from pier 9 to pier 13, it shows a 6% slope. Piers from 6 to 13 are much shorter than the others. The girder is composed by three pre-stressed concrete beams and a concrete slab. The total height of the cross-section is 80 cm. The horizontal distance between the beam axes is 90 cm, the total width of the bridge is 2.50 m, included the two longitudinal parapets. Each span has a length of about 16.70 m, but the first one is 16 m. The beams are supported by the upper plate of the piers by means of leaden pads. All the piers are composed by 4 circular pillars, whose diameter is 50 cm, and by an upper plate of 65 cm height. The pillars start from a rectangular foundation plate, supported by concrete piles with a maximum length of 25 m. The structural elements were in bad conditions due to the carbonation of concrete. All the external beams were damaged, the phenomenon being favoured by the combined action of rain and wind. Several cracks could be seen in the pillars, where the concrete cover was split and the reinforcement bars was uncovered. The upper plates of the piers were damaged too.

We suggested that all the piers should be repaired, in order to be suitable to support the vertical and horizontal loads that can act on the structure. No works were needed on the foundation structures. These may be damaged in the future because of the landslides and the continuous erosion of the soil surface. Therefore they should be monitored or frequently tested.
