Salem Abbey

Conservation of Molasse Sandstone

Albert Kieferle

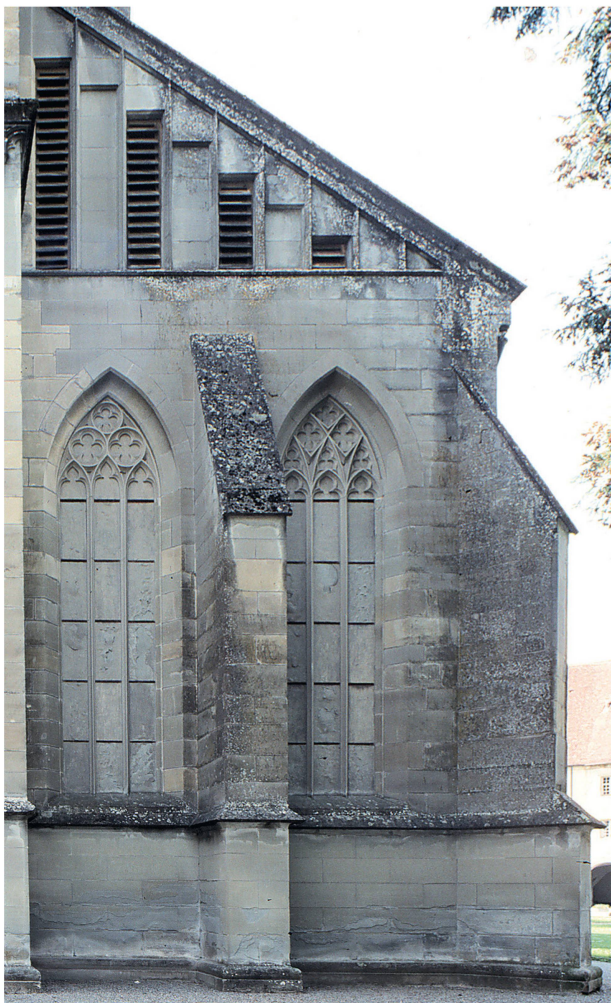
1 Eastern façade before restoration in 1992 (Photo A. Kieferle).

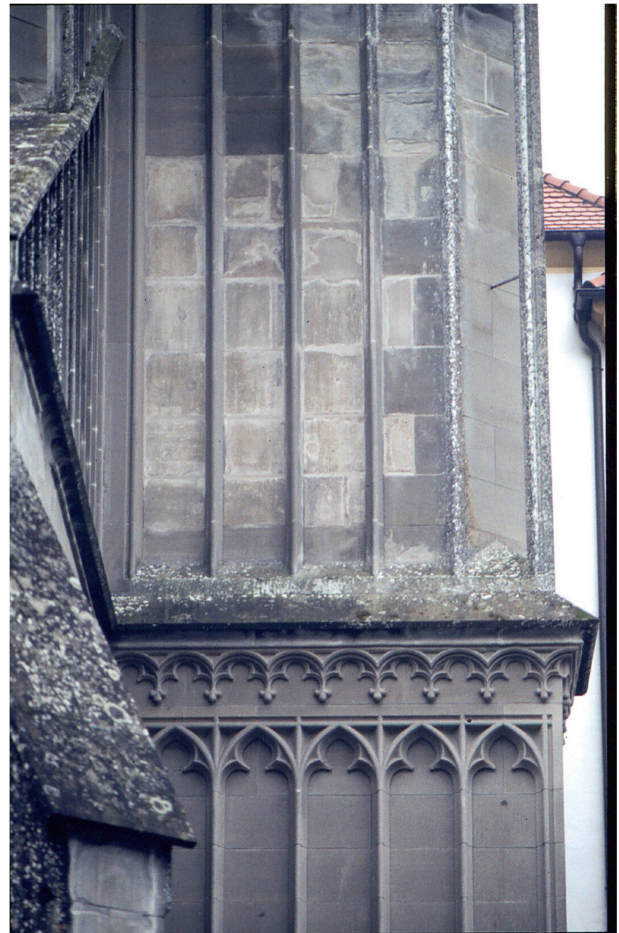
2 West façade after restoration in 2000 (Photo A. Kieferle).

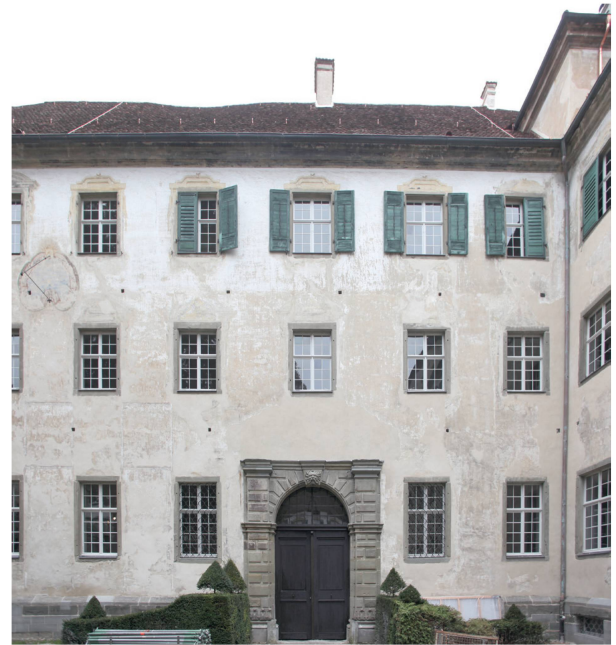
3 *Façade of the eastern court (Sternenhof) after restoration 2011 (Photo AeDis).*

flaking areas. The windowsills that were strongly damaged and are very much exposed to weathering were covered by sills made of lead.
