# The Restoration of a Fortepiano by Conrad Graf, ca. 1838, in the Collection of the Metropolitan Museum of Art

Stewart Pollens

In 2001, the Metropolitan Museum of Art in New York acquired one of Graf's fortepianos made ca. 1838 (Figure 1). Its nameplate reads: Conrad Graf / kaiserl~: kön~: Hof-Fortepianomacher / Wien / nächst der Carls-Kirche im Mondschein N°.102 (Figure 2). The inscription identifies Graf as a court fortepiano maker in Vienna and indicates that his place of business (a former dance-hall named the Mondscheinhaus) was located at no. 102 auf der Wieden, next to the Karlskirche. He worked at that address from 1826 until his retirement, when he sold the property to the piano maker Carl Andreas Stein.<sup>2</sup> The serial number, 2564, indicates that the fortepiano was made shortly before Robert Schumann's Graf (now in the Vienna Kunsthistorisches Museum), which is numbered 2616. The Metropolitan Museum's instrument was acquired from the Castelbarco family in Florence, Italy, and it is said to have been purchased by that family directly from the maker. It has six-and-one-half octaves (CC–f<sup>4</sup>), is triple strung (except for the bottom seven notes, which are

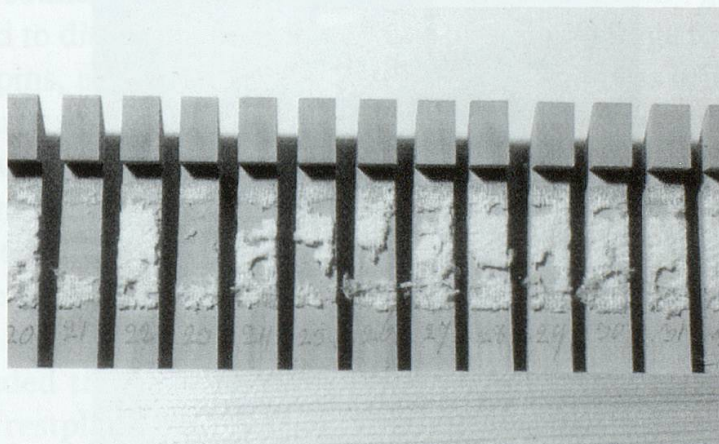
The only original parts that had to be replaced were action cloths (including those mounted on the back rail, escapement rail, escapement jacks, as well as the hammer rests on the key levers), which had been almost completely devoured by moth larvae (Figure 3). As the thickness and resiliency of these pieces of cloth are critical to the proper working of the action, it was necessary to replace them with similar material. Fortunately, the author had a bolt of English wool flannel that matched the thickness and tactile properties of the original parts. When new cloths were installed, the proper key dip was restored, the beak leather slipped nicely into place underneath the escapement levers, and the action came into almost perfect regulation. Though the moderator cloth was somewhat compromised by moth damage, the author elected not to replace it.

Figure 3: Detail of action cloth of fortepiano by Conrad Graf.

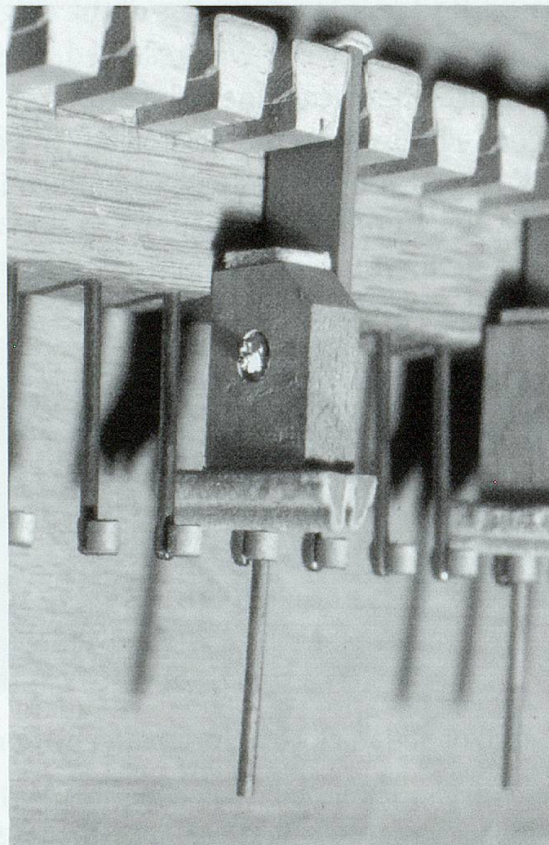
Figure 4: Detail of corroded lead weights in bass dampers.

The damper rack required some re-gluing, and all of the bass dampers were jammed together because the lead weights in them had corroded and expanded (Figure 4). The corroded weights were removed and new ones were fabricated with an arch punch, pressed into place, and leveled with a scraper (Figure 5). Some of the lower extensions of the dampers were broken off. Most of the broken parts were found, but two new extensions had to be fabricated of pear wood and glued in place. Many of the brass guide pins for the dampers were also bent and had to be straightened; a few of the leather-lined parchment loops at the lower ends of these guides were ripped and had to be replaced. A number of the leather covered damper wedges had to be unglued and repositioned so that they would sit squarely on the strings.

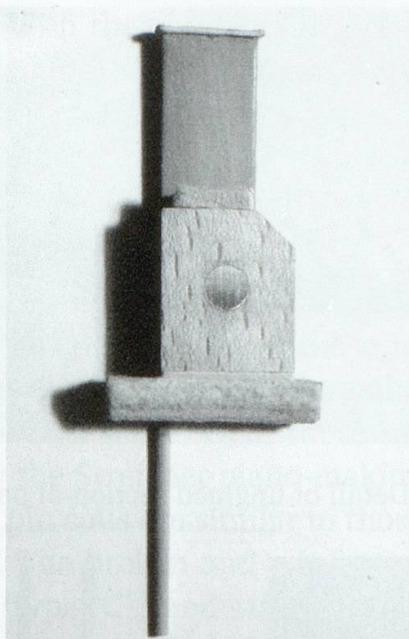
Figure 5: Detail of a replaced lead weight in a bass damper.

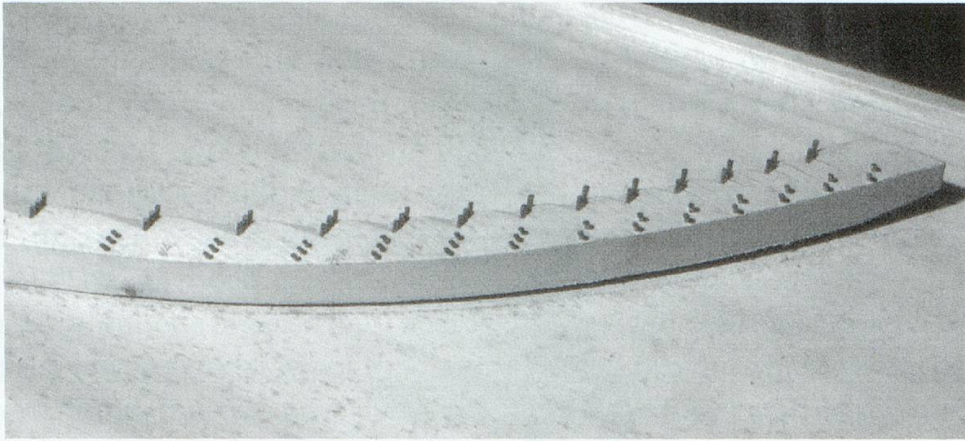
Figure 6: Detail of unglued section of bass bridge.

Graf pianos of this period have screwed-in bottom panels. When removed, the openings provide access to the internal framing and the underside of the soundboard. This facilitated re-gluing of the bass bridge, which was partially unglued and sprung (Figure 6), as well as some of the barring on the underside of the soundboard. To re-glue these parts, boards fitted with Jorgensen veneer press screws were clamped across the top and bottom of the case (Figure 7). The veneer screws were adjusted to apply pressure on the loose part from above while supporting the soundboard from below, and *vice versa*, during gluing operations (pads were used to distribute pressure and to prevent damage to the soundboard, bridge, bridge pins, and other parts). Before gluing the bass bridge, the original strings were carefully loosened so as not to disturb the tuning pin coils, and the hitchpin loops were slipped sequentially onto a length of wire fixed to a block of wood to keep them in order (Figure 8). After the bridge was re-glued, the strings were then re-hitched and tightened up. A fiber-optic viewing device was also used to examine the joinery, and a few needed repairs were made. The wrestplank appeared to be in good condition, with all but a few tuning pins fitting perfectly. Those that needed tightening were repaired by inserting thin hardwood shavings into the wrestplank holes. When removing the tuning pins to insert these shavings, care was taken not to loosen the tuning pin coils so that the original strings could be retained.

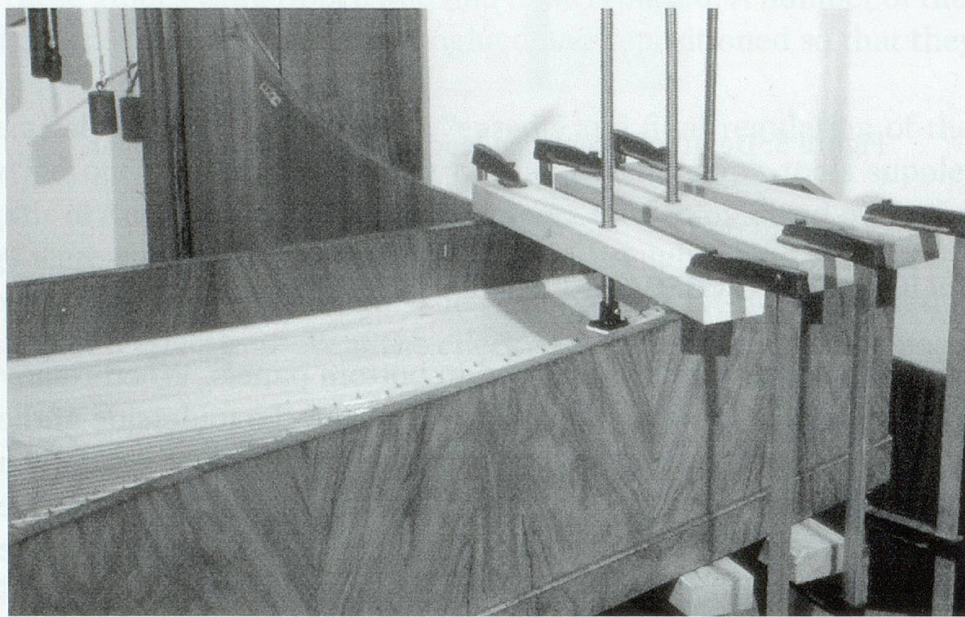
Figure 7: Clamping system devised by author to reglue bass bridge. As pressure is exerted on the bridge from above, the soundboard is supported from below by Jorgensen veneer press screws.

soundboard were leveled with the clamping device described above and then glued with hot animal hide glue; two thin shims were also glued in.

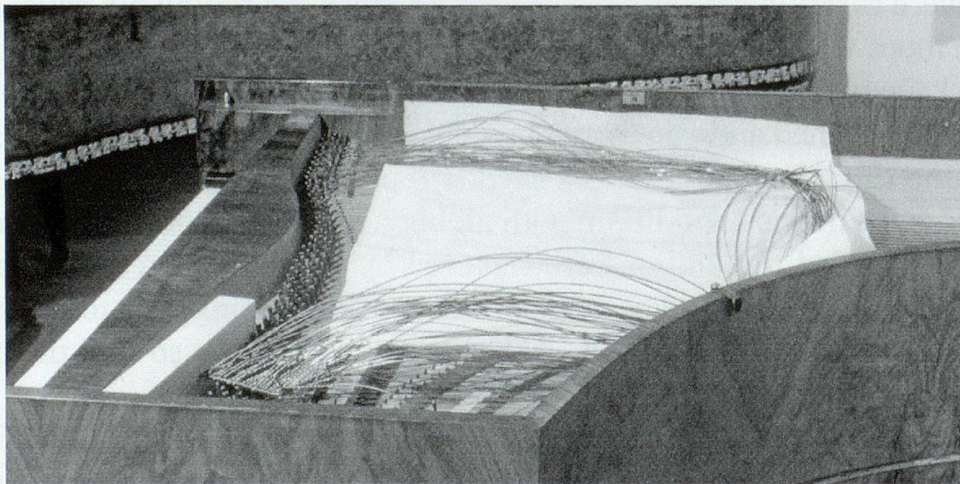
Figure 8: Temporarily unhitched bass strings.
