Zeitschrift:	IABSE congress report = Rapport du congrès AIPC = IVBH Kongressbericht
Band:	6 (1960)
Artikel:	Laboratory testing of full-size aluminium bridge
Autor:	Michalos, James / Kubo, Gerald G. / Birnstiel, Charles
DOI:	https://doi.org/10.5169/seals-7016

Laboratory Testing of Full-size Aluminum Bridge

JAMES MICHALOSGERALD G. KUBOCHARLES BIRNSTIELPh. D., Prof. and ChairmanPh. D., Associate ProfessorM.C.E., InstructorDepartment of Civil Engineering, New York University, New York, N. Y., U.S.A.

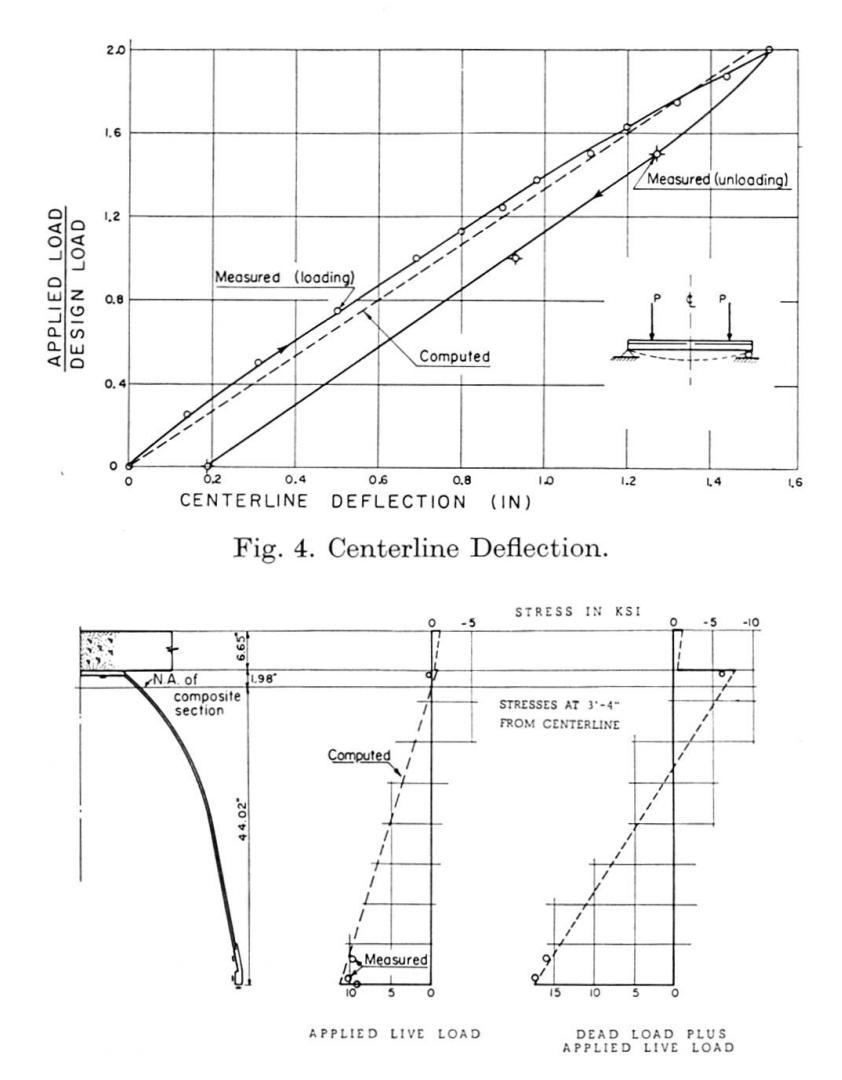
Fig. 5. Stresses at Two Times Design Moment.

Computed bending stresses and those deduced from measured strains, in kips per sq.in., are shown in Fig. 5. In the bottom extrusion the measured values are consistently lower than the theoretical values, with a maximum difference of approximately 10 percent. The strain gage readings on the underside of the top plate, although somewhat erratic because of the very low level of stress, are consistent with the anticipated position of the neutral axis.

Some evidence of structural distress was observed as the applied load was increased from $1^{7}/_{8}$ to 2.0 times design moment and shear. There was some local yielding and buckling in the $1/_{8}$ -in. sheet over the supports. The buckles were of limited size $(1/_{16}$ -in.) and probably represented a readjustment of an unfavorable local condition.

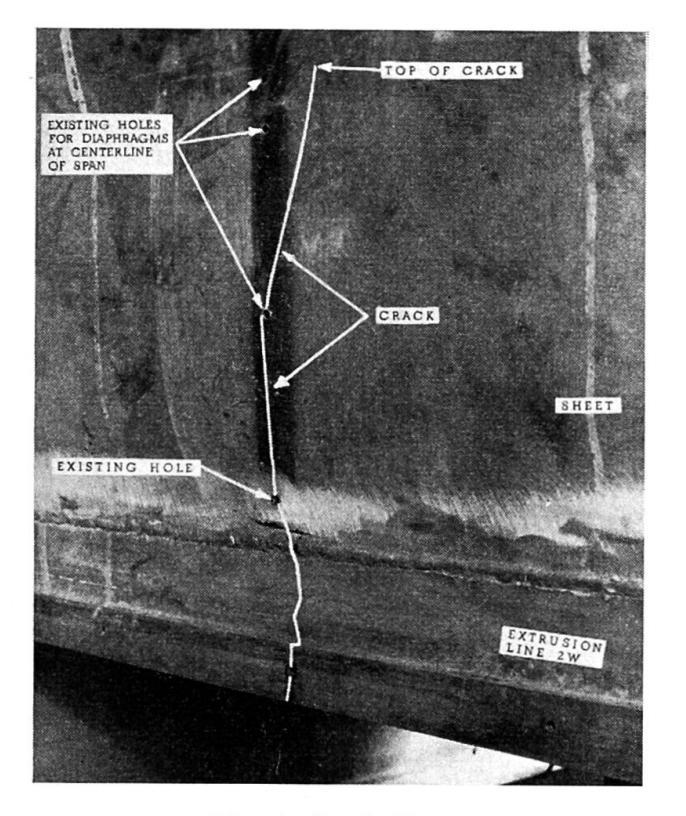
Fig. 6. Crack No. 1.

The 50,000 cycles at 1.0 times design moment were completed without incident. After 360,595 cycles at 1.5 times design moment a crack was discovered. It had progressed through an interior bottom extrusion at mid-span and gone upward into the 1/8-in. curved sheet for a distance of approximately 16 in., almost to the mid-height of the aluminum module. Fig. 6 is a photograph, with the interior diaphragm removed, showing the full extent of the crack. Note its progression through three holes in a vertical line, starting at the 1/4-in. hole in the bottom extrusion.

All of the serious cracks that developed in the structure involved some sort of stress raiser which eventually led to distress under repeated load. The original stress raisers were the holes in the bottom extrusions. As the result of unsatisfactory repair of the cracks induced by these holes, new stress raisers were introduced, and these, coupled with poor weld penetration in some instances, resulted in the formation of still other cracks. In no case was a crack observed that was not due to one of these causes.

A 6-in. wide section of the bottom extrusion and a 4-in. wide by $7^{1}/_{2}$ -in. high portion of the curved sheet was cut out to remove the bulk of the crack. The balance of the crack in the sheet was enlarged with a saw after a hole

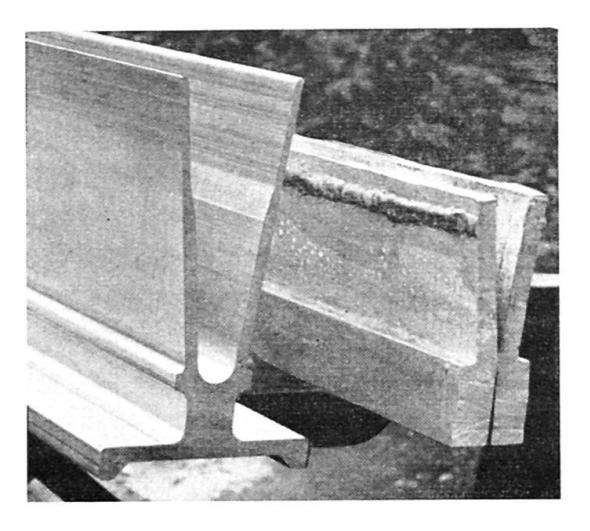
Fig. 8. New and Original Extrusions.

extrusion. It was repaired in a manner similar to that used for the first crack. In addition, 53 holes in the central portion of each extrusion were drilled to 1/2-in. diameter and reamed. Of these holes, the 21 closest to mid-span were then plug welded. Due to the limited size of opening in proportion to depth, it was difficult to obtain full weld penetration. The third crack, working its way through a plug-welded hole in still another interior extrusion, forced a shut-down after an additional 39,760 cycles.

After the third crack, the sponsor decided to discontinue the practice of making repairs as they became necessary and instead remove the central 49 ft. 6 in. of the bottom extrusions and replace them with others of a new design in which all holes were eliminated. Extrusions on interior lines were to be single units rather than pairs.

It was recognized that the test structure would then consist of two groups of parts with different loading histories. The new extrusions would have no history of repeated loads, while the remainder of the structure would have sustained 50,000 cycles at 1.0 times design moment and 447,000 cycles at 1.5 times design moment. In addition, there would be various difficulties involved in making such a major repair, but nonetheless the sponsor considered it preferable to replace the extrusions. A new extrusion is shown in Fig. 8 adjacent to the pair of extrusions it replaced.

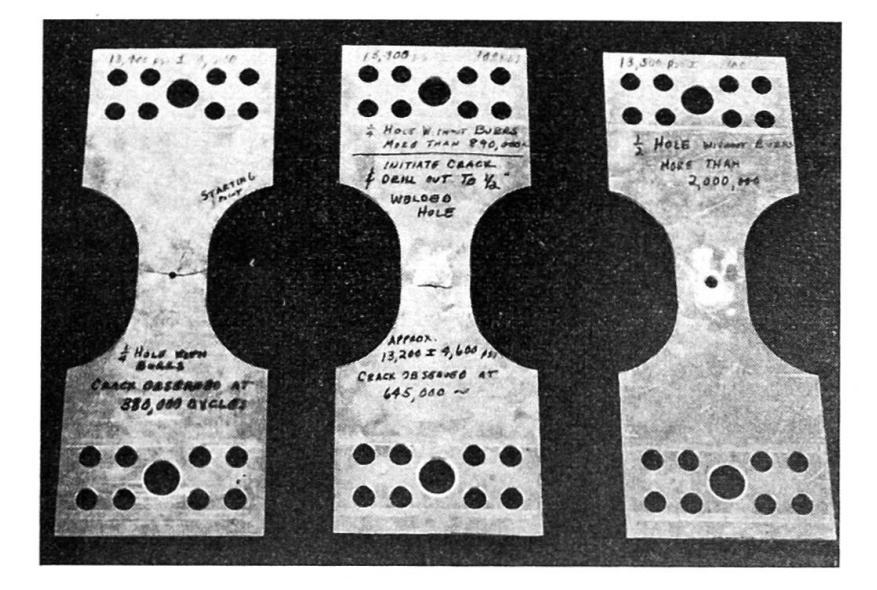
Fig. 9. Fatigue Specimens.

Fig. 9 shows three laboratory specimens that were subjected to repeated load from approximately 9,000 psi to approximately 18,000 psi. This stress range corresponds roughly to dead load and dead load plus 2 times live load. The left-hand specimen, containing a 1/4-in. drilled hole, underwent 380,000 cycles before it cracked. The results compare well with the history of crack number 1 although the cycling of the specimen was at a higher stress level. The middle specimen, which had a drilled hole reamed to 1/4 in., underwent 890,000 cycles before cracking. The hole was then enlarged to 1/2 in. and filled by welding, and the specimen underwent an additional 645,000 cycles before cracking. The specimen on the extreme right was drilled and reamed to 1/2 in. After more than 2,000,000 cycles no crack was observed.
