Zeitschrift: **IABSE publications = Mémoires AIPC = IVBH Abhandlungen**

Band (Jahr): **25 (1965)**

# **Ship Collisions Against Bridge Piers**

CHR. OSTENFELD

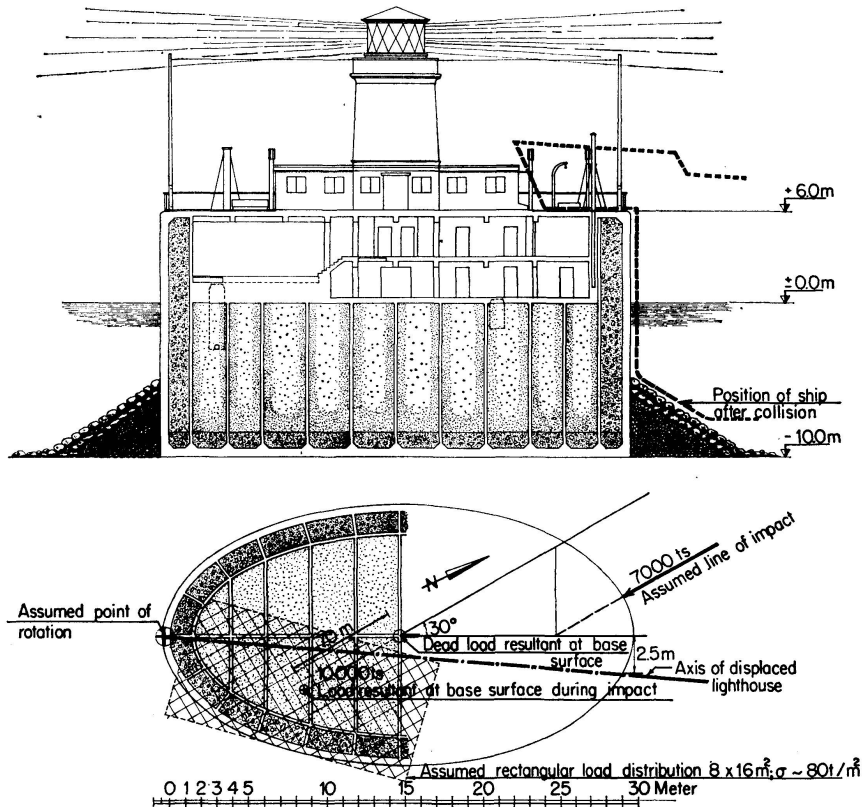
Fig. 1. Drogden Lighthouse, in Øresund, SE of Copenhagen. The plan indicates the ship's line of approach, the displacement of the foundation and the assumed distribution of pressure in the underlying soil at the time of collision.

Northern end of lighthouse (the end involved in the collision) displaced 2.5 m eastward (refer fig. 1). One metre below water level a hole in the concrete resulted,  $2.1 \times 2.5 \times 0.7$  m deep, probably caused by a deck in the ship at this level.

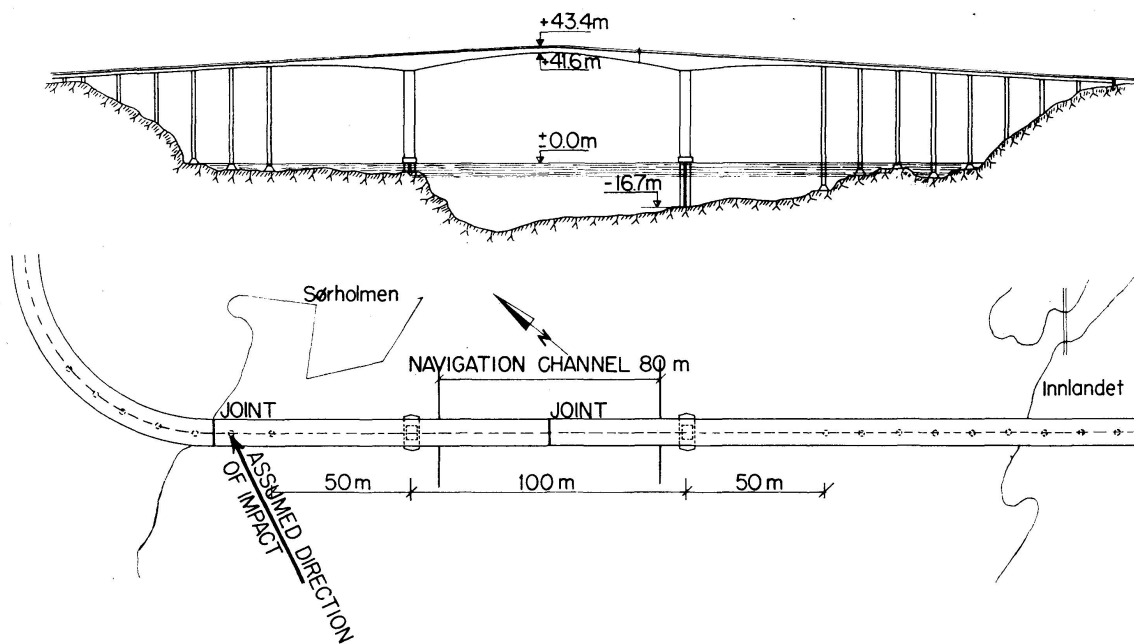
Fig. 2. Sørsund Bridge at Kristiansund, Norway. On the plan is indicated the supposed line of approach of the ship.

The column broke in two places: at the bottom and at the collision-point (the location is not exactly known). The deflection of the column at the collision-point was about 65 cm. The bridge deck was not damaged but was deflected upwards and warped. At a dilatation joint in the deck, located between the column involved and the next landward column, a deformation of 3 cm was observed on one side and 8 cm on the other.

When the column was pressed back into correct position the deck assumed its original shape. The concrete tongue in the joint was broken.

Damages amounted to approx. N. Kr. 200,000.

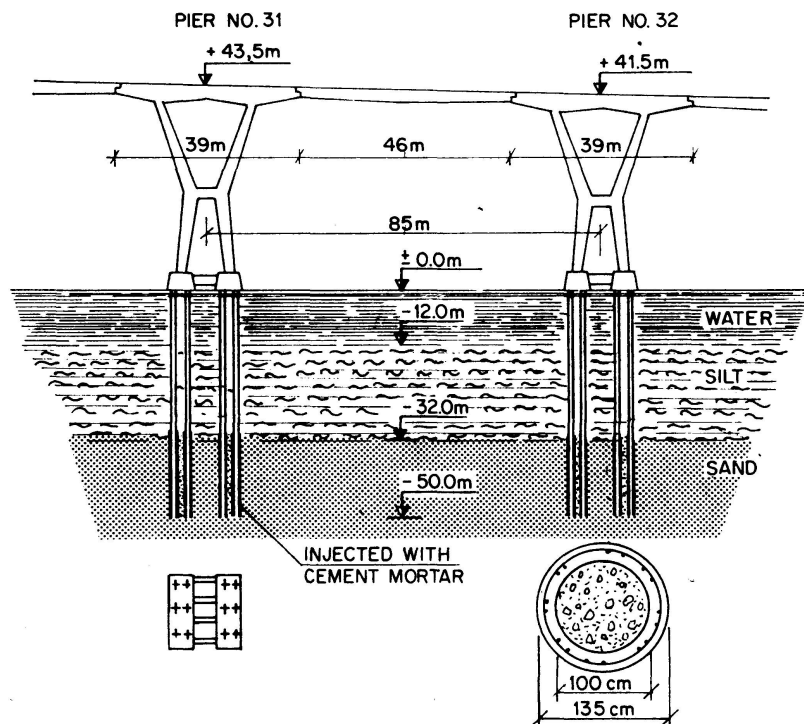
Fig. 3. Maracaibo Bridge, Venezuela. The figure shows the two piers, which were destroyed by the collision.

Two piers (Nos. 31 and 32) and their cantilever structures were destroyed (the piles broke). Three suspended spans fell into the water, and several persons perished, driving in motor cars which happened to be on these spans, or during darkness running their cars into the gap. The damage is estimated at about 5 million dollars.

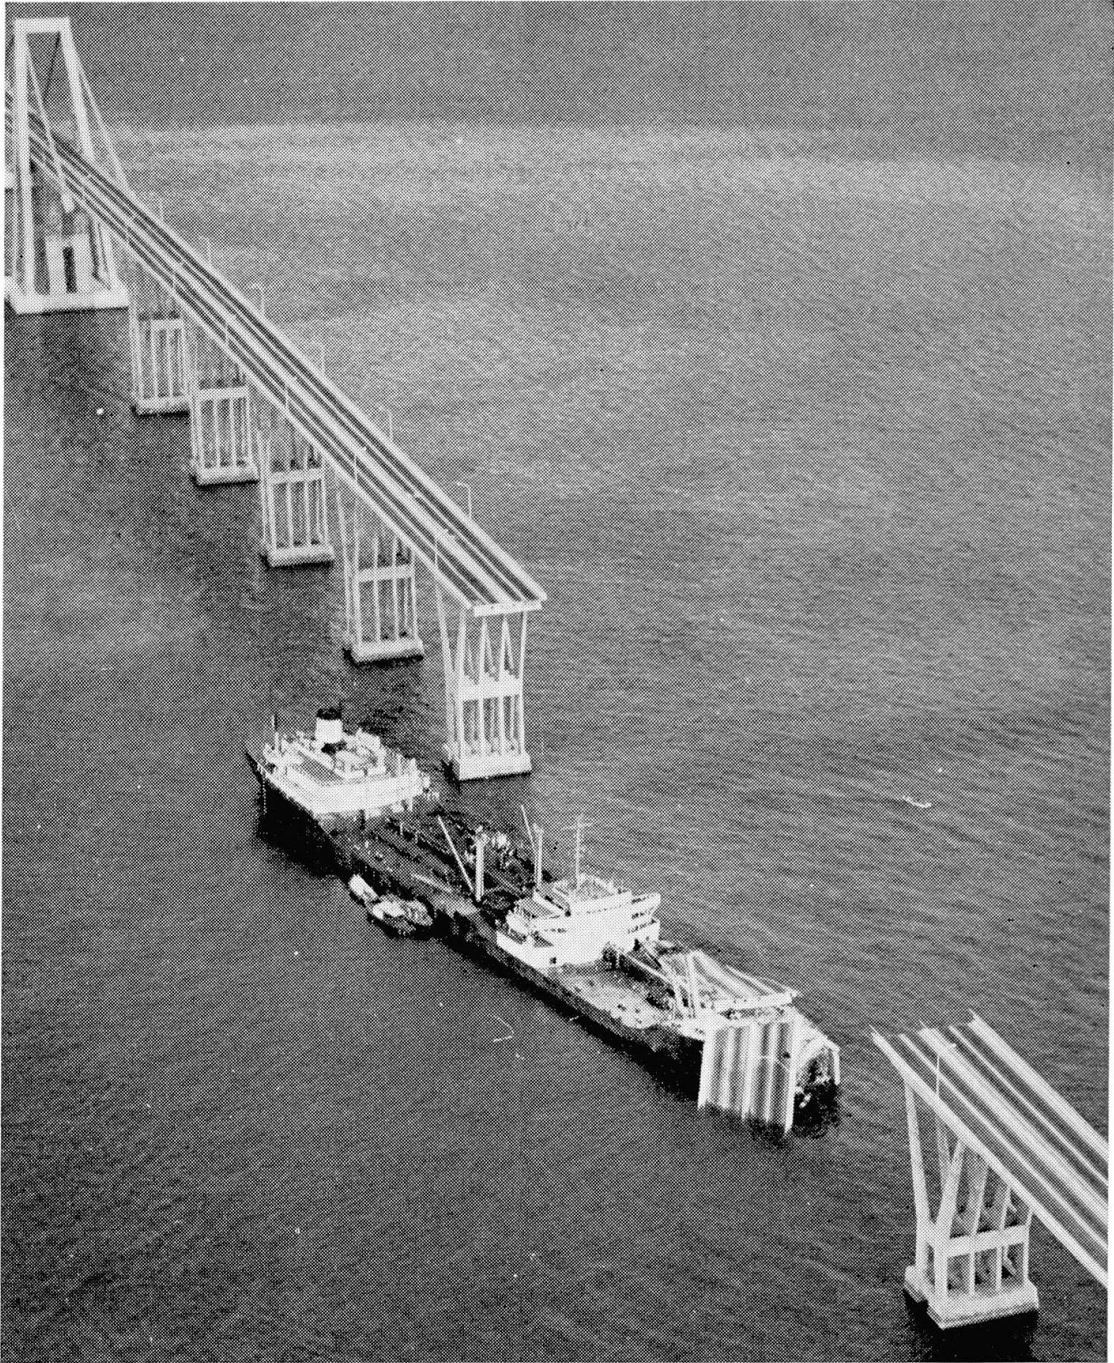
Photo 1.

Suspended spans fell down upon the bow of the ship and considerable damage resulted. The ship sprang a leak, it remained afloat, however (see photos 1 and 2).

Maracaibo bridge after the collision.

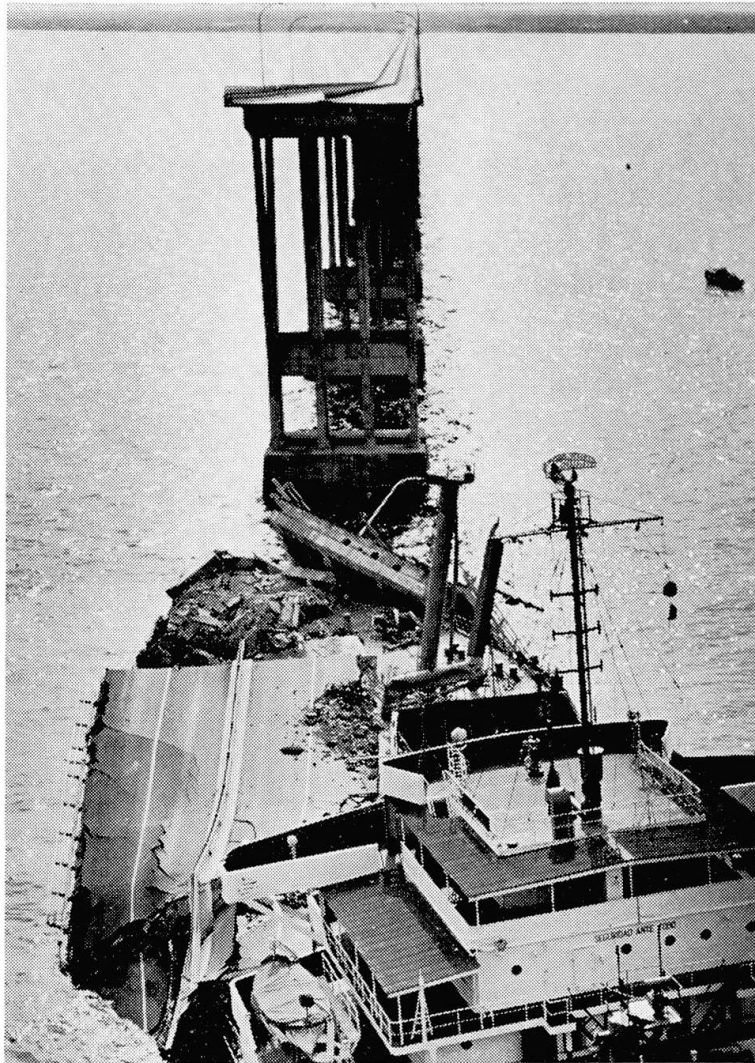
Photo 2.

Maracaibo bridge after the collision.

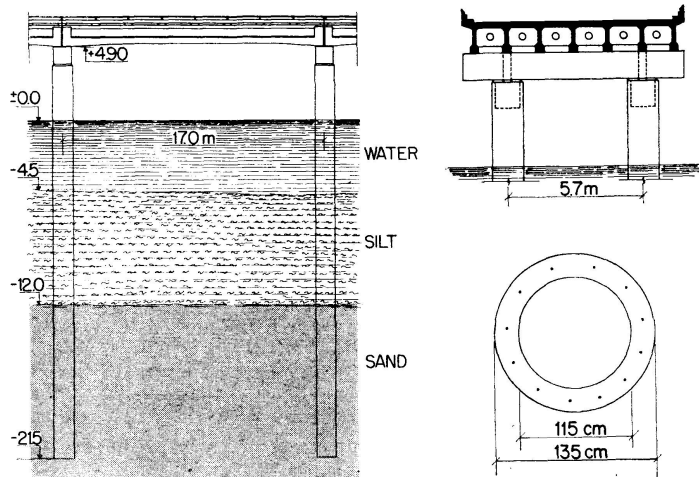
Fig. 10. Pontchartrain Bridge at New Orleans.

3 trestles were hit by the collision, 4 bridge deck elements fell into the water. Two of the trestles were renewed (new piles driven), the third was repaired. Four new bridge deck elements were erected. Total cost of repair about 150,000 dollars.

Due to the frequent collisions (five up to now) the repair service of this bridge is exceptionally well organized. Piles and deck elements are ready in stock. A floating derrick-crane drives the piles and erects the elements. In this particular case the bridge was ready for use within five days.

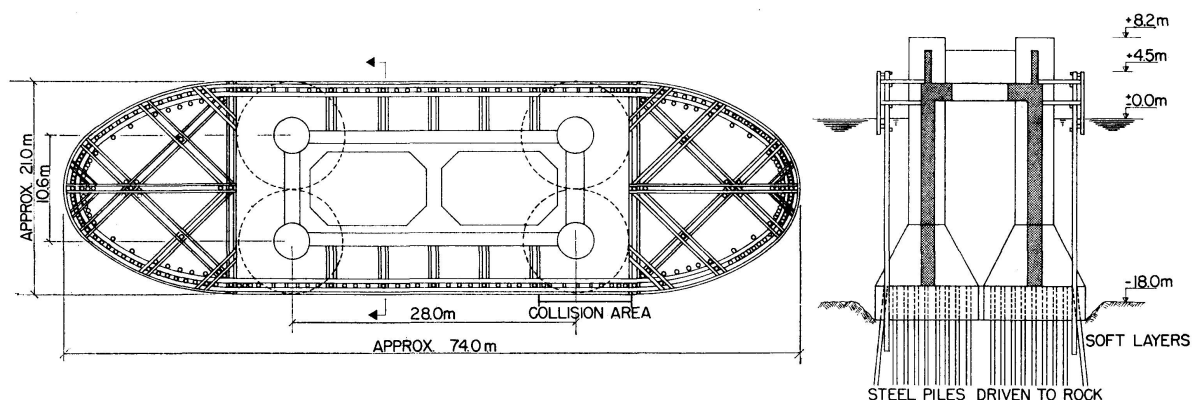
Fig. 15. Richmond-San Rafael Bridge, California. Pier protection, plan and section. Note particularly the extent of the protection in comparison to the four slender bridge piers.

The part of the protecting structure that was hit (opposite to a pier shaft) was completely destroyed. The damage amounted to about 23,000 dollars. The pier suffered no damage.

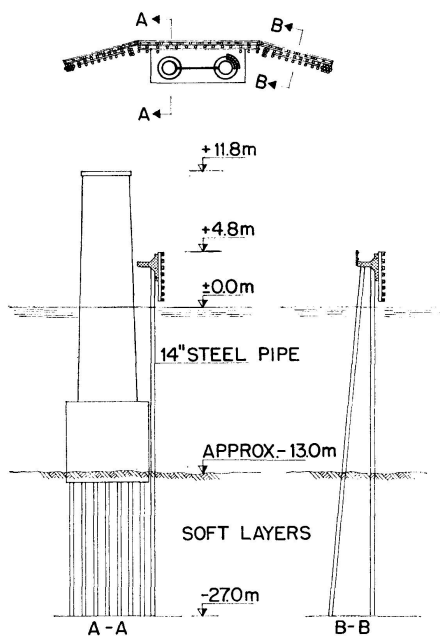
The part of the protecting structure directly involved in the collision was totally destroyed. The damage amounted to about 75,000 dollars.

Fig. 17. San Mateo-Hayward Bridge, California (old bridge). Plan and section of pier protection.

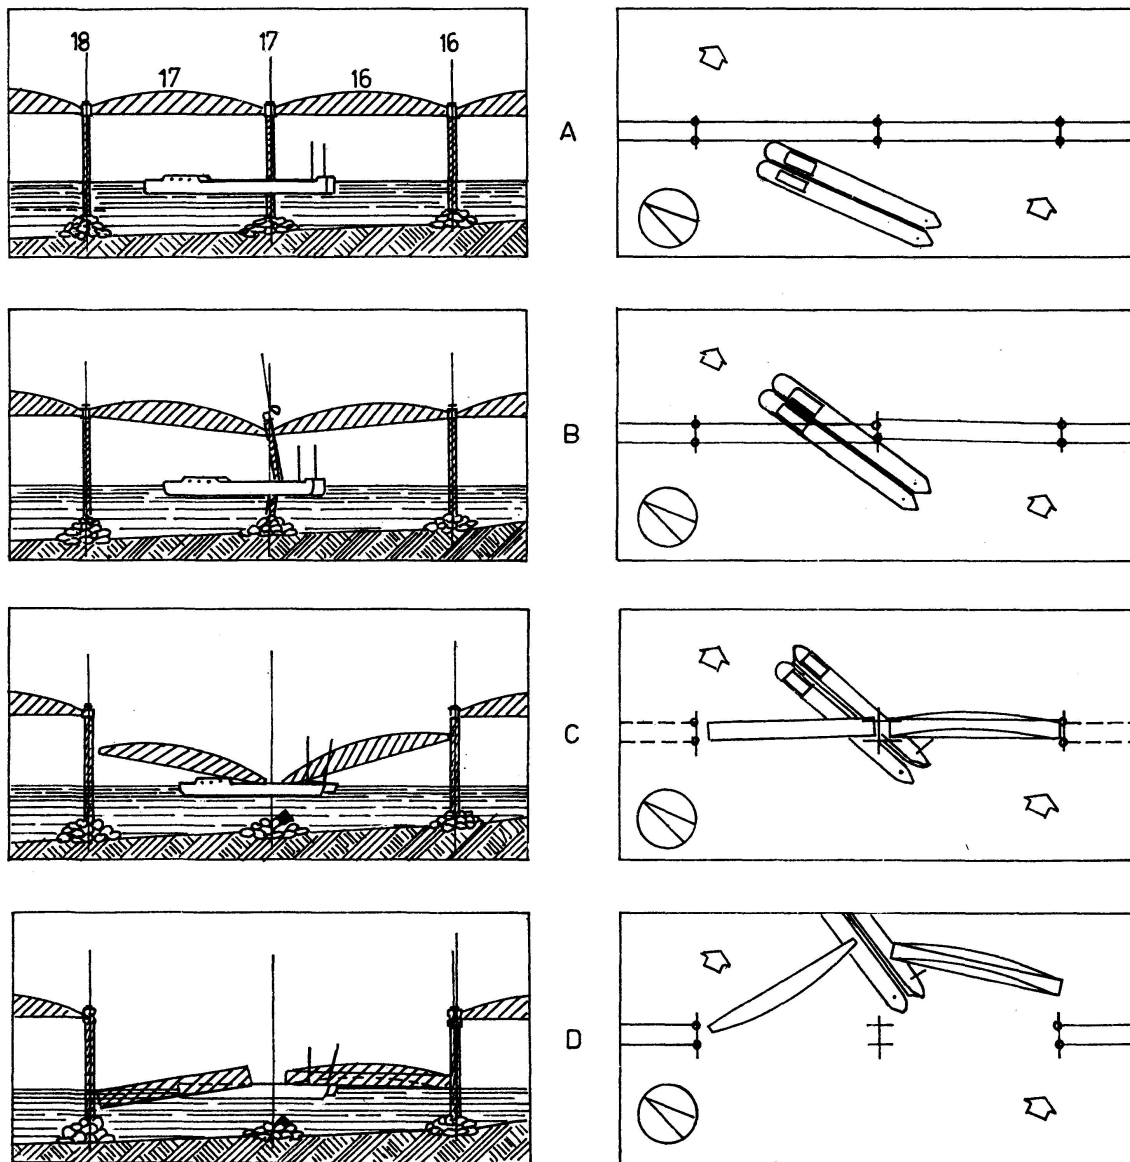
Fig. 21. Severn Railway Bridge, England. Reconstruction of events.

Fig. 21 illustrates the results of a thorough investigation undertaken by Peter Mason, Consulting Engineer. As a matter of course, Peter Mason undertook, among other investigations, a calculative analysis of the impact, and found — quite naturally — that the pier could not take any impact of importance.
