| Zeitschrift: | IABSE structures = Constructions AIPC = IVBH Bauwerke |
|---|--|
| Heft: | C-46: Repair and rehabilitation of bridges: case studies I |
| Artikel: | The bridge in the Radnika Street in Belgrade (Yugoslavia) |

9. The Bridge in the Radnička Street in Belgrade (Yugoslavia)

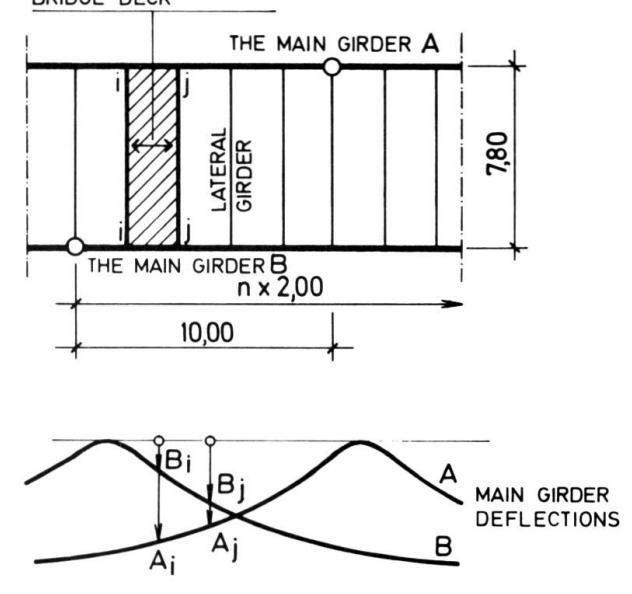
Fig. 2 The connection between main and lateral steel girders

The bridge is skewed, in vertical curvature with the biggest slope of 6%, the length being $9 \times 36 + 10 = 334$ m and the useful width 6 m, (Fig. 1). The main box girder, lateral compound I beams, horizontal bracing and box columns are made of steel. The connection between the main and lateral steel girders is presented in Fig. 2.

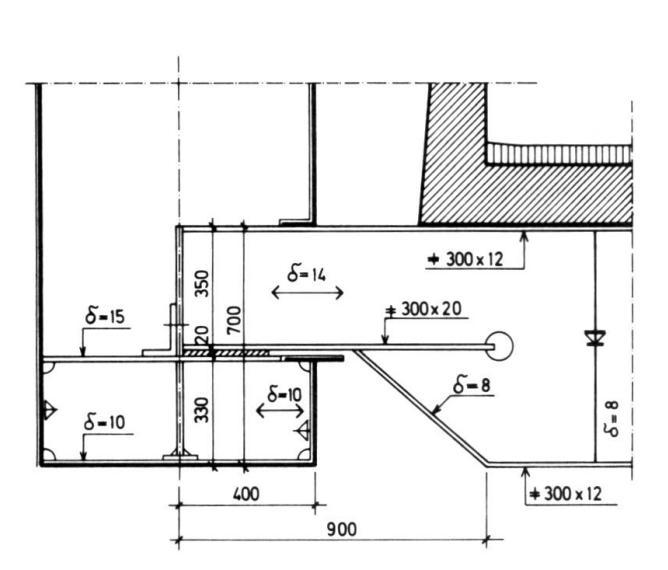
As the direction of lateral girders did not coincide with the skew position of the columns, unequal deflections of the lateral girders ends used to take place whenever a vehicle crossed the bridge and those girders were the supports of reinforced concrete deck slabs, Fig. 3. The permitted movement of heavy vehicles by the right main girder only, still increased the unequal deflections of the lateral girders ends causing torsion and additional inconvenient stressing of reinforced concrete deck slabs.

Those slabs were connected to the upper chord of the lateral steel girders by tins anchored into the mass of concrete with four skrews on both supporting edges. In the course of time, the connection was weakened and permanent damages of bridge decks above lateral girders took place. The lateral joints in asphaltic bridge deck, placed on each 2 m along the length of the bridge caused, beside uncomfortable drive, constant unforseen dynamic impacts to the structure of the bridge. The repair of the bridge deck was practically impossible.

Fig. 3 Unequal deflections on lateral girders ends by which reinforced concrete deck slabs were supported

That was why, in 1981, rehabilitation of the bridge had to be done. All prefabricated reinforced concrete bridge slabs were replaced by the new slabs with the increased reinforcement without haunches. Through 1 cm thick rubber strips and arbolite substratum the slabs were elastically supported by the lateral girders. The interconnection of slabs was also elastic, achieved by four longitudinal bars sealed by epoxy putty. The strains between the slabs were sealed with a soft material. The basic idea was to enable independent deformation of individual slabs when vehicle crossed the bridge.

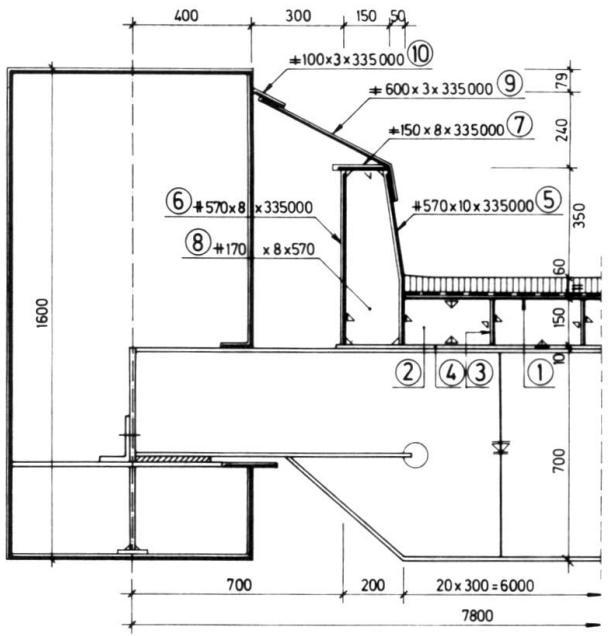
Fig. 4 The cross section of the bridge after rehabilitation

A relatively expensive but from the engineering point of view the most correct alternative solution was applied. The reinforced concrete bridge deck slabs were replaced by a orthotropic steel plate. However, due to the required minimum traffic brake and due to the existing connection between lateral and main girders, a modified orthotropic steel plate instead of the classical one was applied. Prefabricated, 10 m long assemblies of the orthotropic plate were delivered to the site and, in order to facilitate erection, their width was half the width

of the bridge so that the medium longitudinal seam was welded on the site. The connection of the orthotropic plate with the upper chord of the lateral girders was achieved by welding to the lower flange of the orthotropic plate, (Fig. 4).

Beside a correct engineering solution for the specific case, the application of the orthotropic steel plate achieved a decreased dead load of the structure which in the course of time proved very convenient for the increased live load.
