Zeitschrift:	IABSE structures = Constructions AIPC = IVBH Bauwerke
Band:	12 (1988)
Heft:	C-46: Repair and rehabilitation of bridges: case studies I
Artikel:	Rehabilitation of Yamuna Bridge at Kairana (India)
Autor:	Manjure, P.Y. / Rohra, M.R.
DOI:	https://doi.org/10.5169/seals-20929

10. Rehabilitation of Yamuna Bridge at Kairana (India)

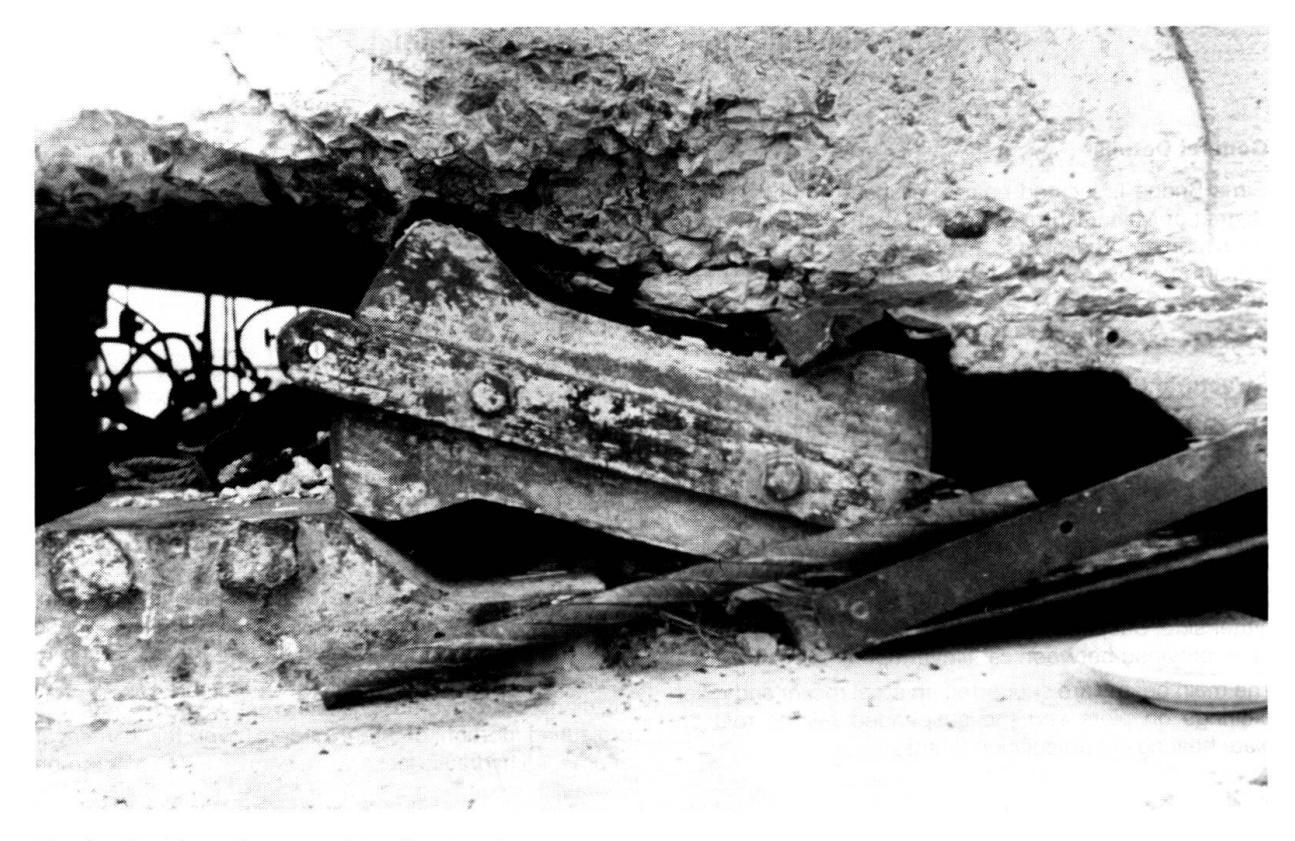
Fig. 2 Position of segmental roller bearings

Tapered steel shims were used to cater for change in inclination of span over supports, during lifting operation. After bringing the span to the level position, the suspended spans were shifted longitudinally to their original position by use of Freyssinet flat jacks at the expansion joint positions.

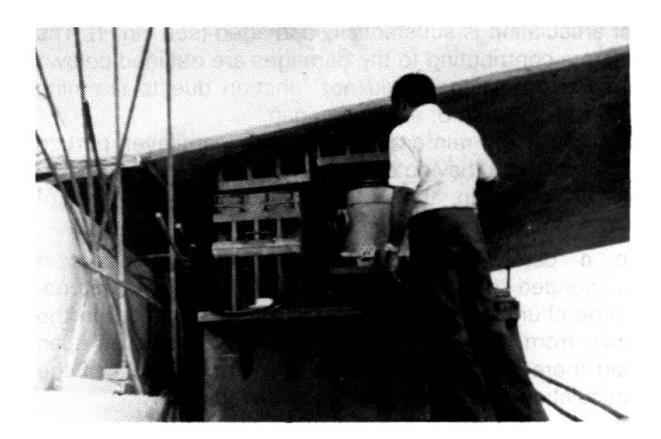
Fig. 3 Lifting arrangement

The well cap was also strengthened. Six numbers steel supports were erected from the well cap for lifting of the box girder. Each box girder was provided with two lifting points, one on either side of the pier. The large diameter Hydraulic Jacks of 200 tonnes capacity with safety nut arrangement were used for lifting the weight of 800 tonnes. In addition to the jacks stand-by support points were provided. Steel packing was provided over these support points continuously during lifting operation.

Before commencement of lifting operation, all the cracks were injected with epoxy resins. The sloping suspended spans were properly held with the cantilever tips to prevent any undesirable movement during lifting operation. To achieve uniform reaction at all the lifting points, all the jacks were connected to a common hydraulic circuit. The soffit of box girder was sloping. Therefore, wedge shaped steel boxes were fixed to the soffit for getting level surface at lifting points. Lifting arrangement is shown in Fig. 3. Packing boxes of different heights were planned so as to have a minimum number of them in position at any given time.
