Zeitschrift:	IABSE structures = Constructions AIPC = IVBH Bauwerke
Band:	12 (1988)
Heft:	C-46: Repair and rehabilitation of bridges: case studies I
Artikel:	Rehabilitation of Girna Bridge (India)
Autor:	Manjure, P.Y. / Rohra, M.R.
DOI:	https://doi.org/10.5169/seals-20930

# 11. Rehabilitation of Girna Bridge (India)

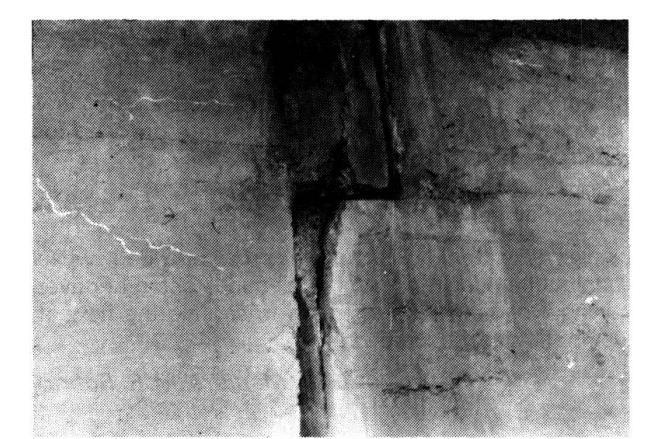
The distress mainly was in the superstructure. In the year 1980, it was observed that the concrete in the zone of articulation is substantially damaged (see Fig. 1). The factors contributing to the damages are outlined below:

- i) Plate bearings could not function due to jamming and absence of expansion gap.
- ii) The main reinforcement in the cantilever portion was found having excessive cover.
- iii) Concrete in the articulation zone was not of adequate quality.

In a particular span (No. 6), distress noticed in suspended span at articulation was of higher magnitude. Large chunks of concrete were found separated in the span from the cantilever tips and the suspended span had therefore settled by about 40 mm. In most of the articulation tips, wide cracks had developed.

Fig. 1 Distress at articulation

Replacement of steel plate bearings by Neoprene Bearings and repairs to damaged concrete portion at the articulation were considered essential. For this purpose, it was necessary to lift the suspended spans and reconcrete the cantilever tips. Lifting of suspended spans was required to be done from the deck level since height of the superstructure was about 15 metres from river bed (see Fig. 2).

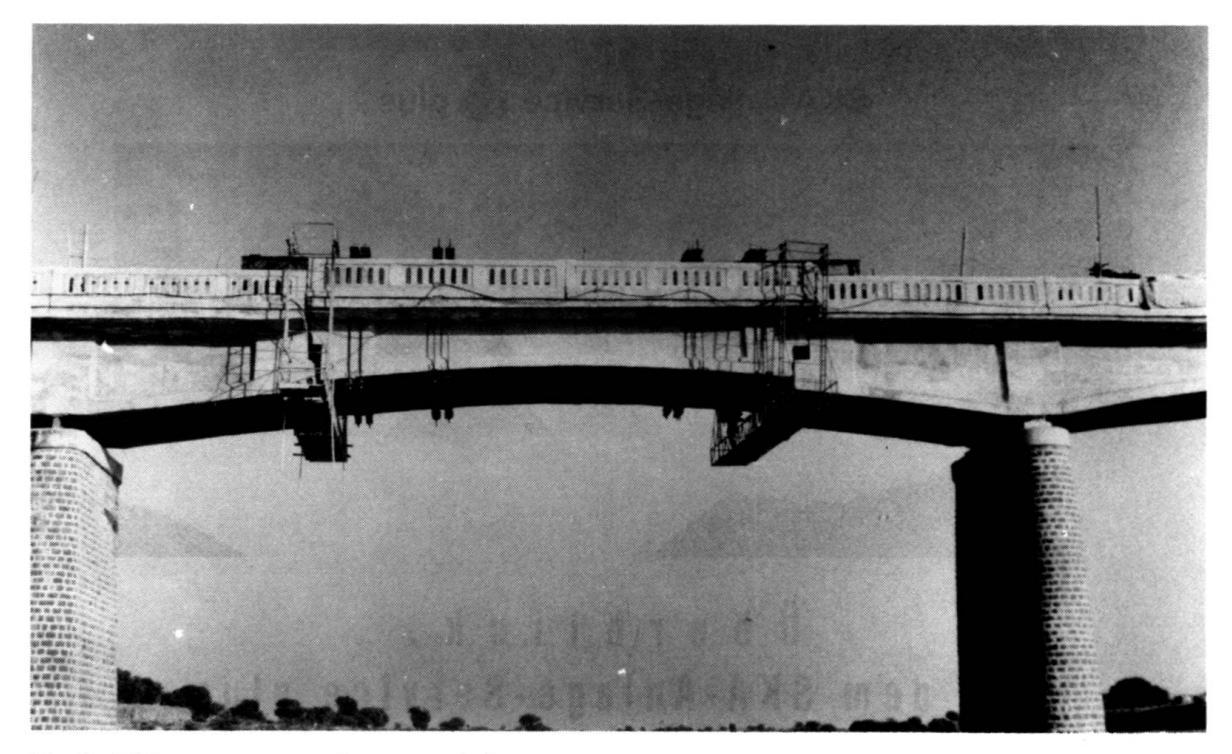
Fig. 2 Lifting arrangement for suspended span

Fabricated steel girders were placed in line with reinforced concrete beams over articulation portion. These steel girders were connected to reinforced concrete beams by means of Alloy steel suspenders at two locations. The hydraulic jacks were placed under the projecting portion of steel girders over the cantilever beams. All hydraulic jacks were connected to a common hydraulic circuit.

Lifting of the suspended span could be achieved by pressurizing the hydraulic circuit. It was possible to obtain almost uniform lifting, by controlling the valves on the circuitry. The span was raised by about 40 cms. Specially fabricated light weight platform was suspended from the deck for providing access to the articulation zone. Damaged concrete was removed by using pneumatic tools. Additional reinforcement was welded to the existing reinforcement (see Fig. 3) and reconcreting was done by using epoxy bond layer at the interface of old and new concrete. At this face, subsequently, epoxy was injected through the inlets provided at the time of concreting.

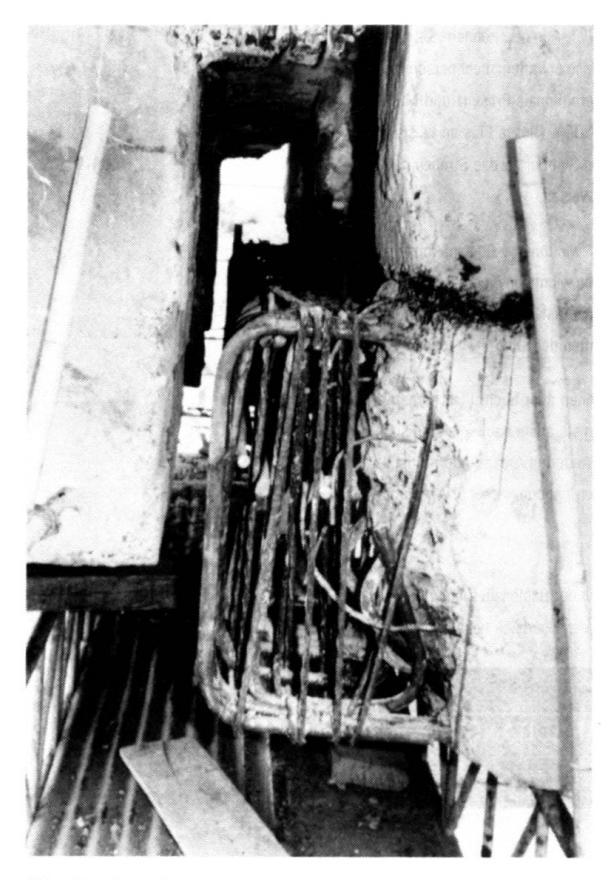
Fig. 3 Cantilever tip is broken and additional reinforcement is provided

In one span, external prestressing rods were provided to prevent separation of old concrete to new concrete besides other measures.

Neoprene Bearings were placed in position and the span was lowered onto these bearings after the new concrete has attained minimum strength for dead load reaction. The prestressing rods were grouted after 3 months or so, to enable monitoring at articulation during this period. These rods were restressed to make up slight loss of prestress and then grouting was carried out.
