Zeitschrift:	IABSE reports = Rapports AIPC = IVBH Berichte
Band:	42 (1983)
Artikel:	Case stories of dolphin accidents and remedies
Autor:	Naoi, Yoshiaki / Ishikawa, Toshiyuki
DOI:	https://doi.org/10.5169/seals-32401

# **Case Stories of Dolphin Accidents and Remedies**

The report outlines recent ship collision accidents with dolphins in Iwakuni, Japan and their remedies.

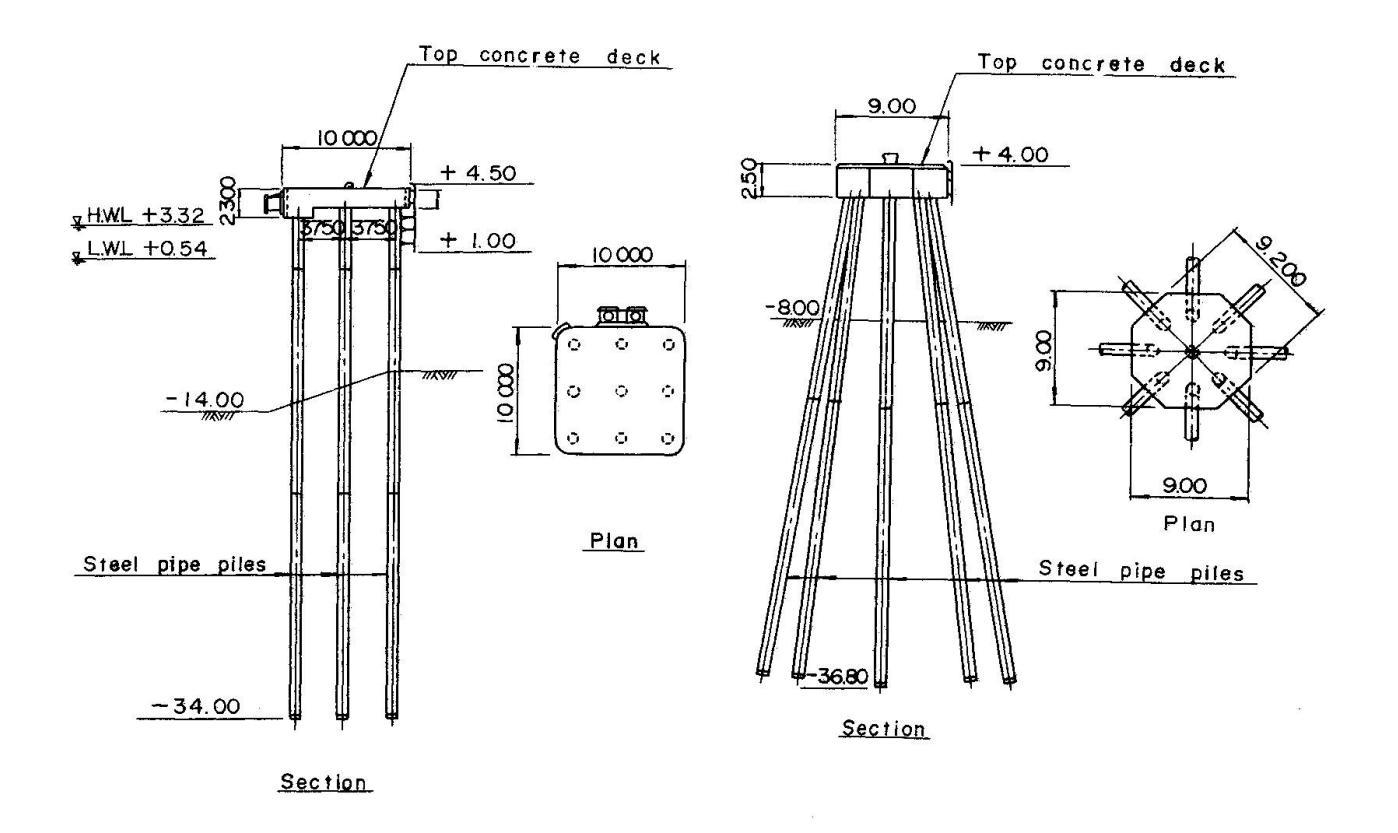
Fig.2 Structure of Dolphin B-3

As shown in Fig.2 the Dolphin B-3 consists of 9 steel pipe piles (914.4 mm in diameter, 16.0 mm in thickness, and 41.5 m in length) and the top concrete deck. The structure has the flexibility to absorb the kinetic energy of ship berthing for an approaching velocity of 15 cm/sec. That is, the resisting capacity against impact is maintained by the mutual effect between the rigidity of the steel pipe piles and the viscoelasticity of the foundation strata.

In the structure of the Dolphin M-1, 9 steel pipe piles (609.6 mm in diameter, 12.7 mm in thickness, and 40.5 m in length) composed of 8 radial battered piles and 1 vertical pile are rigidly connected with the top concrete deck. This mooring dolphin has a rigid structure in contrast with the breasting dolphin, that is, the static load worked through mooring ropes is borne by the structure so that a ship can keep a certain distance with the berth.

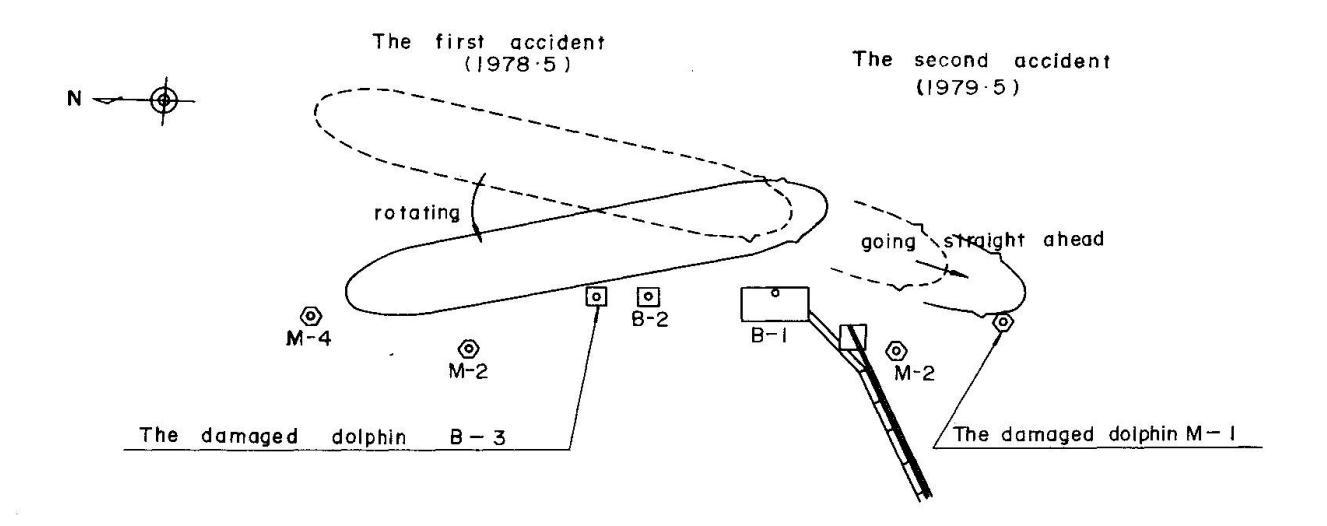
#### Fig.4 Geometry of the Collisions

While the vessel was approaching on her starboard side to the sea berth, the ship swung her stern towards the right side in order to maintain the correct direction for her berthing. After that, the side of the vessel collided with the fender on the corner of the north sub-breasting dolphin B-3.

The fender itself had no function to absorbe the impact energy of ships, therefore, the inertia force of the moving ship was directly loaded on the dolphin structure, and the foundation piles were deformed.

As in the first accident the same cargo vessel, in 1979, lost proper speed while she was approaching the berth from the north, then collided with the south mooring dolphin M-1.

Both collisions were caused by the mistakes of the operators. But, as described in the beginning of the article, Japanese coastal/offshore structures are located in very confused sea areas and it is one of the reasons of the frequent occurence of ship collision casualties.

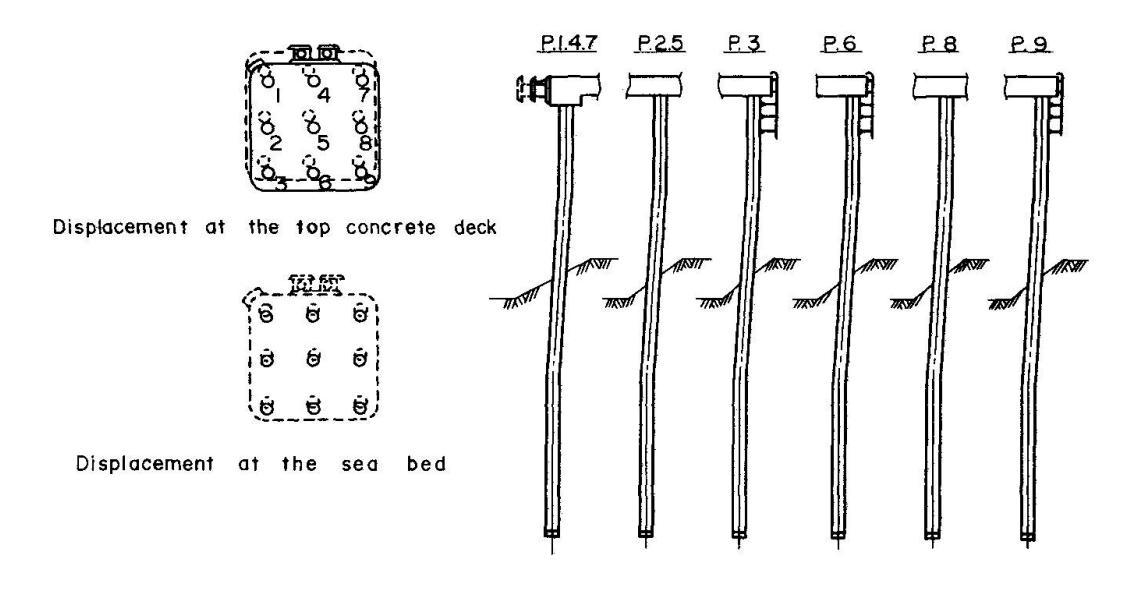
Fig.5 Deformation of Dolphin B-3

Upon measuring the damaged dolphin, the deformation was found to be the residual displacement of the top concrete deck:

Horizontal displacement:

In the direction of the berthing line ----- 25.2 cm In the direction of right angle to the berthing line ----- 97.2 cm

Vertical displacement:

Inclination towards the shore on the diagonal line ----- 0° 20'

Upon inspecting the piles in the water, the buckling on the piles were found near the welded joints of No.3,6,8 & 9 piles 2 m deep in the water and the shells thereon had been torn off.

The deformation by the collision was more severe on the opposite piles of the collision side. From that fact it was presumed that the dolphin was rotated by the collision impact (the horizontal force) so that those opposite piles were loaded by both the force at a right angle to the axes and the axial force (the compressive forces).

Further, the maximum deformation was found on the middle piles (12.7 mm in thickness) while the upper piles above D.L. -0.50 m were still vertical with little deformation. The reason for this is that the materials of the upper piles were thicker (16.0 mm in thickness) and they were stuffed with filling concrete.

After the diving inspection, voids of 40 cm in width and 100 cm in depth were observed in the sea bed on the offshore side of the piles. It indicated that plastic deformation in the ground occured by the energy exerted by the collision.

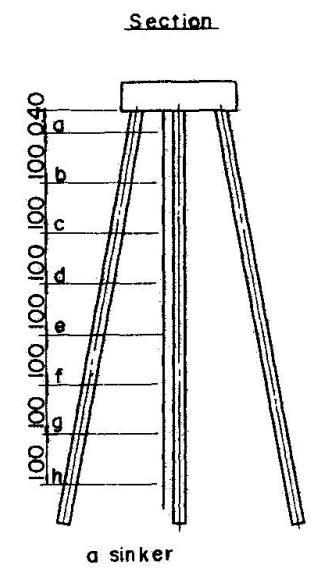
Fig.6 Deformation of Dolphin M-1

An opening made by the collision was found at the junction of the top concrete deck with the steel pipe piles. This opening was 20 cm at its maximum in a direction of north-west. At the same time a wedge from the shearing force (1.6 m in width, 0.2 m in height, and 0.4 m in depth) appeared in the concrete deck.

Upon measuring the deformation of the central vertical pile in three directions, the maximum displacement of 25 cm was observed in the direction of south-east. (See Fig.6)

Shells of barnacles and sea mussels had been torn off around the tidal zone at the top of the piles, and it indicated the hysteresis of deformation.
