Vulnerability of Norwegian Bridges across Channels

Per TAMBS-LYCHE Director Bridge Division Public Roads Administration Oslo, Norway

SUMMARY

The paper describes the procedures for protective actions taken for securing bridge foundations against ship collisions. Relevant loads used in the design are given. No major catastrophe has occured. Some minor collisions causing relatively serious damage are described. A survey undertaken in 1982 to spot and evaluate the bridges that could be in danger of ship collision are presented.

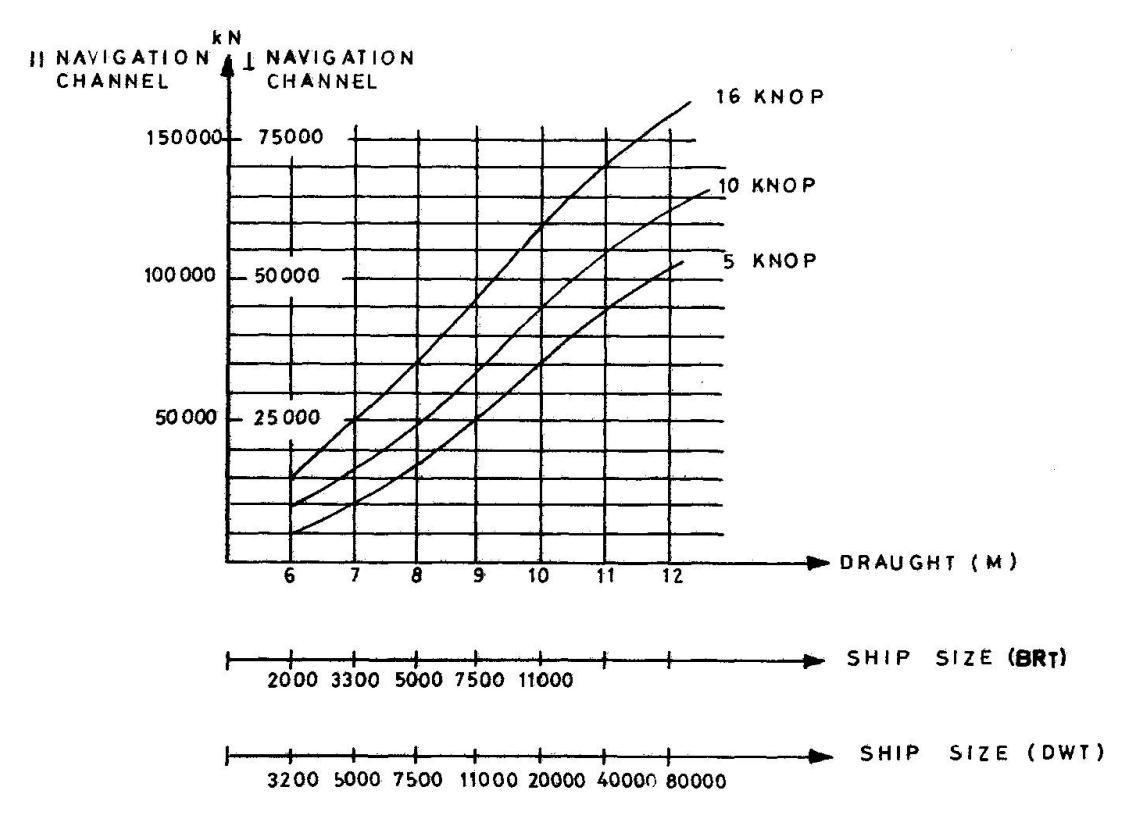
Fig. 1 Magnitude of ship collision force as a function of ship size and speed

Norwegian bridge foundations adjoining a ship channel are as a rule designed for a static force of 3000 MP perpendicular to the bridge's axis (parallel to the channel) and 1500 MP parallel to the bridge. The foundations are usually supposed to be rigid. The size of this force is approxemately supposed to represent a ship of 8000 dwt at a speed of 5 knot.

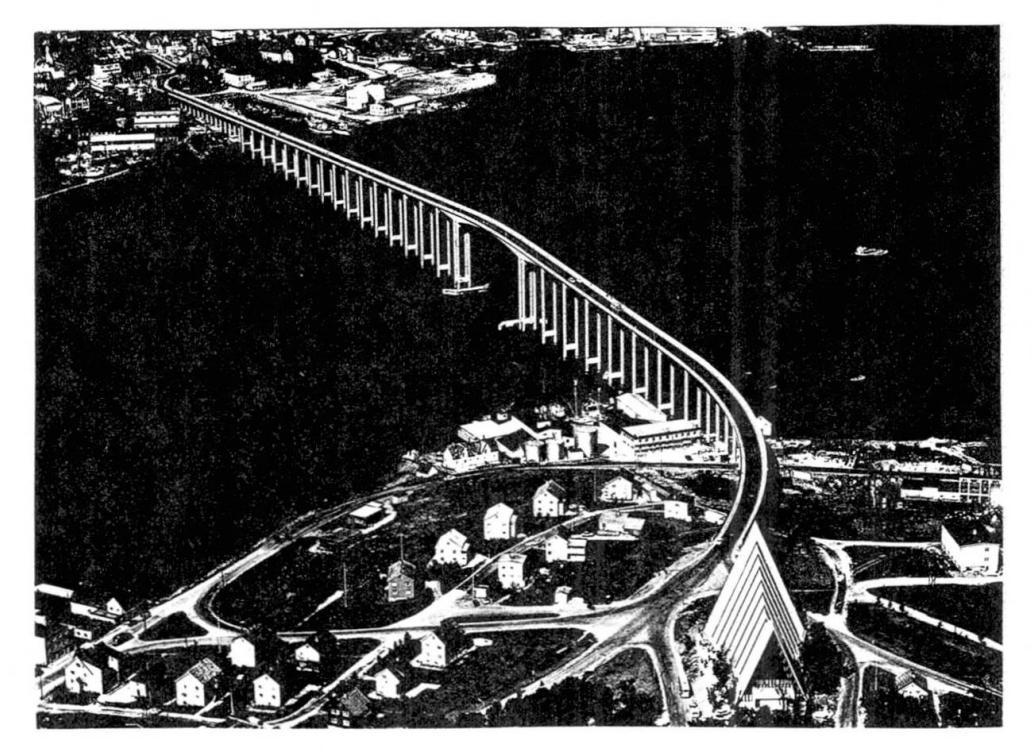
Fig. 2 Tromsø Bridge

To day, having learned by experience from several serious accidents around the world, and also a great number of smaller accidents in Tromsø Sound, we must state that the risk of collision between passing ships and the columns of Tromsø Bridge, was not satisfactorily judged when the bridge was planned.

The center to center distance between the two pairs of columns on each side of the main span is only 80 metres, and between fenders protecting these columns, the channel is only 60 metres wide. Between the main span and the abutments on the Tromsø side and the Tromsdal side respectively, the distance between the pairs of columns varies from 24 to 10 metres.

- I Installation of radar echo equipment along the main channel (on buoys of skerries).
- II Installation of navigation lamps and/or improving existing lighting systems on the bridge.
- III Installation of special warning devices to stop all the traffic across the bridge in case of serious damage to the structure.

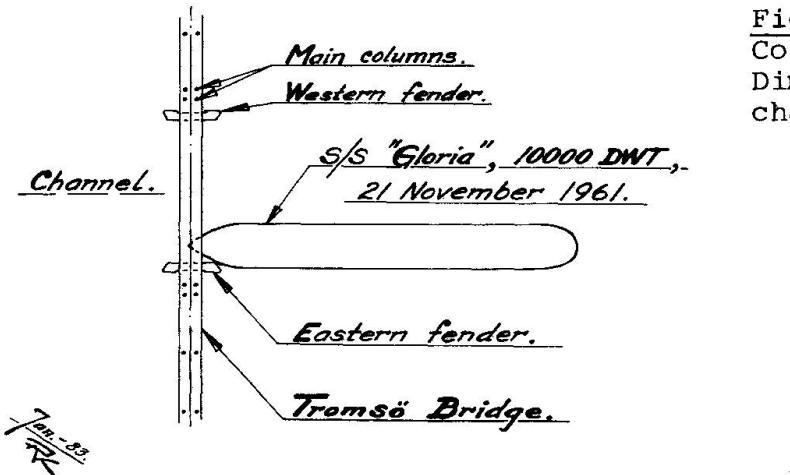
On the 21 November 1961, the 10 000 dwt. S/S "Gloria" ran into the eastern fender. The fender slab above the water as well as most of the concrete piles carrying the slab were completely destroyed and ended on the bottom of the sea. Fig. 3 shows the dimensions of the ship, the channel and the fenders.

Fig. 3 Tromsø Bridge: Collision, November 1961. Dimensions of ship, channel and fenders.

When the two fenders were rebuilt in 1962-63, hollow steel piles KP 35, filled with concrete, were used. The clearance between the fender slab and the nearest columns was 5 metres. Fracture of the piles were expected at a horizontal deformation of the fender of 4.3 metres. This would, approximately, be sufficient to stop a 10 000 dwt ship drifting into the fender at a speed of 0.5 m/sec.

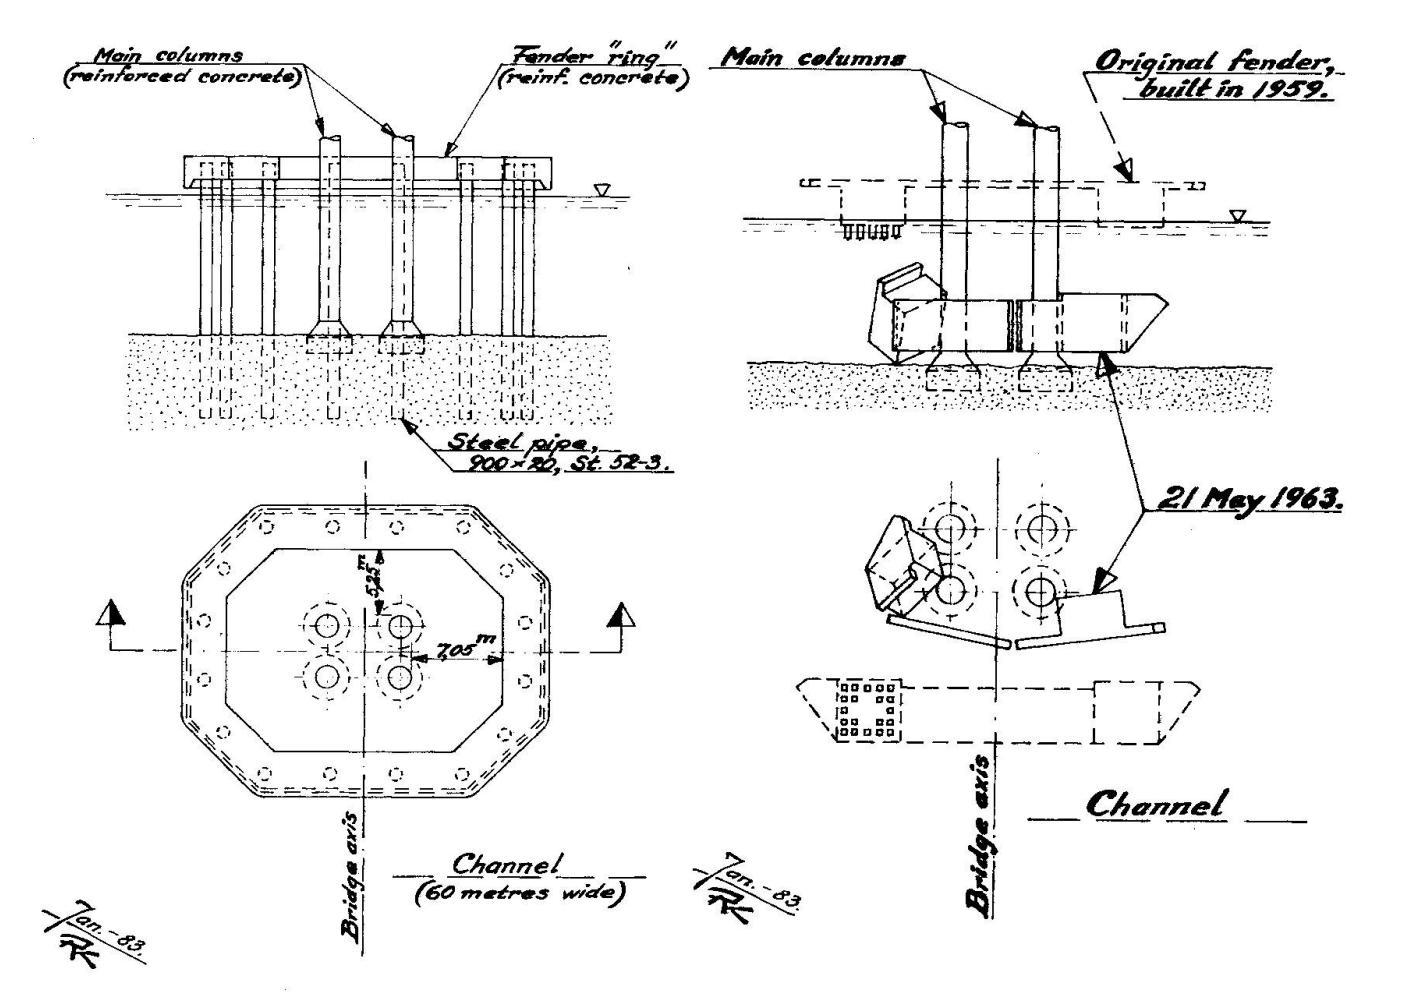
On the 21 May 1963 the western fender suffered the same fate as its easterly twin. M/S "Rotesand", a 1560 dwt ore-ship, then ran foul of the fender which collapsed and had to be removed. Fig. 4 shows the fender structure after the breakdown.

Ring-shaped reinforced concrete structures resting on steel piles, now encircles the groups of four columns on each side of the main span. The clearance between concrete ring and the nearest pair of columns, is 5.25 metres measured at right angle to the channel, and 7.05 metres measured parallel to the channel. Fig. 5.

Fig. 4 Tromsø Bridge: Western fender before and after having been destroyed. (The destroyed fender was partly resting on heaps of broken piles, which are not shown on the figure). Fig. 5 Tromsø Bridge: New fender. Ring-shaped reinforced concrete structure resting on steel piles.

The existing fender structure which were built in 1974-75, were therefore designed to withstand the impact of a 7000 tons body (ship plus hydraulic mass) with a speed of 4 m/sec. The design was based on assumptions so chosen that the resulting forces should be on the safe side as far as the bridge structure is considered. (2), (3).

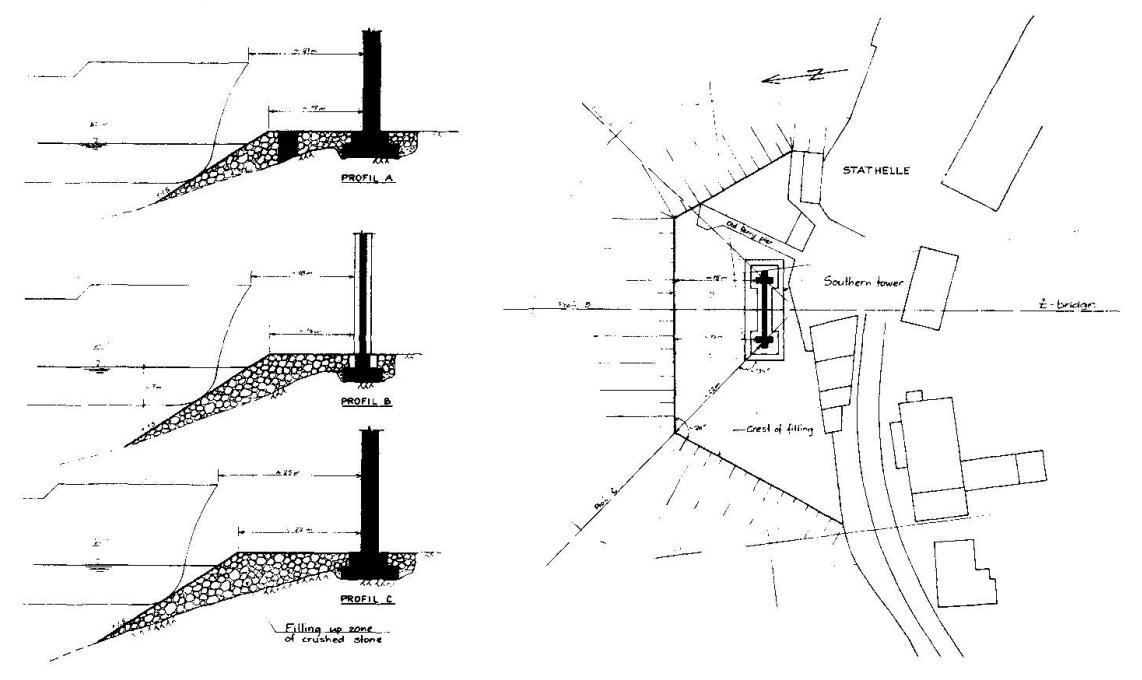
The southern tower of the main span has been regarded as vulnerable to the shiptraffic taking place through the channel. The navigational conditions are not the best ones through the shallow, narrow and tidal waters of the inlet, though certain equipment with regard to surveillance of the ships concerned has been in operation for some time.

Even though, incidents are now and then taking place in the channel including two cases of running aground close by the tower. One of the towerpiers was left with spalled concrete after one of these episodes. In addition three other close by incidents (agrounds within 20m from the tower) have been registered. All the run-agrounds in the bridge area have taken place while ships were leaving the harbour. According to attached figure 7 the tower is obviously most exposed to collision from ships moving in that direction. It should be emphasized that part of the tonnage passing the sound carries dangerous cargo, e.g. gastankers.

Fig. 7 Brevik Bridge; Filling up zone, southern tower

- I A proposed filling up zone as indicated in figure 7, will reduce sailing depths at the southern tower and will also provide an energy absorbing cushion for ships running aground.
- II Installation of warning devices to stop road traffic in case of serious damage to the structure.

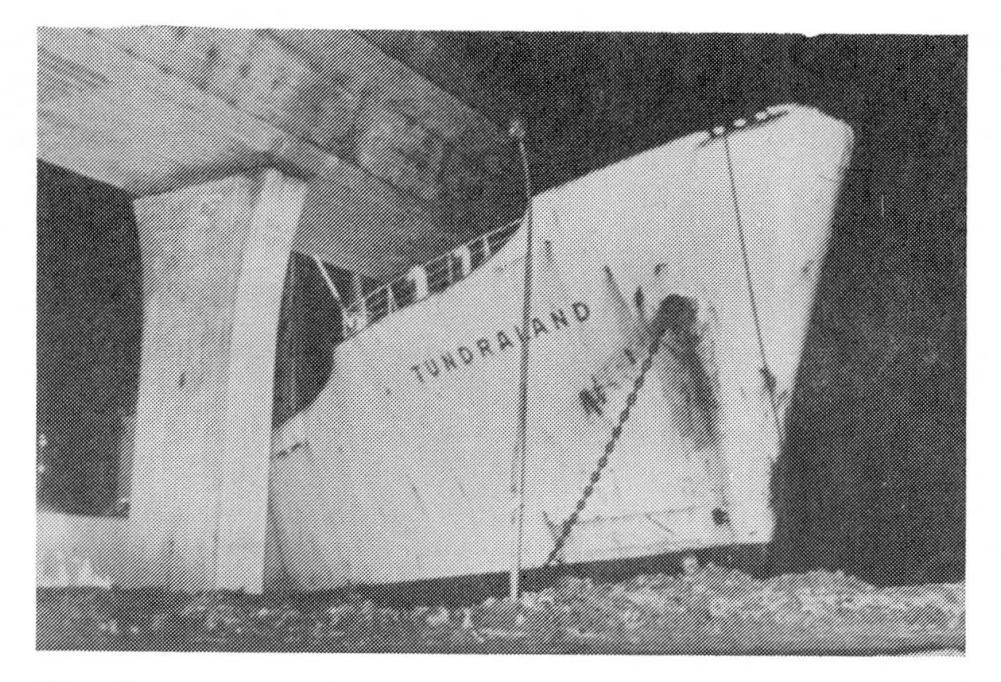
This motorway bridge was finished in 1975. It is a concrete box-section construction with spans around 50m. Close to the bridge is a quay in use for larger ships. In 1978 a ship of 4572 dwt was not able to reverse the engine. However, by very good seamanship the ship was grounded after manouvering between two columns. The superstructure of the ship only caused minor damages to the edges of the box-section. Fig. 8.

Fig. 8 Drammen Bridge; Nearly catastrophe
