Repair and Strengthening of Reinforced Concrete Buildings

Tsuneo OKADA Professor Univ. of Tokyo Tokyo, Japan

In 1978, a severe earthquake shook the Peninsula Izu located 120 km southwest of Tokyo, Japan. Several R/C school buildings were damaged. This paper presents the damage, the method of repair and strengthening, and the seismic capacity of the pre- and post-strengthened buildings.

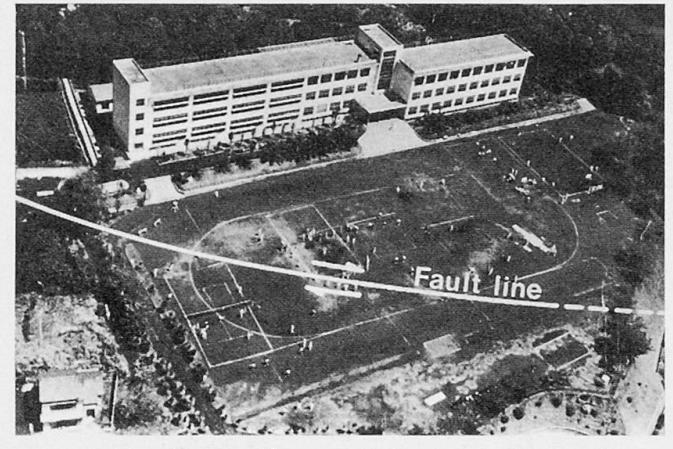
Fig. 3 Bird's eye view of Inatori Junior High School

A short discription about earthquake damage is shown in Table 1. Among them, the damage of Inatori junior high school building was most severe, while the frames could maintain structural performance after the earthquake. As shown in Fig.3, a major fault line was found across the ground. A number of cracks were found in columns, beams, walls and slabs. The damage was most significant in the slabs at the center core. The crack pattern showed that the east wing and the west wing moved in the opposite direction(Fig.4).

In the case of Inatori junior high school buildings, the center core was demolished immediately and reconstructed. The expansion joints were newly provided between the center core and both wings. The cracks in the west and east wing were repaired by epoxy injection. Cracks in other buildings were also repaired by epoxy injection.

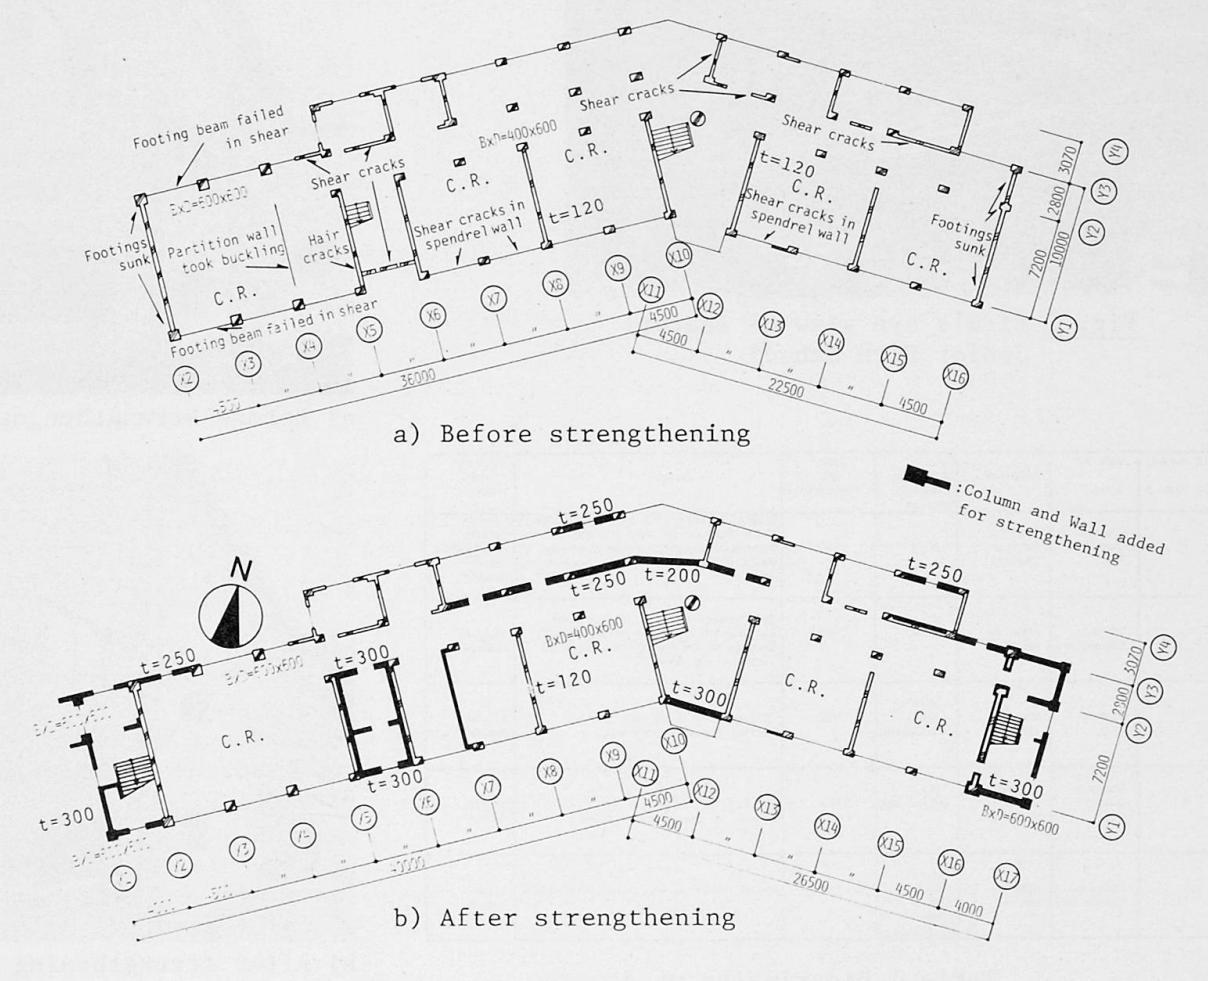
Fig. 7 Plan of Atagawa Junior High School

Atagawa junior high school building was one of the damaged buildings. A number of cracks were seen in columns, beams and walls. Both ends of the building were sunk several centimeters. By the excavation of ground, it was found that the footing beams at the west end were failed in shear. Seismic performance of other school buildings were quite well, while hair cracks in the structures, and damage to the non-structural elements were found.

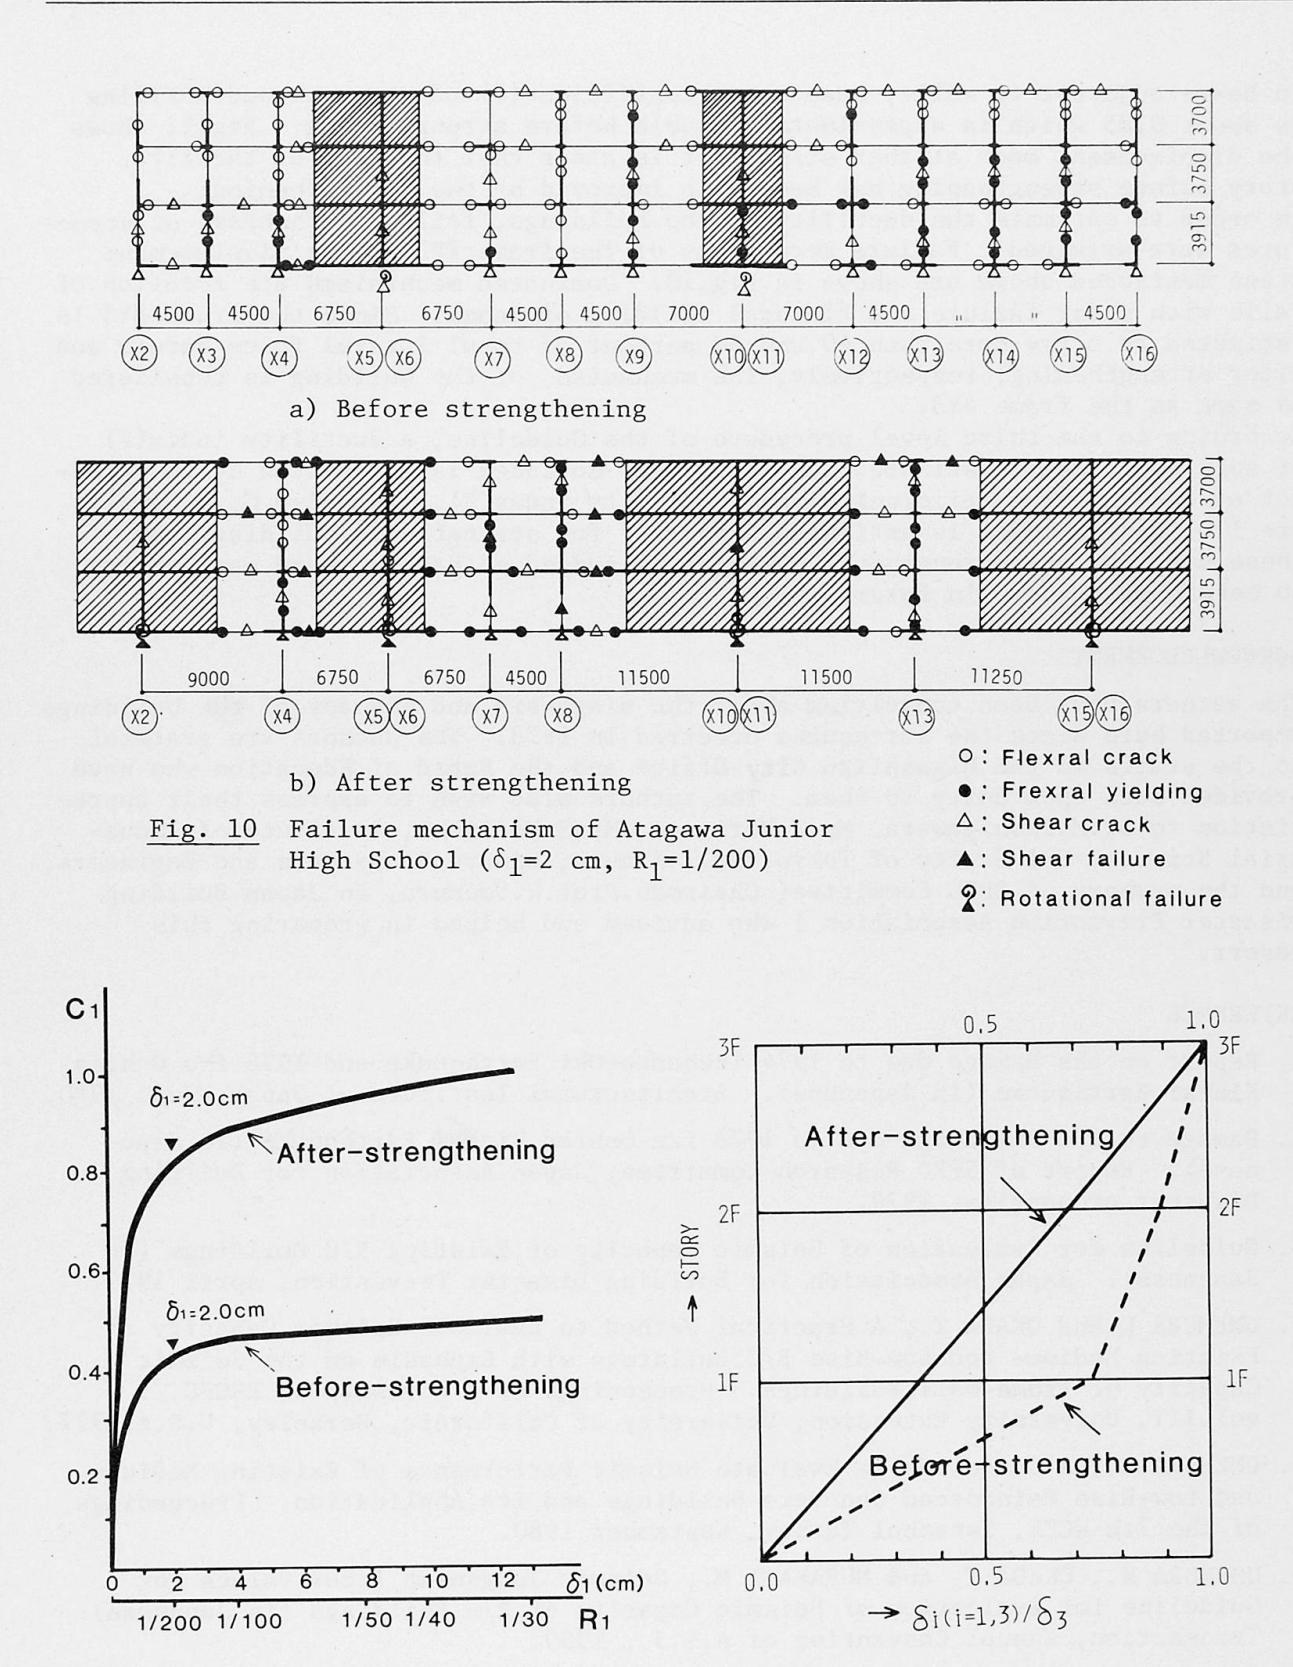
$\frac{\text{Fig. 12}}{\text{of Atagawa Junior High School}}$

in beams adjacent to walls, base shear coefficient(C) of strengthened building is about 0.85 which is approximately double before strengthening. Fig.12 shows the displacement mode at that stage. It is clear that the sway at the first story before strengthening has been also improved by the strengthening. In order to estimate the ductility of the buildings, failure mechanisms of structures were examined. Failure mechanisms of the frame #Y3 at the displacement stage mentioned above are shown in Fig.10. Dominated mechanisms are rotation of walls with shear failure and flexural yielding of beams. Since the frame #Y3 is estimated to carry more than 40 and 60 percent of total lateral force before and after strengthening, respectively, the mechanism of the building is considered as same as the frame #Y3.
