## Strengthening of a Prestressed Concrete Shell Structure

Hassan HOSNY Dr., Assoc. Prof. Mansoura Univ. Mansoura, Egypt

In this paper, strengthening of a prestressed concrete shell in a chemical factory, in Cairo, is presented. The valley beams were strengthened by external prestressing cables anchored outside the building in precast end blocks. The shells were strengthened by casting 4 cm thick resin concrete on top of the existing shell.

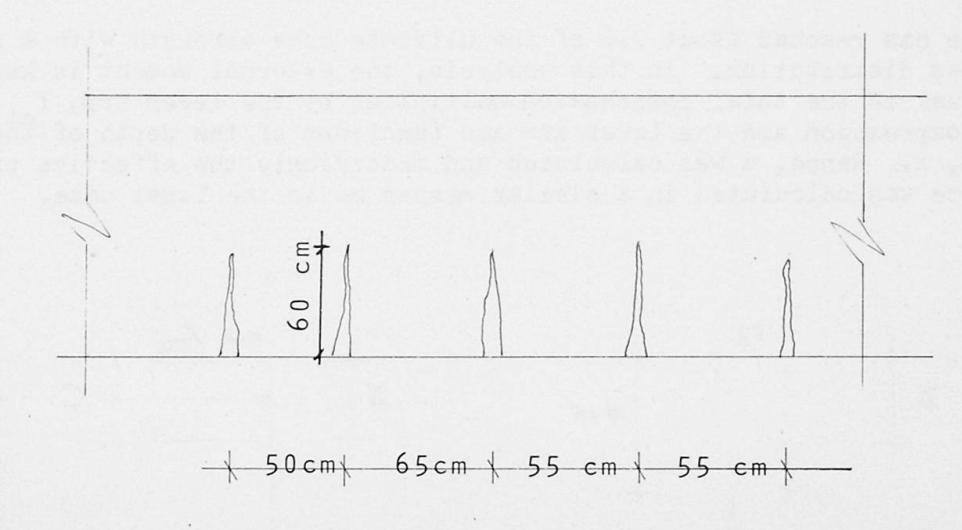
- In the webs of the prestressed beams - especially for those of the intermediate beams- several cracks spaced about 50cm between each other were noticed at mid-span. These cracks were extending vertically about 60cm from the bottom surface of the beams with crack widths varying from 0.5 to 3mm on both sides and on the bottom surface of the beams as shown in fig.2.

Fig. 2 Cracks At Mid Span Of Beams

The main reasons for the damages were the miss use and bad maintenance. A steel water tank of two cubic meters capacity was located on top of one of the shells. Plenty of pipe networks were also located on top of the shells. These pipes were not well connected and leakage of water and chemicals was noticed. The gutters over the valley beams, between adjacent shells, were found to be almost filled with mud which prevented proper drainage of water to take place. This mud and water added an extra load on the beams which was not taken in to account in the original design.

Due to the above mentioned reasons, the beams were cracked and the prestressing cables started to corrode. Accordingly, the effective prestressing forces were reduced considerably, followed by rupture of prestressing cables and sudden collapse.
