# Additional insulation of flat roofs with thin-walled metal structures

Autor(en): **Höglund, Ingemar / Andersson, Patrick**

Zeitschrift: **IABSE reports = Rapports AIPC = IVBH Berichte**

Band (Jahr): **49 (1986)**

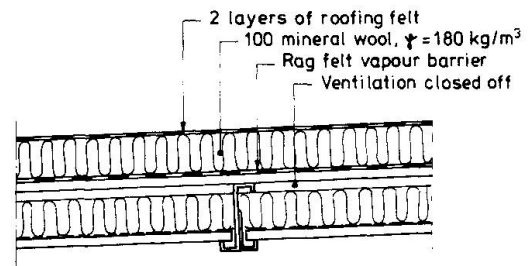
During the winter months dripping from the ceiling caused a problem. This was due to moisture transport by air convection caused by leaks between the vapour barrier in the ceiling and the structural beams. Since the construction does not contain organic material, damage to the ceiling was restricted to impaired heat

**Fig. 6** Double metal sheeting roof. Warm, moist air penetrated owing to leaks between the vapour barrier and structural beams caused condensation against the outer metal sheeting during cold periods.

**Fig. 7** Roof construction after rebuilding. A vapour barrier of rag felt was glued to the roof to prevent air convection. Dripping from the ceiling has stopped.
