Repair of an Existing Prestressed Concrete Shell of a Mill in Egypt

Magdi R.A. YOUSSEF Consultant Civil Engineer Misr Concrete Development Co. Cairo, Egypt

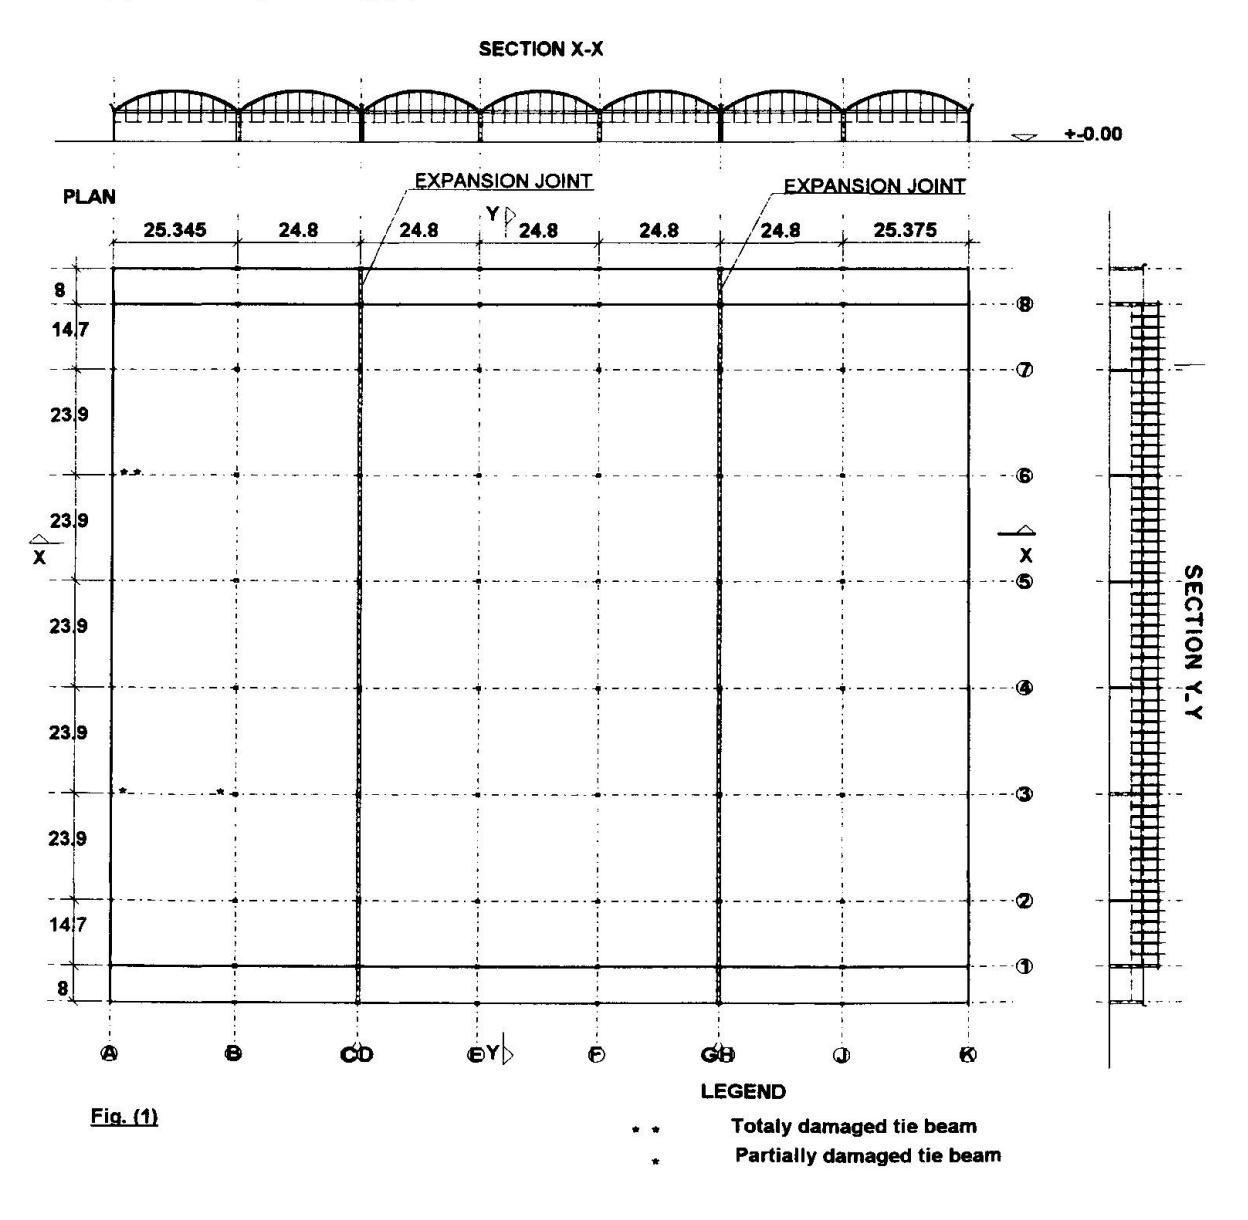
A prestressed concrete shell 164.9 x 173.9 m. for a spinning mill that was constructed and later repaired by "The Misr Concrete Development Co.". The roof consisted of concrete shell 7 to 25 cm. thickness supported on truss diaphragms with post tensioned tie beams in the longitudinal direction and on valley beams in the short direction. There was also a concrete flat plate slab hanging from the shell roof by high tensile steel bars. The shell was supported on 64 columns hinged up and down as link members and 16 fixed columns on axes 7 and 8. The mill foundations were supported on piles. Fig.(1).

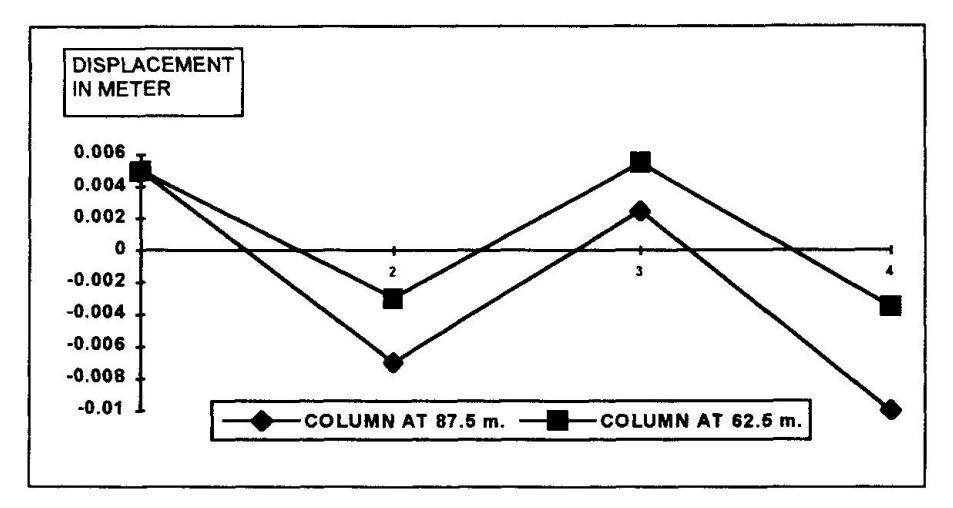
Fig.(2) : Displacement of the columns

From the final calculation of the displacement the stresses on the columns were calculated

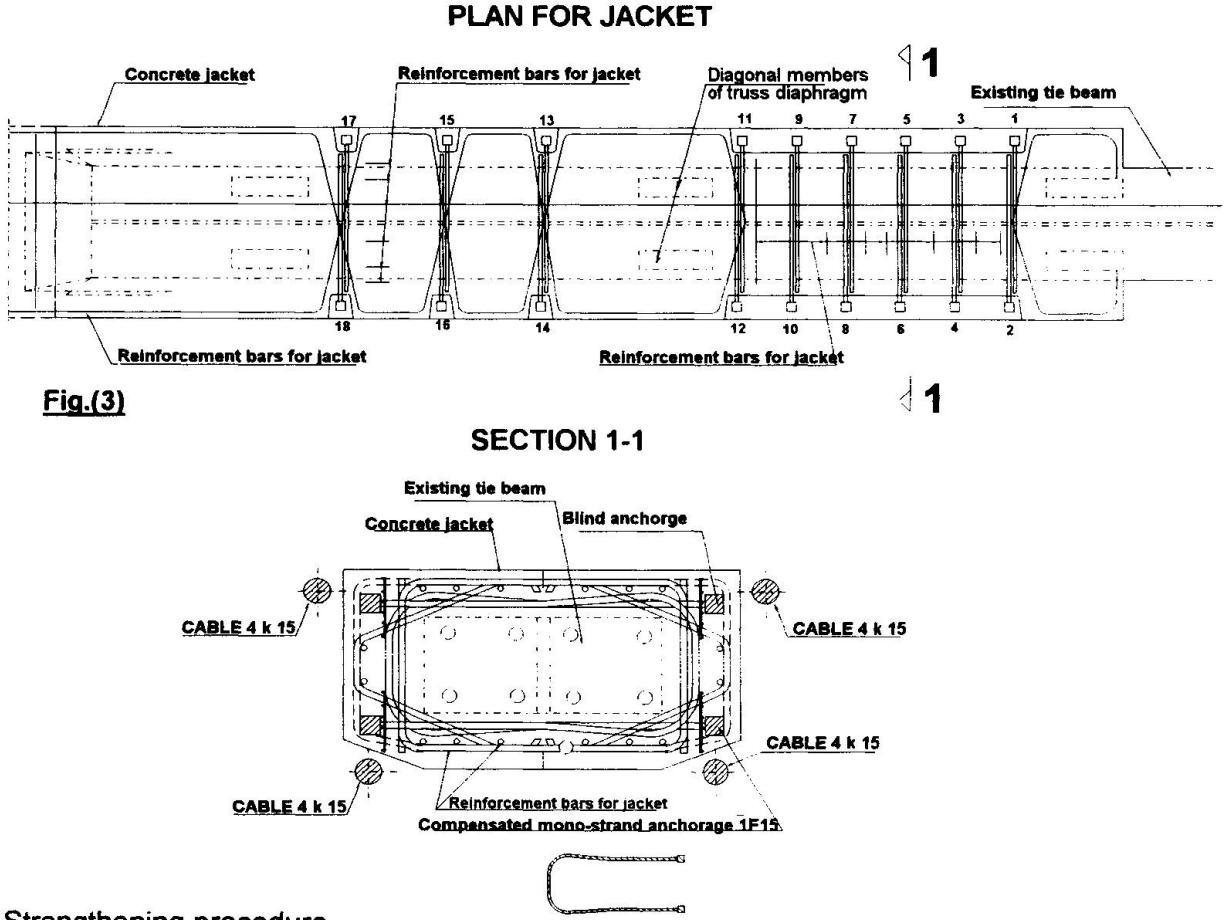
5-4 Protection of tie beams at the damaged parts

Before strengthening, repair of the damaged concrete was done for the tie beams where the concrete was damaged over a part of the total length. This repair consisted of constructing a concrete jacket that was post tensioned using mono-strand anchorage of compensated type. This jacket overlapped an undamaged part of the tie beam. Fig.(3)
