Zeitschrift:	IABSE reports = Rapports AIPC = IVBH Berichte
Band:	77 (1998)
Artikel:	War and earthquake damage in Dubrovnik: preventive and remedial measures
Autor:	Croci, Giorgio / Bonci, Alessandro
DOI:	https://doi.org/10.5169/seals-58279

War and Earthquake Damage in Dubrovnik: Preventive and Remedial Measures

Summary

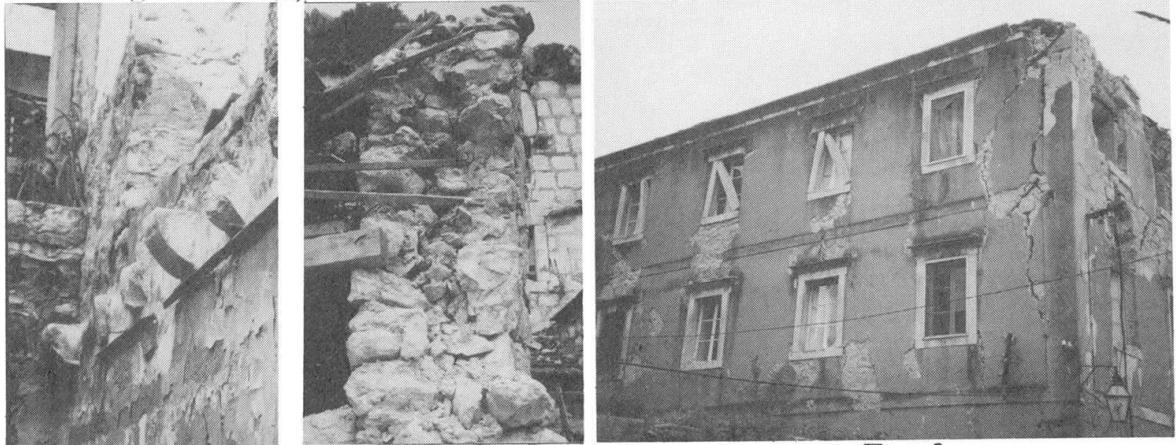
Fig. 1

The main walls of the buildings of Dubrovnik and Ston are usually made of sack masonry, with the timber floors and roofs supported by stone cantilevers inserted in the walls (Fig. 1); this structural solution, because of the lack of connection to the walls, does not help develop the co-operation among the walls themselves, which would allow them to resist the horizontal forces more effectively.

In Dubrovnik the signs of shell impacts are still visible on the fronts of the houses: direct hits struck about 70 % of the 824 buildings of the inner city. Further damage was produced by the fires following to the explosions (Fig. 1): the roofs of 5 buildings were affected by fire and in 9 buildings the roofs and floors were completely destroyed.

Intrinsic weakness of the sack masonry (weak bond, decay of the mortar): which explains the detachment of blocks in the external skin and the collapse of entire sections of wall. (Fig. 2).

<u>Structural weakness of the walls</u>: in the façades which were almost parallel to the seismic action (left façade in Fig. 3) cracks under the windows, due to the insufficient stiffness of the floor bands (reduced thickness of the zone under the windows, the lack of horizontal ties), were frequently noted; the façades almost perpendicular to the seismic action were often detached due to the inadequate connections to the lateral walls (left façade in Fig. 3). <u>Lack of connection between roofs and floors with the walls</u>, which not only reduces the co-working of the walls, but sometimes leads to the slippage of the roofs themselves.

<u>The materials</u>: the intrinsic weakness of the sack masonry construction requires, both as a preventive and a remedial measure, the injection of the walls, or, in the case of very loose material, which was very common, the use of grout percolated in from the top; cracks, depending on their width, could be filled with grout or repaired with the technique of "unpicking and sewing".(toothing out and bonding)
