| Zeitschrift: | IABSE reports = Rapports AIPC = IVBH Berichte |
|---|---|
| Artikel: | New Zealand case studies of scour at bridge foundations |
| Autor: | Coleman, Stephen / Melville, Bruce |

New Zealand Case Studies of Scour at Bridge Foundations

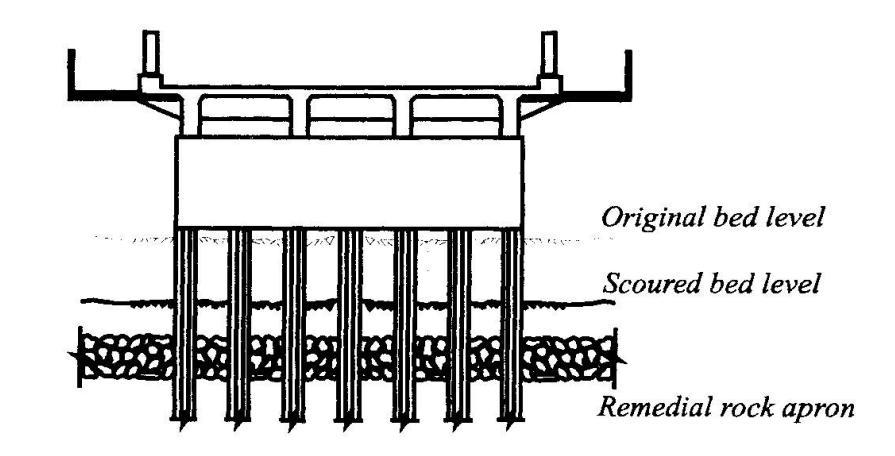
Figure 1 Typical Side Elevation of a Foundation and Remedial Works for the Ashburton River Road Bridge

General scour exacerbated by gravel extraction from the river upstream and downstream of the bridge has resulted in a gradual lowering of the bed level at the bridge site (Figure 1). The average bed level lowered approximately 0.9 m from 1937 to 1994, each of the piers within the river channel having exposed piles. In 1978, the average bed level was measured at a level of 1.7 m below the underside of the pile cap. The bridge at this time was concluded to be extremely vulnerable to scour damage by pier undermining arising from the progressive degradation of the bed. Concern for the stability of the bridge was accentuated by the shallowness of the foundation piles and also debris rafts forming at the site increasing the potential for local scour pier undermining and bridge damage or failure in significant floods.

approximately 2 m below the base of the pile cap. Aprons act to reduce the scour potential at piers both by armouring the bed against local scour due to local hydraulic vortices, and also by protecting against general scour by dropping at the apron extremities as this scour develops. Aprons nevertheless cannot provide total assurance against scouring, particularly for ongoing general degradation. Inspection in 1994 indicated the rock apron to be exposed at one pier only. Bed levels in the river channel continue to be regularly monitored.

Rock aprons were constructed in 1979 around each of the piers within the active channel (Figure 1). Each apron measures 5 m wide, 15 m long and 1.6 m thick. Rock riprap of a median size d_{50} of 0.5 m was used to construct the aprons, with the upper surface of each apron located beneath the riverbed surface and

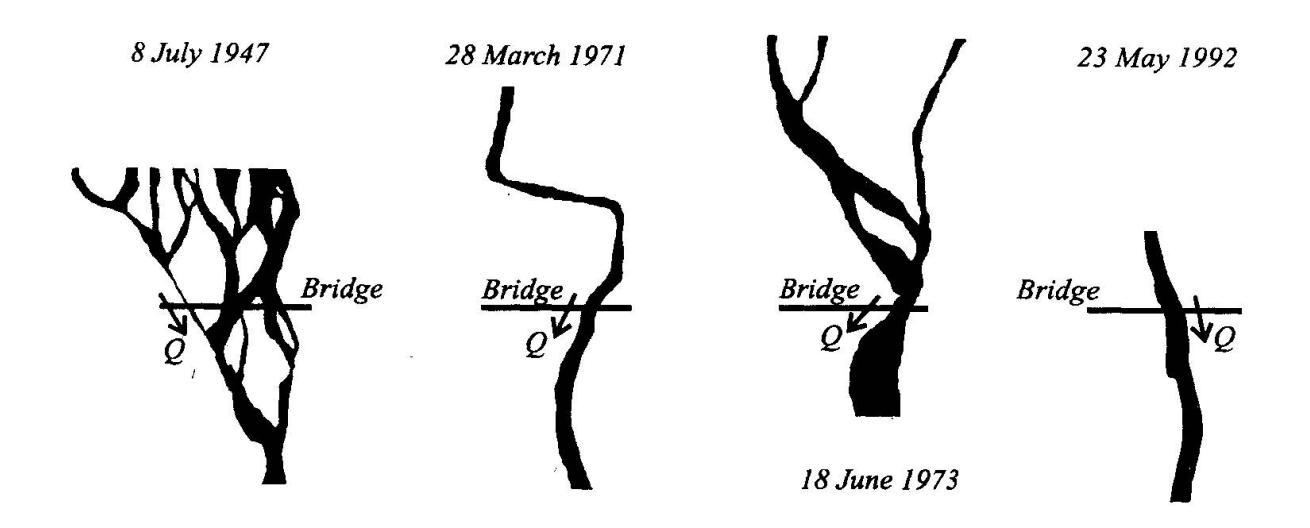
Figure 2 Development of the Principal Flow Channels of the Rangitikei River at the Bulls Road Bridge

In 1947, the river was significantly braided (Figure 2), with numerous channels upstream of the bridge site. Bed levels were relatively uniform over the width of the cross-section. With gravel extraction occurring from 1949 upstream and downstream of the bridge site, the number of braided channel branches reduced to 1-2 main channels meandering within the wider channel (Figure 2). The new flow channels were deeper and narrower than the previous channels. Such developments arising from gravel extraction from a river can be forecasted based on qualitative methodologies describing channel development. River control works were developed over the period from 1949 to 1973 to protect the outsides of the meander bends upstream of the bridge. A high terrace that is relatively erosion-resistant defines the true-left bank of the wider channel. The river meanders reinforced by the bend protection works immediately upstream of the bridge and passing underneath the end of the bridge at an angle of about 55° to the bridge centreline in the early 1970s (Figure 2).

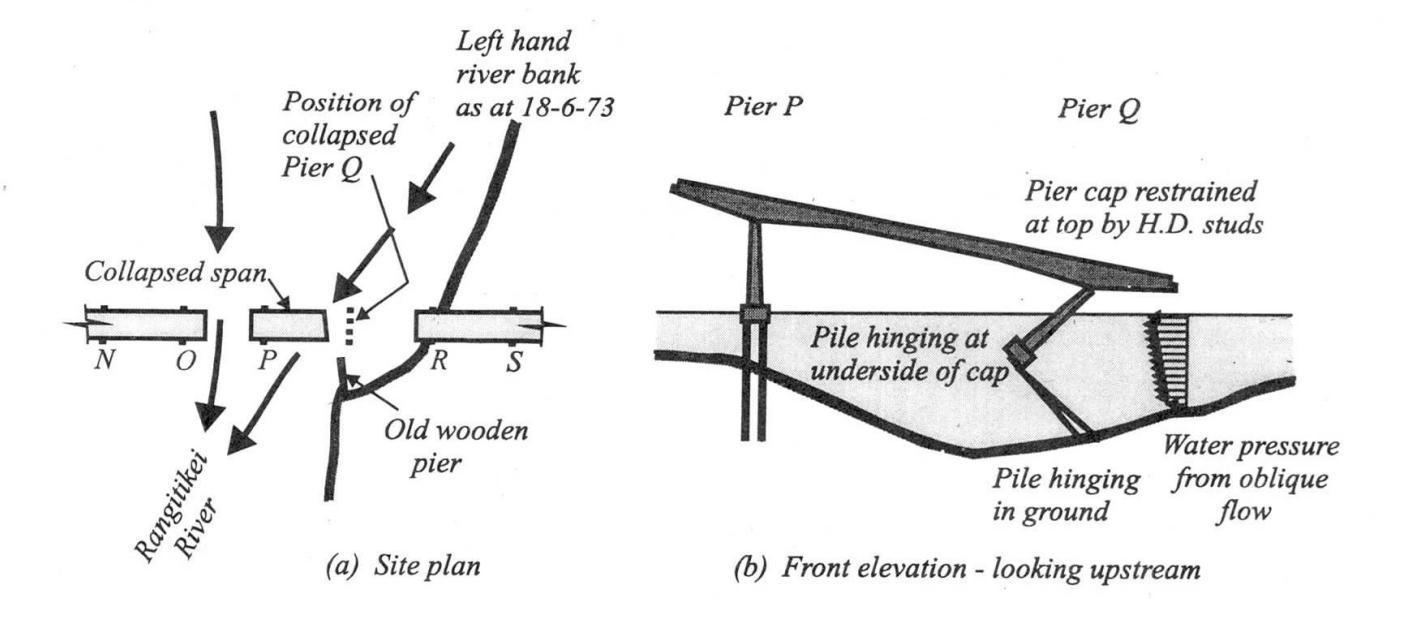
In conjunction with the gravel extraction, mean and minimum bed levels at the bridge site fell relatively steadily over the period from 1945 to 1972. Anecdotal evidence based on cross-section measurements indicates the existence of about 6 m depth of scour at Pier Q about one month prior to failure. With the deepening of the main flow channel under the bridge, an old timber pier was exposed immediately downstream of Pier Q in 1971-1972 (Figure 3).

On June 15, 1973, failure of the bridge occurred on the falling limb of a flood hydrograph estimated as approximating an annual flood event. The flood flows oblique to Pier Q (Figure 3) are estimated to have eroded through the thin papa layer and exposed the underlying fine river sand to the flow. The oblique angle of the flows to the slab-type pier and the increase in material erodibility would then have increased the depth and rate of development of the local scour at this pier. Flow between Pier Q and the exposed

debris-enlarged old timber pier immediately downstream (Figure 3) would also have induced increased local flow velocities around Pier Q, further increasing local scour rates and depths. The reduced fixity at the base of the piles as the scour developed, combined with the flows oblique to the pier exerting lateral pressures on the exposed piles, resulted in hinging occurring both at the base of the piles and also at the underside of the pile cap for Pier Q (Figure 3). The collapse of Pier Q together with the end of the bridge deck connecting Piers P and Q also caused rotation of Pier P, with the suspended spans adjacent to Piers P and Q falling into the river (Figure 3).

Each of Piers P and Q was replaced by a single column of 1.83 m diameter supported by a cylinder of 2.13 m diameter. The respective cylinders for Piers P and Q extend to 17.1 m and 18.9 m below the level of the base of the old pile cap. Piers R, S and H to O were also underpinned by 2 cylinders of 1.7 m diameter spaced at 12.95 m centres, the cylinders extending down to 17.1 m below the level of the underside of the original pile cap. To control bed levels, strict control has also been introduced on gravel extraction. It is of interest to note that from 1992 to 1997, the main river channel passed principally between Piers J-M (Figure 2).

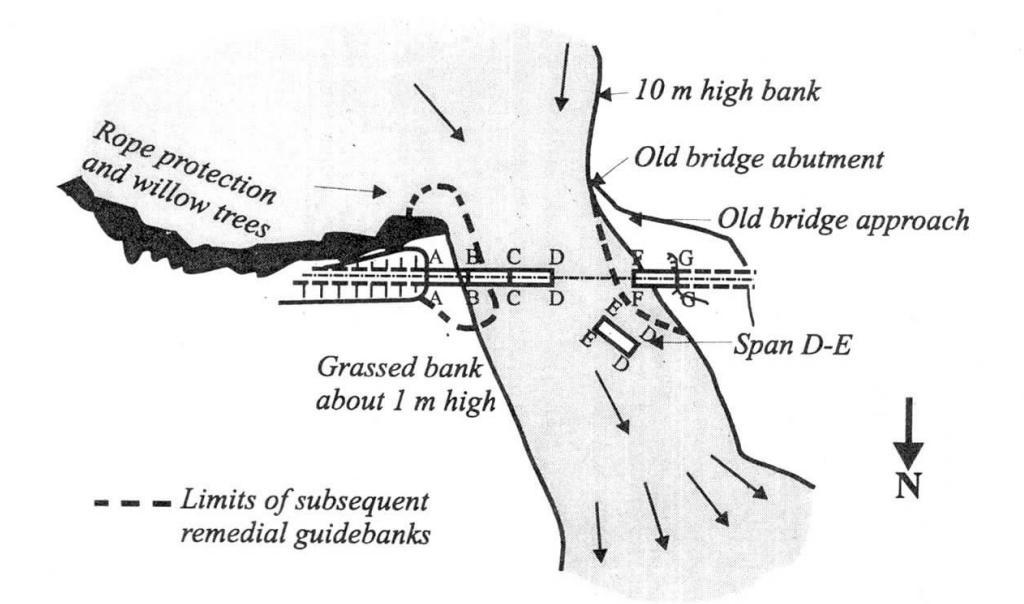
Figure 4 Schematic Site Plan of the Waitangitaona River Road Bridge Failure

The bridge, which spans a channel forming a sudden contraction for flood flows, is located at the exit from a wide channel containing a braided river at low flows (Figure 4). A shift and shortening in the river course downstream of the bridge resulted in rapid bed degradation at the bridge site during construction of the bridge in 1967. This degradation and later flooding resulted in piles extending to only 6.8 m below the minimum bed level. The angle of flow attack on the slab piers also increased at this time. The channel, which was relatively flat between the five central piers, was subsequently essentially stable in alignment and cross-section.

For the 1982 flood, it appears that the two approach embankments concentrated flow between Piers D and F at an angle of about 30° to the face of Pier E (Figure 4). The flood flows at a skewed angle to the pier, exacerbated by debris accumulation effects, resulted in increased lateral loading and increased scour depths for Pier E. Pier E was consequently scoured out, with the associated loss of the two adjoining deck spans (Figure 4). The remaining sections of the bridge were undamaged. Scour holes at the piers were noted to be infilled as the flood receded.

New guidebanks extending into the channel were subsequently established through the bridge site (Figure 4). A 1.5 m thick riprap layer at a slope of 2:1 (H:V), extended by a horizontal riprap toe apron 2 m thick with its upper surface at the existing bed level, was used to protect existing piers located within the new guidebanks. For these piers, the existing piles were also supplemented with three steel H-piles at each end

of the pile cap, these additional piles extending to 13 m below the design bed level. The riprap utilised consisted of rocks of $d_{50} = 750$ mm. Each pier remaining in the revised stream channel was underpinned with two cylinders of 1.5 m diameter at 11 m centres, each cylinder connected to the existing pier via a 1.0 m octagonal column above the design bed level. The cylinder foundations were driven to 13 m below the bed. The existing piled foundations and mass concrete skirt for each of these piers in the revised stream channel were removed along with the base of the slab pier to 2m above the design flood levels, this level allowing some clearance to minimise any debris accumulations at the piers.
