Artikel: Installing prestressing tendons in arduous conditions

**V****Installing Prestressing Tendons in Arduous Conditions**

G.R. SIDES
Ph.D. F.I.C.E.
Simonbuild Ltd.
Stockport, England

Prestressing operations require care and expertise even in the best working conditions. This article describes such activities afloat, 24 hours a day, in the winter months and in conjunction with slipforming operations during the construction of the 67 m high towers of the Cormorant 'A' oil production platform.

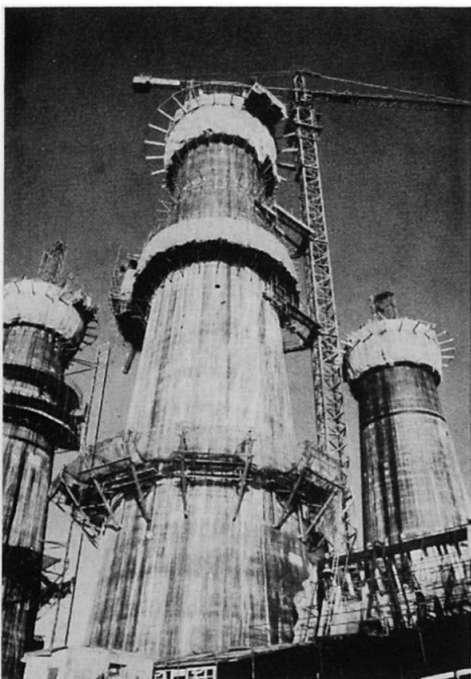
Fig. 2 Slipforming the 67m high towers.

The Sub-contract was to install the prestressing tendons in each of the four 67m high towers whilst the towers were being constructed by the slipforming process, fig. 2. These Sub-contract works were completed by BBRV Marine which is a joint venture of the BBRV Licensees in Scandinavia (A/S Strangbetong), Switzerland (Stahlton AG) and the United Kingdom (Simonbuild Ltd).

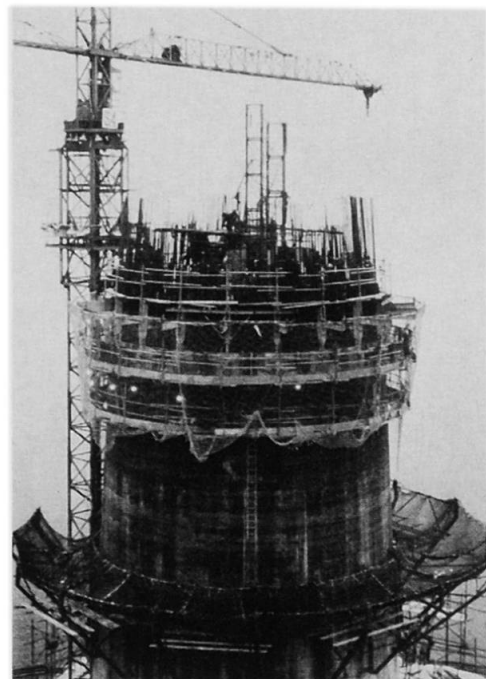
Fig. 3 The slipform platform

The load applied to the slipforming platform during tendon installation was to be kept to a minimum as increased loads would require extra lifting equipment which would cause congestion in an already limited area, fig. 3. It is also important in slipforming to avoid eccentric loads. Thus to lift tendons weighing up to 1.5 tonnes from different points around the slipforming platform would cause unacceptable slipforming conditions.

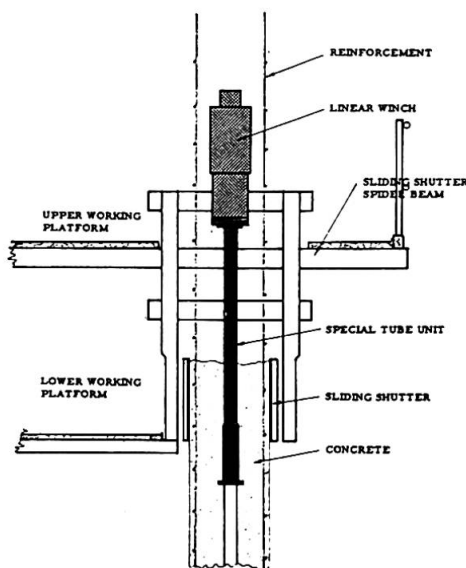
Fig. 4 Tendon lifting arrangements

The method to avoid these problems whilst allowing the installation of the prestressing tendons during the slipforming process involved fastening an "upper tube unit", fig. 4, onto the top of the ducting at each tendon installation level. This unit was 3m long and incorporated :-

- a conventional end anchor plate at the top end
- a smaller bearing plate at the bottom end to distribute the stresses applied, during the installation of the tendon, to the relatively young concrete of the tower.

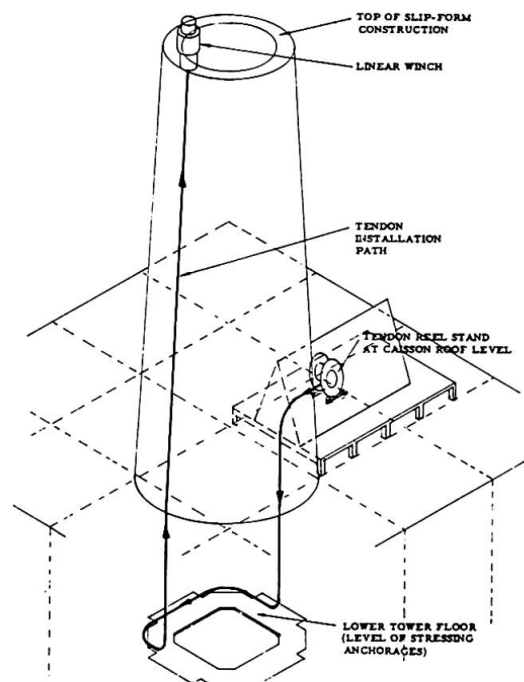
Fig. 5 Tendon installation route

The tendon was installed along a tortuous route extending from the platform deck to the slipform platform as shown in fig. 5, by fixing a lifting device (a linear winch) to the top plate when the concrete had been placed to within 0.5m of the upper plate. At this stage the lower plate was 2.5m into the concrete and was bearing on concrete which had achieved sufficient strength to withstand the loads transmitted through the tube unit from the lifting device. When the tendon had been lifted to the correct distance above the top plate of the tube unit, chocks were positioned between the tube unit upper plate and the underside of the tendon fixed anchorage. The lifting device was then removed and the slipforming proceeded, without delay, past and covering the completed fixed end anchorage, fig. 6.
