Zeitschrift: **IABSE reports of the working commissions = Rapports des commissions de travail AIPC = IVBH Berichte der Arbeitskommissionen**

RECENT EXPERIENCE ON WEARING SURFACES FOR STEEL BRIDGE DECKS OF LIGHTWEIGHT CONSTRUCTION

K.H. BEST
Great Britain

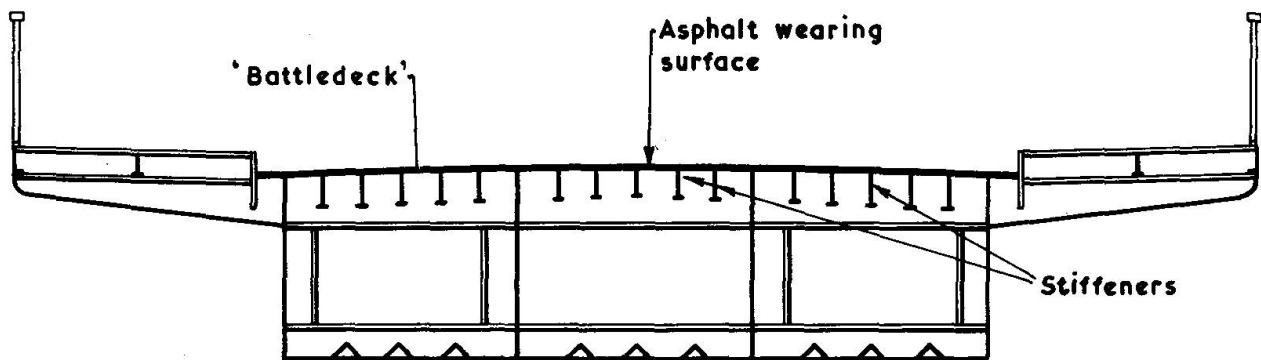
FIG. 1. CROSS SECTION OF SWING BRIDGE AT REGENTS CANAL DOCK, LONDON.

Figure 1 illustrates the cross section of a swingbridge at Regents Canal Dock, London, designed in 1959. The deck plate is 9/16th in. (14.3 mm.) thick with stiffeners at 12 in. (305 mm.) centres. At that time the British Road Research Laboratories were testing sample panels of steel battledeck to investigate alternative methods of construction and surfacing under heavy traffic.

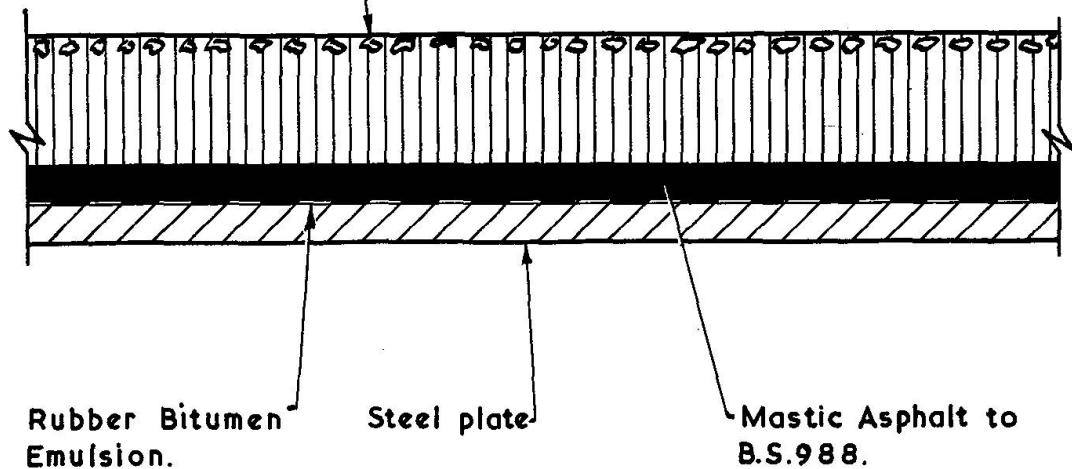
Mastic Asphalt to B.S. 1446.
with stone chippings.

FIG. 2. SURFACING OF SWING BRIDGE AT REGENTS CANAL
DOCK, LONDON.

Mastic asphalt to B. S. 1446, Table 1, Column 3, was then laid as a wearing course. This was specified to include 35% - 40% of coarse aggregate with a penetration of 25 - 35. Whilst the asphalt was still warm and plastic, hard $\frac{3}{4}$ in. (19 mm.) stone chippings, pre-coated with asphaltic cement were rolled into the surface.

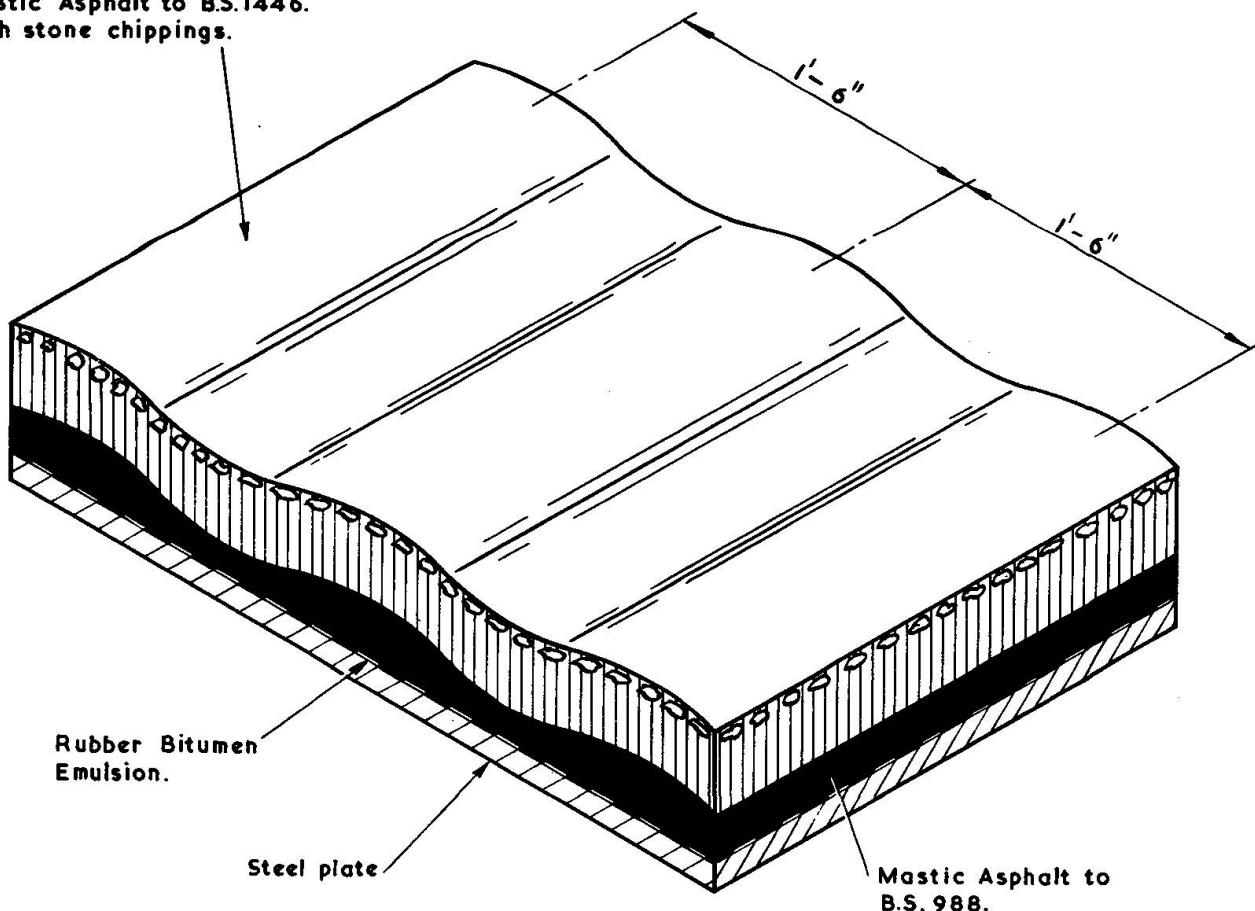
FIG. 3. DEFECT - TRANSVERSE WAVES IN ROAD SURFACE.

Four years after the bridge was opened a series of transverse waves or corrugations at about 1. ft. 6 in. (0.457 m.) centres appeared in a section of the deck, coincident with wheel paths in the areas of heavy braking. This type of defect is illustrated in Figure 3. The defective areas were removed without difficulty and re-laid to the original specification. We found that the mastic insulating layer had been laid to a greater thickness than specified in this area and the Road Research Laboratories also made tests on samples. As a result it was recommended that for future work the stone content of the wearing course should be increased and a harder grade of asphalt cement adopted. Measurements of the rate of indentation during a wheel tracking test with a loaded wheel repeatedly running over specimens at 45°C. suggested that deformation was likely if heavy traffic was turning and braking hard, although the surfacing might be satisfactory for normal conditions.

Analysis of samples showed that the stone content was at the lower limit of the specified range, that is, about 35% and the penetration value of the recovered soluble bitumen was found to be rather low.

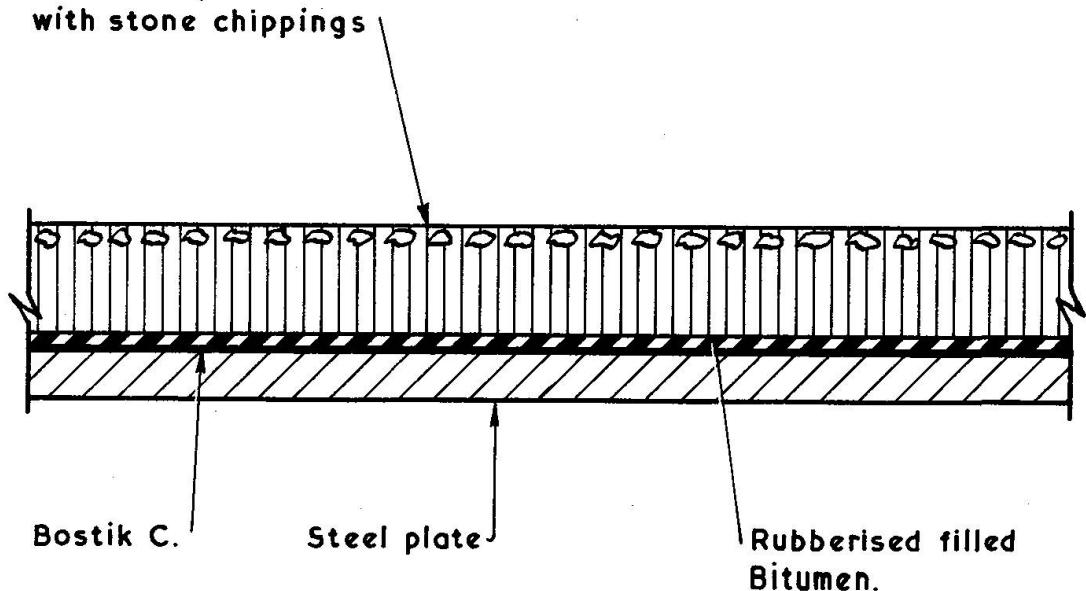
Mastic Asphalt to B.S.1447.
with stone chippings

FIG. 4. NEW SPECIFICATION FOR SURFACING AT WOOLWICH
AND MIDDLESBROUGH DOCK SWING BRIDGE.

The wearing course is $1\frac{1}{4}$ in. (32 mm.) thickness of mastic asphalt to B.S. 1447, Table 1, Column 3, having a penetration of 15/25 including 40 - 45% coarse aggregate. The surface was finished, as before, with $\frac{3}{4}$ in. (19 mm.) pre-coated chippings at the rate of 100 sq. yards per ton (82 sq. metres per tonne).

Thus the specification was improved from that adopted for the earlier swingbridges by replacing the relatively thick and soft insulating layer by the thinner and more resilient rubberised filled bitumen and the stone content and hardness of the wearing course was slightly increased.

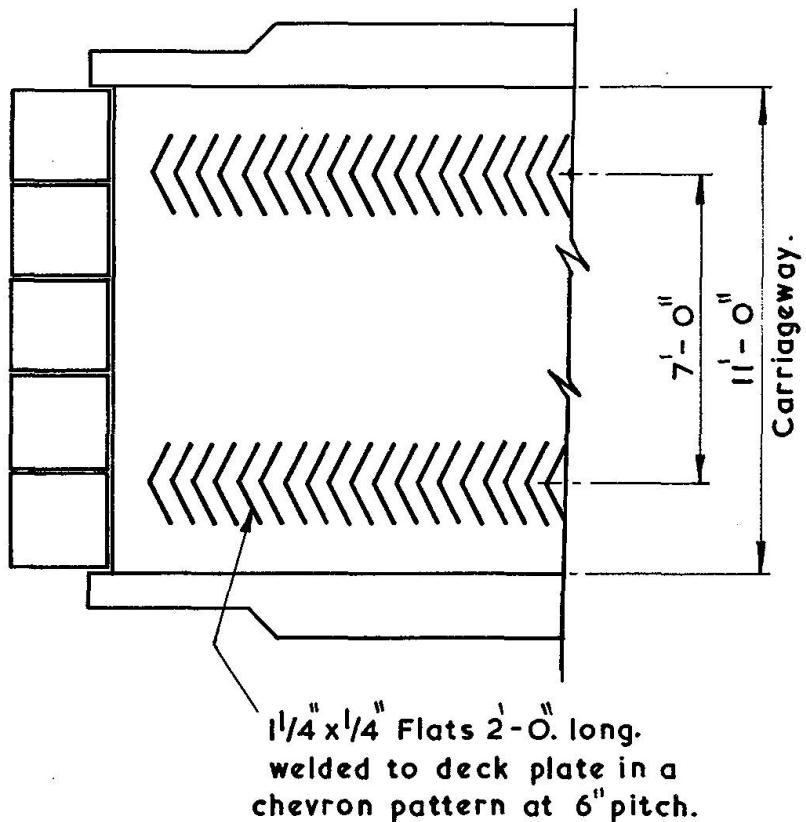
FIG. 5. REINFORCEMENT AT END OF RAMPS.

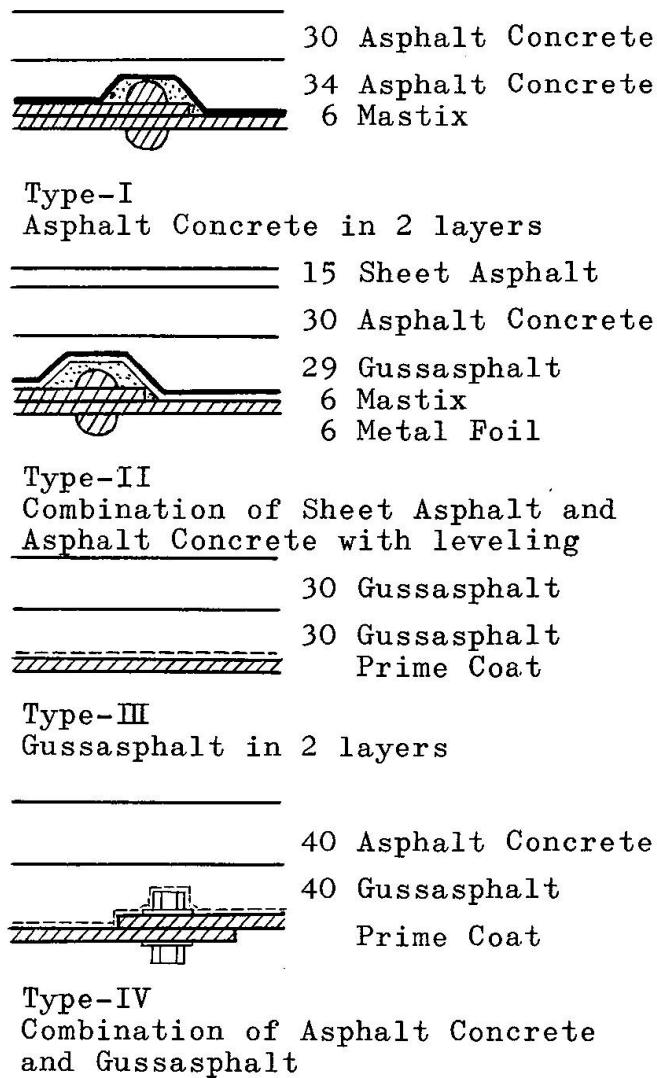
Fig.-1 Typical Cross Section
of Pavement (mm)

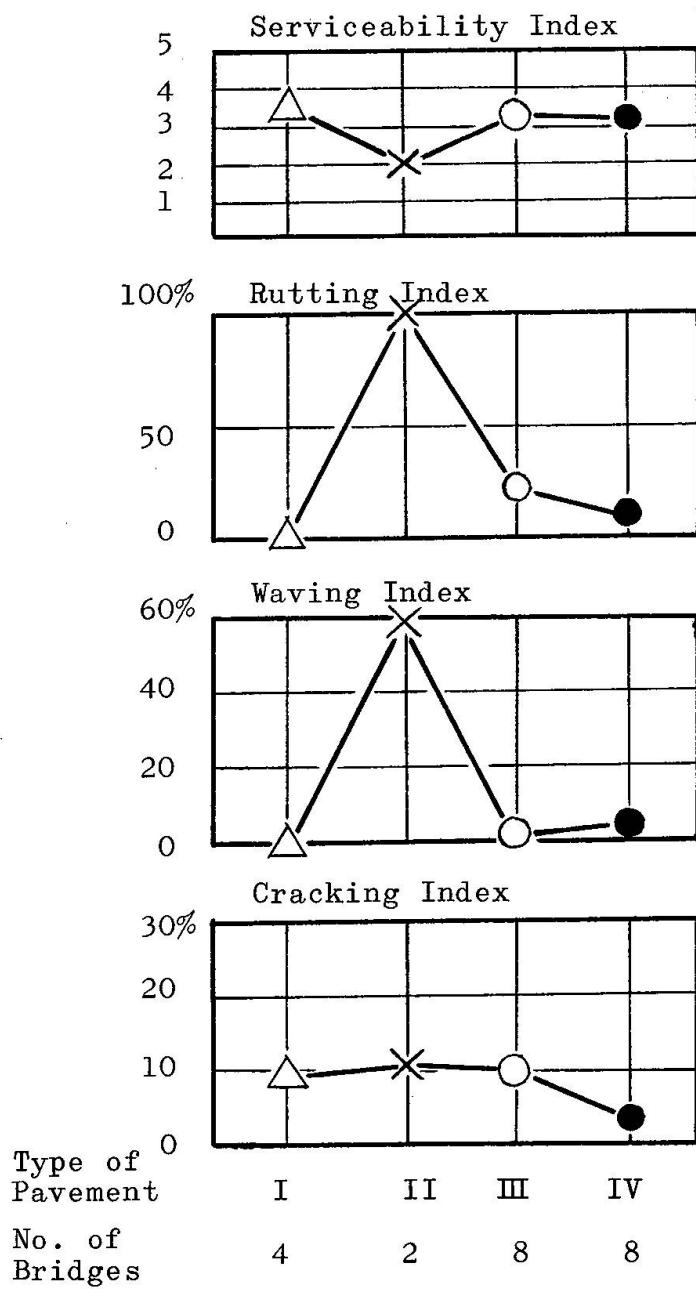
Fig.-2 Performance by Type of Pavement

Serviceability Index 4 denotes comparatively good and needing little repair. 3 denotes needing a little repair and 2 denotes needing considerable repair.

Fig.-2 indicates the relation of the performance and the type of pavement.

The pavement that resulted best in performance was Type I pavement consisting of asphalt concrete mixtures placed in 2 layers and Type III pavement consisting of new type gussasphalt mixture placed in 2 layers.

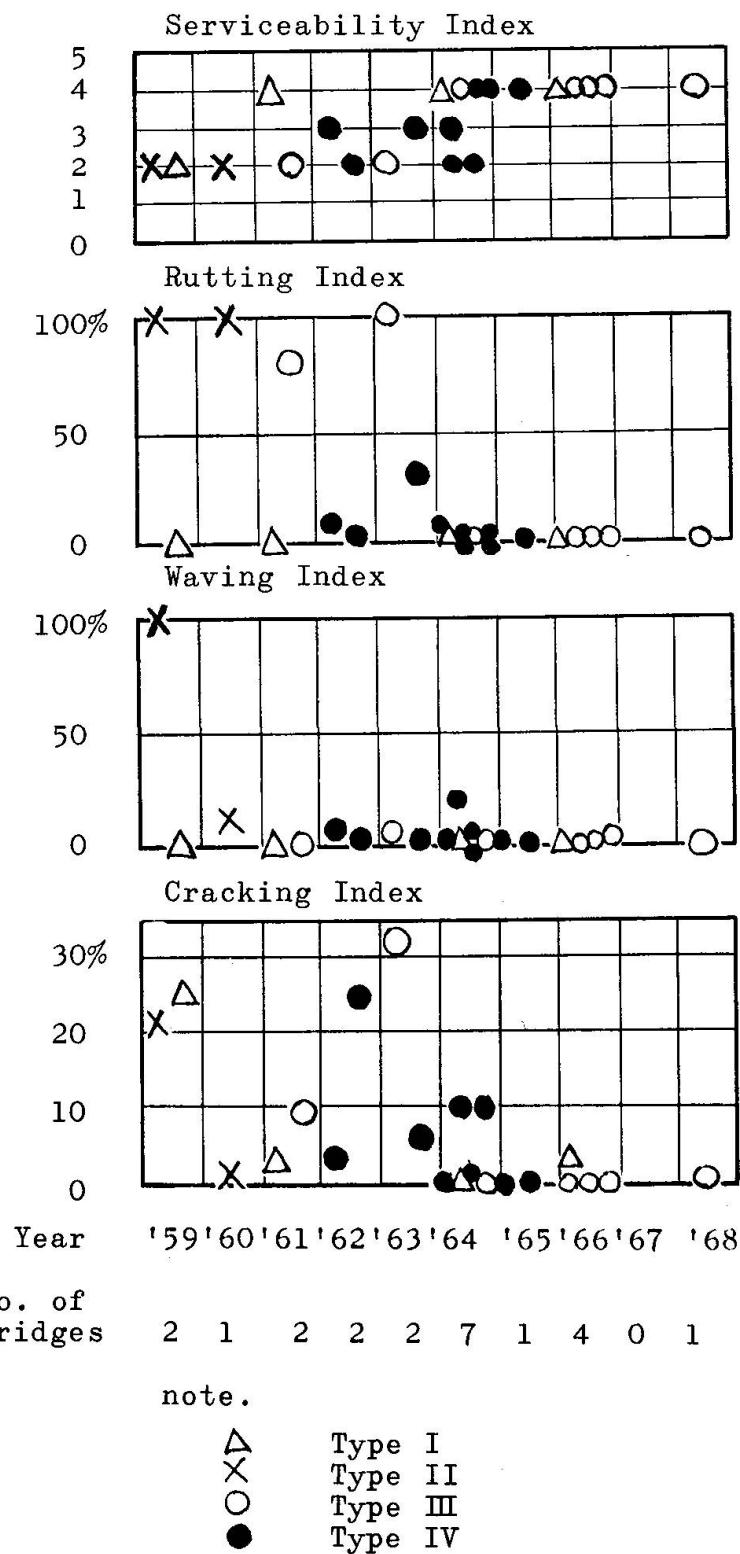
Fig.-3 Performance by Year of Construction and Type of Pavement

Many of the pavements constructed before 1963 are found faulty.

The pavements with asphalt concrete in 2 layers (Type I) are keeping very good condition without relation to the period in service.

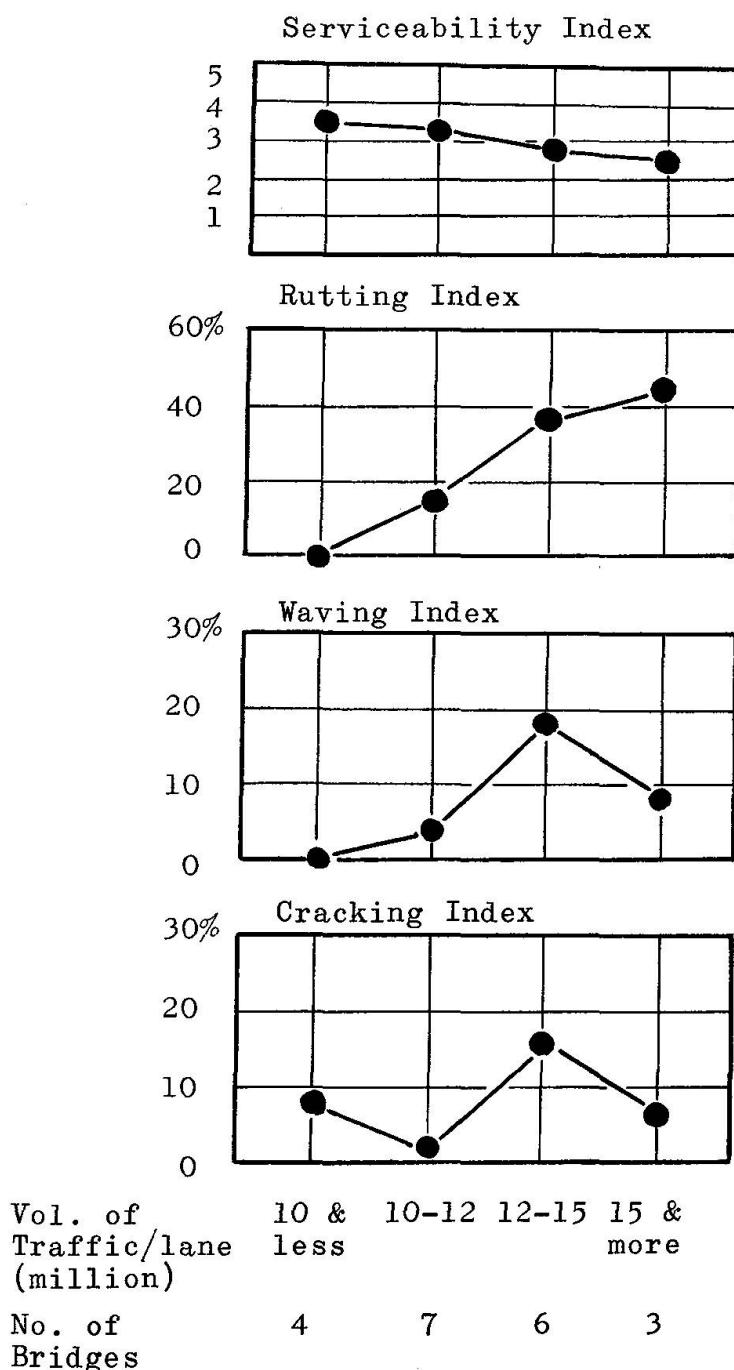
Fig.-4 Performance and Total Traffic/Lane

Fig.-4 indicates the relation of the performance and the total traffic (number of vehicles) of a lane since opening for traffic up to date, showing a considerable correlation in waving, rutting and serviceability index, but correlation with the type of the pavement was not so conspicuous as that with the period in service.

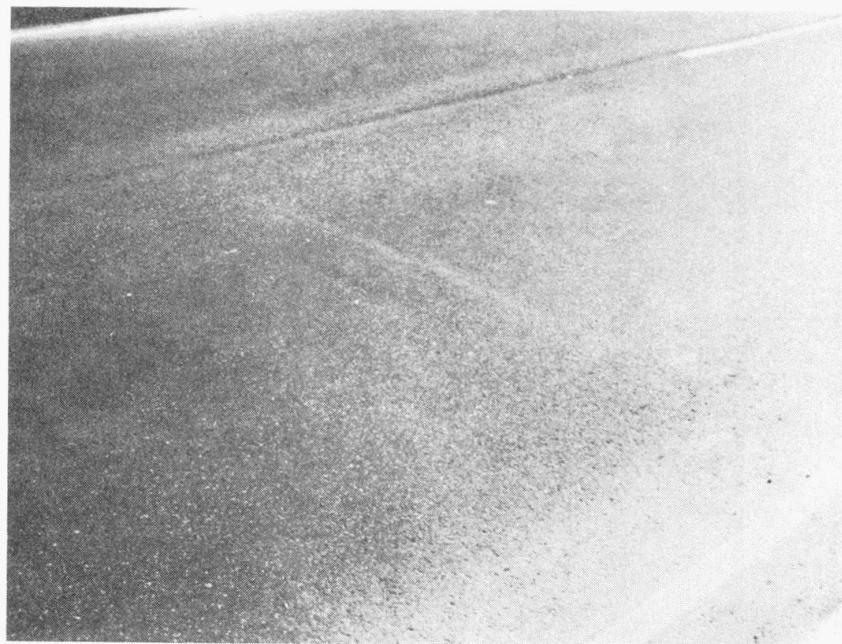
FIGURE 1. SLIGHT UNEVENNESS IN THE SURFACE COURSE
OVER THE SPLICE PLATES ON THE PORT MANN BRIDGE
AFTER 2-1/2 YEARS IN SERVICE

Port Mann Bridge -- After more than 4 years under heavy traffic, the condition of the pavement must be considered excellent. The only noticeable defect observed was some slight unevenness over a few of the splice plates after about 2 years in service. This condition is shown in Figure 1. A more recent inspection (after four years) indicated that transverse cracks may be forming at a few of these locations although there are none yet visible to the unaided eye. One such location is shown in Figure 2.

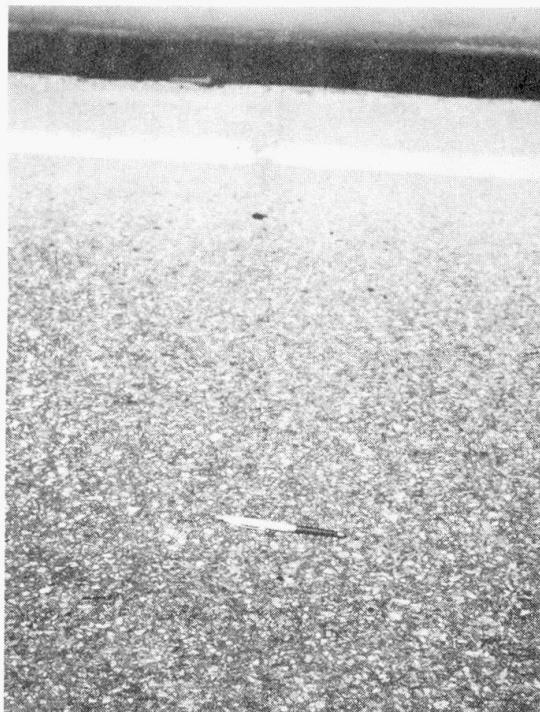
FIGURE 2. EVIDENCE OF A TRANSVERSE CRACK FORMING OVER THE SPLICE
PLATES ON THE PORT MANN BRIDGE AFTER FOUR YEARS OF SERVICE

With the exception of these few isolated spots, no other defects such as longitudinal cracking or shoving and rutting were noted. It is expected that any cracks which may form over the splice plates will be noticeable within an additional year.

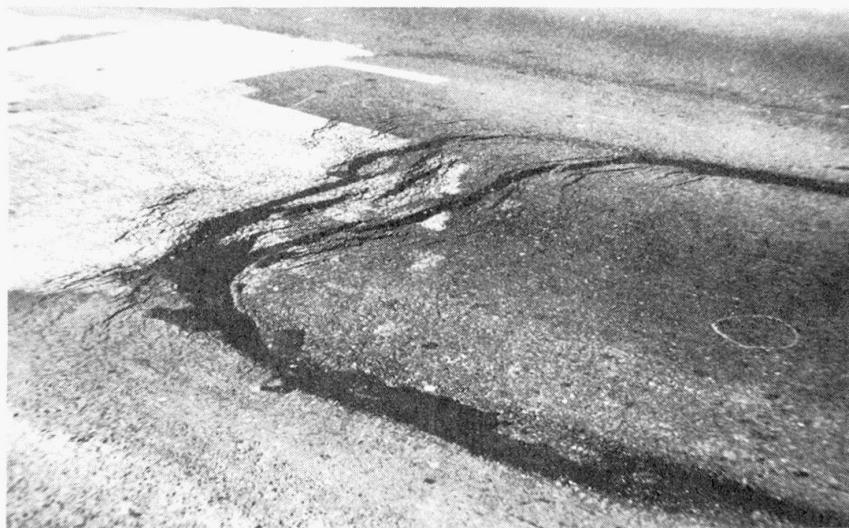
FIGURE 3. MODE OF FAILURE DUE TO DEBONDING OF THE AC PAVEMENT ON THE ULATIS CREEK BRIDGE AFTER ONLY A FEW MONTHS IN SERVICE

Within a few weeks after being opened to traffic, random cracks appeared in the AC surfacing. Shortly thereafter the pavement began debonding and within three months was literally shoved off the bridge. The mode of failure can be seen in Figure 3. The AC was replaced again using only an emulsion tack coat to bond the pavement to the deck plate. Within nine months the new AC pavement had again failed in the same manner as before. The pavement was replaced a second time in the same manner. This third pavement has remained in place and is performing reasonably well after almost two more years of service.

As was shown in Table 2 there is a wide variation in the amount and gradation of aggregate chips used. The importance of an effective bond can be determined from the experience of the AC surfacing placed on a portion of the Ulatis Creek Bridge. In this installation, only an emulsion tack coat was used to provide bond between the deck and the pavement. This lack of bond resulted in a complete failure of the pavement. Another instance of a lack of good bond was noted on the Troy Test Bridge where a heavy loading of fine stone chips was used in conjunction with an AC leveling course. After about 2 years in service, moderate cracking had occurred in the surfacing and upon removal of the pavement, little or no bond was found between the seal coat and the asphalt pavement. There was, however, sufficient shear resistance to prevent the pavement from shoving. The only other instance where the bond between the bond coat and the pavement was qualitatively checked was on the Humphreys Creek Bridge. In this instance the bond was found to be excellent.

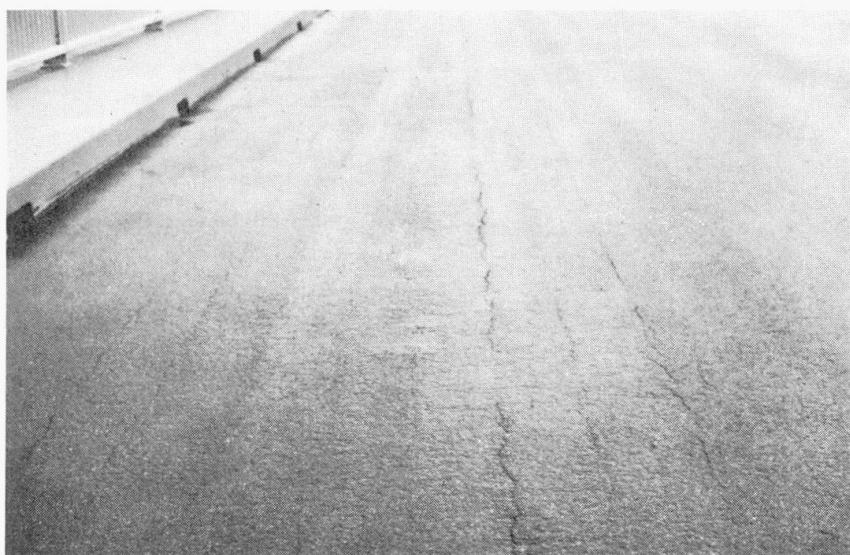
FIGURE 4. LONGITUDINAL CRACKS IN THE ACPAVEMENT ON THE CONCORDIA BRIDGE AFTER TWO YEARS IN SERVICE

Concordia Bridge - This bridge is located within the Exposition grounds in Montreal. Half of the bridge width is used for rail traffic while the other half has little traffic at this time. The bridge was however used for all construction traffic prior to the opening of Expo '67. An inspection of this bridge was made approximately two years after completion. Numerous longitudinal cracks were formed essentially over the entire length of the bridge as shown in Figure 4. The most severe crack (shown in the center of Figure 4) is located over the web of the supporting box girder while the finer cracks are located over the stiffening ribs where they are attached to the deck plate.

Cracks have been observed in the wearing course of the Concordia and Dublin Bridges. On both of these bridges the most severe longitudinal cracks occurred over the main girder webs where high negative bending movements are produced. Transverse cracks occurred over a pier on the Dublin Bridge--also an area of high negative movements. Comparable points of high negative movements are not present on the Port Mann and Humphreys Creek Bridges where no surface cracks have been observed.

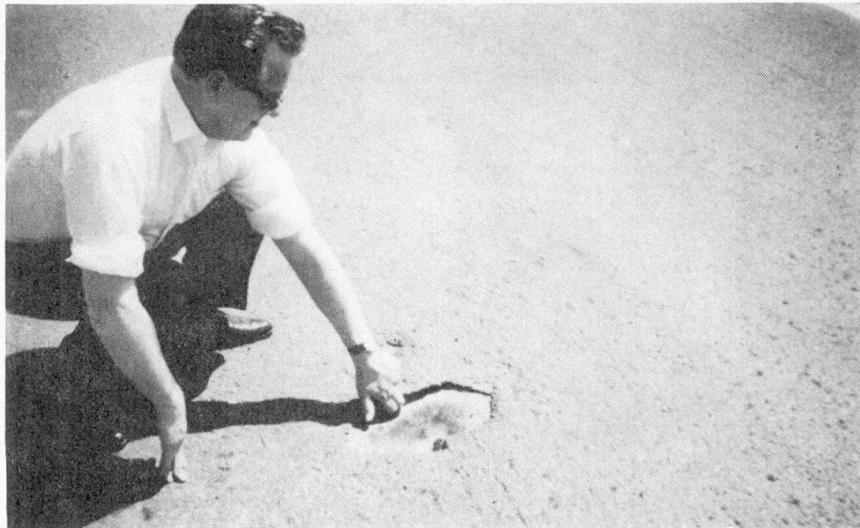
FIGRE 5. BREAKOUT OF WEARING COURSE OVER SPLICE PLATE ON CONCORDIA BRIDGE AFTER TWO YEARS OF SERVICE

About the same time a small breakout occurred in the wearing course over a splice plate as shown in Figure 5. Although the damage is still relatively confined, the pavement adjacent to the breakout could be easily lifted up indicating essentially no bond to the deck plate. It is merely a matter of time before this defect increases in size.

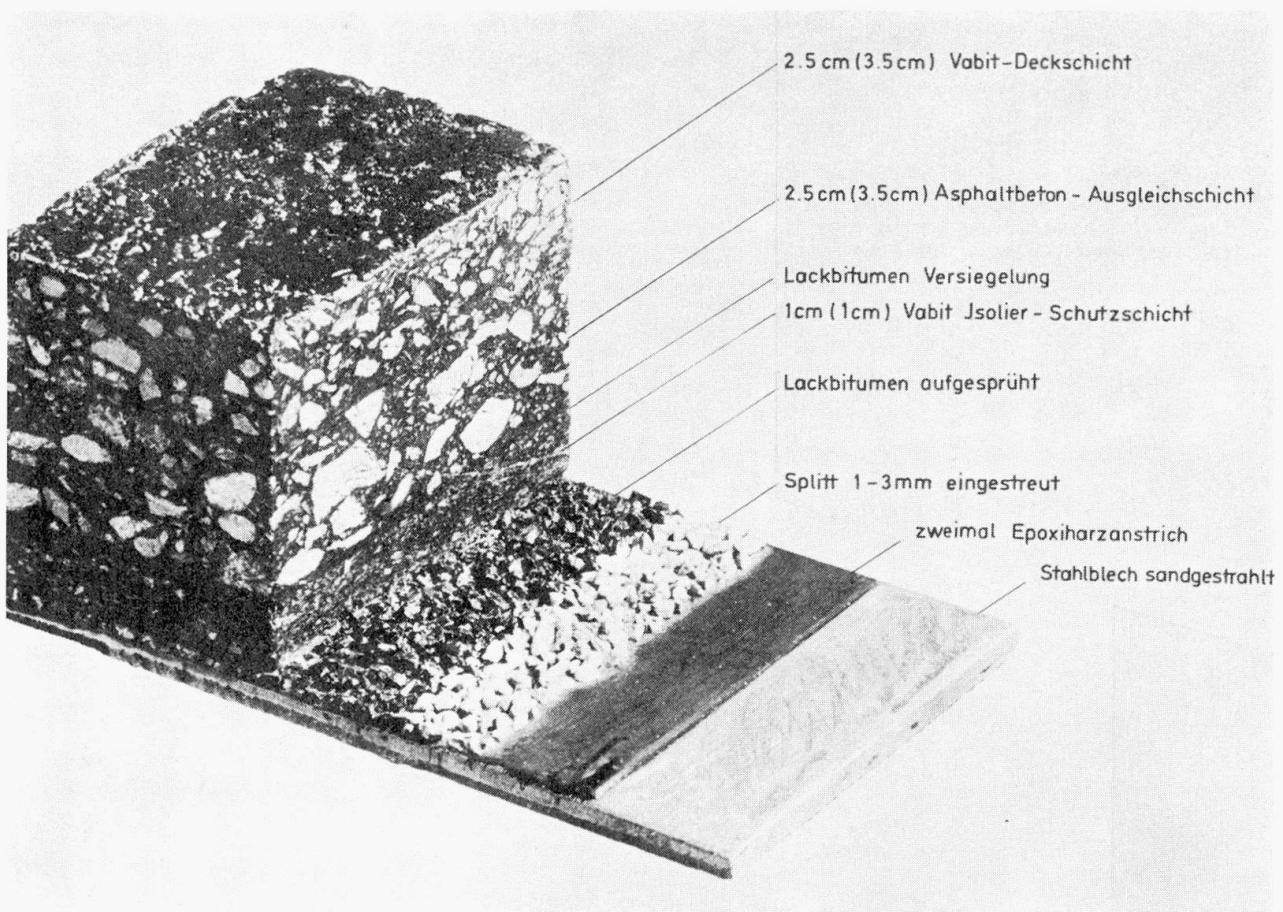
Der Aufbau des Fahrbahnbelages ist auf Abb. 1 dargestellt:

- 1.) Entrostung der Stahlplatte metallisch blank
- 2.) Beschichten mit Epoxiharz
- 3.) Einstreuen von Feinsplitt 1 - 3 mm in das noch weiche Epoxiharz
- 4.) Oberseite der kunststoffbeschichteten eingestreuten Stahlplatte anspritzen mit ca. $0,5 \text{ kg/cm}^2$ Haftkleber
- 5.) Aufbringen einer sandasphaltartigen Isolier-Schutzschicht mit ca. 1 cm Stärke
- 6.) Versiegeln der Isolier-Schutzschicht mit ca. $0,2 \text{ kg/qm}$ Lackbitumen
- 7.) Aufbringen einer 2,5 bis 3,5 cm starken Ausgleichsschicht aus Asphaltfeinbeton
- 8.) Aufbringen einer 2,5 bis 3,5 cm starken VABIT-Deckschicht aus Asphaltfeinbeton

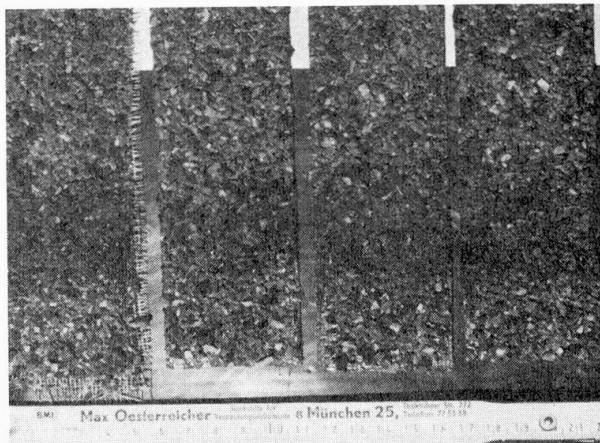
Abb. 5

Die gute Haftung des Epoxiharzes auf dem Stahlblech steht bei richtiger Verarbeitung allgemein außer Zweifel. Die Haftung des Asphaltbelages auf der Epoxiharzsenschicht muß mindestens so gut sein, wie die Schubfestigkeit des Asphaltbelages selbst. Dies wird - wie oben beschrieben - durch Einstreuen von Feinsplitt der Körnung 1 - 3 mm in den noch weichen Epoxiharzanstrich und durch einen dann aufgesprühten bituminösen Haftkleber erreicht. Außerdem entsteht durch das Aufwalzen der ersten Asphaltbetonschicht (Sandasphalt) eine Verzahnung mit den Splittkörnern. Die Untersuchungen haben gezeigt, daß verschiedene Teerepoxiharze nicht geeignet sind, weil nach dem Aufwalzen der heißen Asphaltsschichten (160°C) ölige Aussonderungen beobachtet worden sind, welche die Haftung des Asphaltbelages auf der Beschichtung verhindern und zwar mindestens solange, bis sie verdunstet oder verharzt sind. Die dauernde Haftung zwischen Asphaltbelag und der Stahlplatte wird sowohl durch die Horizontal-Komponente der durch den Verkehr auf die Fahrbahndecke ausgeübten Kräfte als auch durch die Schubspannungen in Anspruch genommen, die sich aus der Verbundwirkung infolge des statischen Zusammenwirkens des Fahrbahnbelages mit der Stahlplatte ergeben (siehe weiter unten Bericht über Pulsatorversuche). Das Epoxiharz muß bereits bei der Herstellung des Asphaltbelages eine harte Forderung erfüllen: Es darf trotz Einwirkung von 160°C durch das heiße Mischgut nicht weich werden, weil sonst während des Walzens, besonders der ersten Asphaltbetonschicht, eine Zerstörung der Beschichtung entstehen würde. Diese Forderung muß bei der Auswahl des Epoxiharzes berücksichtigt werden. Die Prüfmethode, nach der vorgegangen wurde, ist folgende: Fertig beschichtete Blechstreifen von 3 cm Breite wurden in einem Paraffinbad auf 190°C erhitzt und dann unter eine 20 kg schwere Stahlwalze gelegt, wobei zwischen Blechstreifen und Walze ein Hartgummilappen gelegt wurde. Dieser Hartgummilappen wurde sogleich mit Gewalt unter der Walzenlast herausgezogen und beansprucht dabei die Beschichtung auf Abschiebung (Abb. 2 u. Abb. 3). Beschichtungen von mangelhafter Qualität werden dabei glatzig, d.h., sie gehen z. Teil vom Blech ab (Abb. 4). Gute Beschichtungen halten diese Beanspruchungen aus ohne daß die Splittkörnchen von der Epoxiharzbeschichtung herausgerissen werden (Abb. 5).

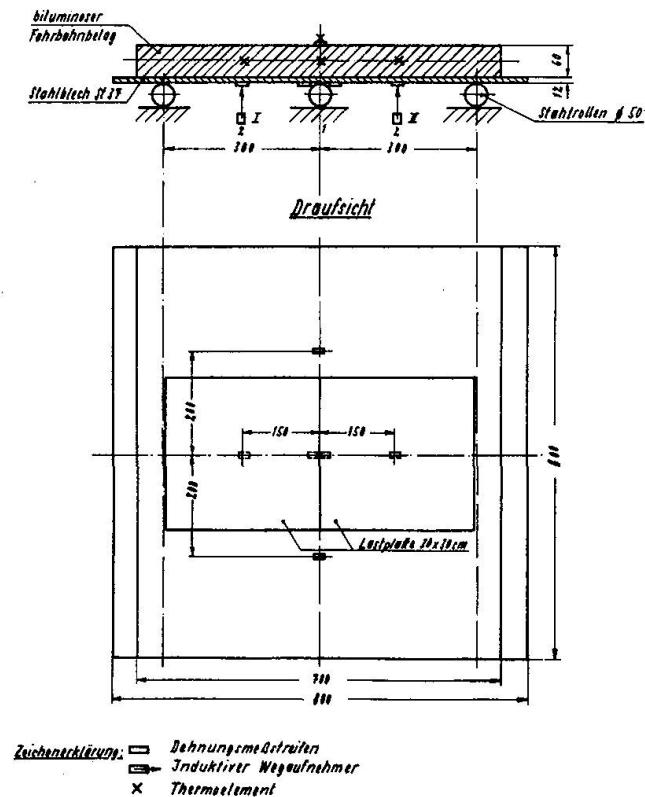
Abb. 6

Die ganze Versuchsanordnung wurde in einem Isolierkasten untergebracht, in dessen Innerem die Versuchstemperatur genau reguliert werden konnte.

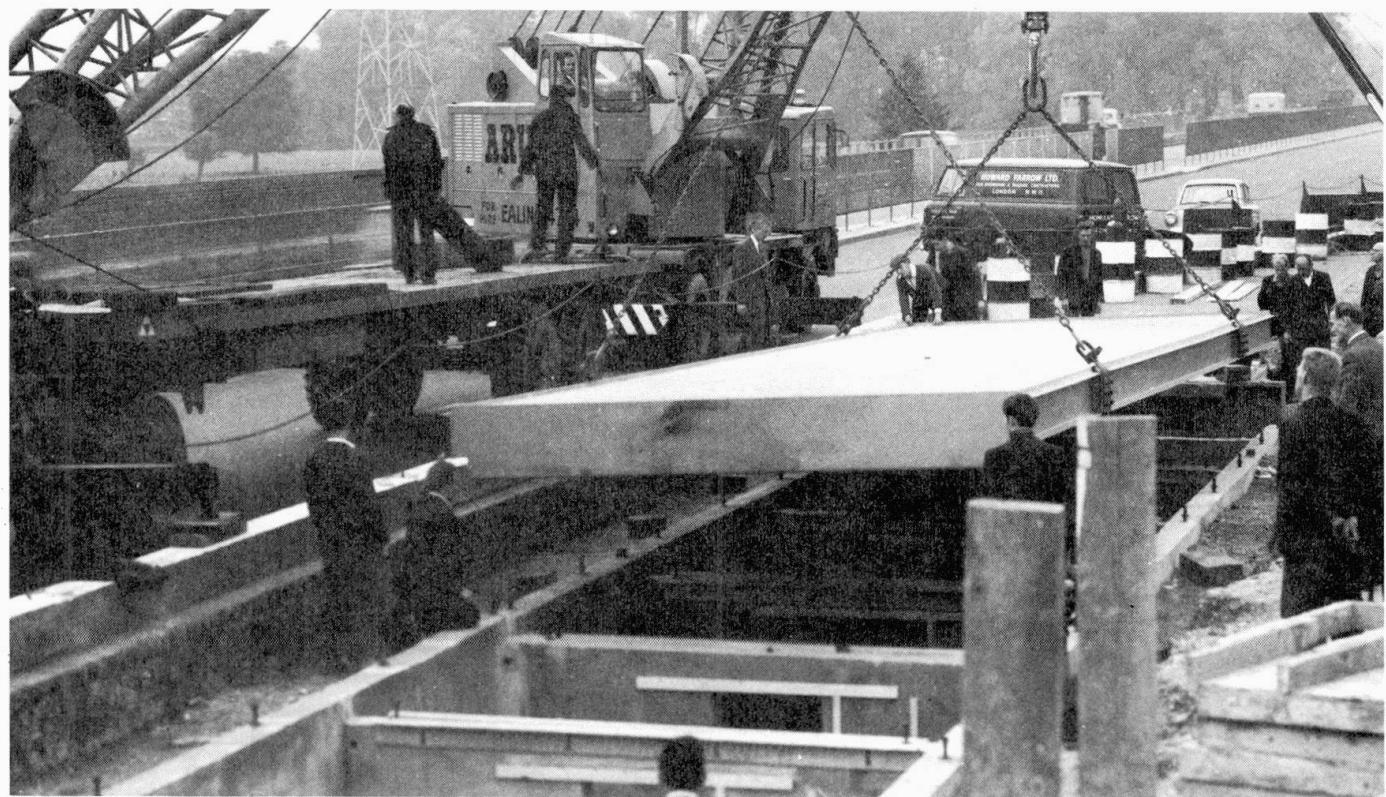
FIG. 1 TEST SITE UNDER CONSTRUCTION

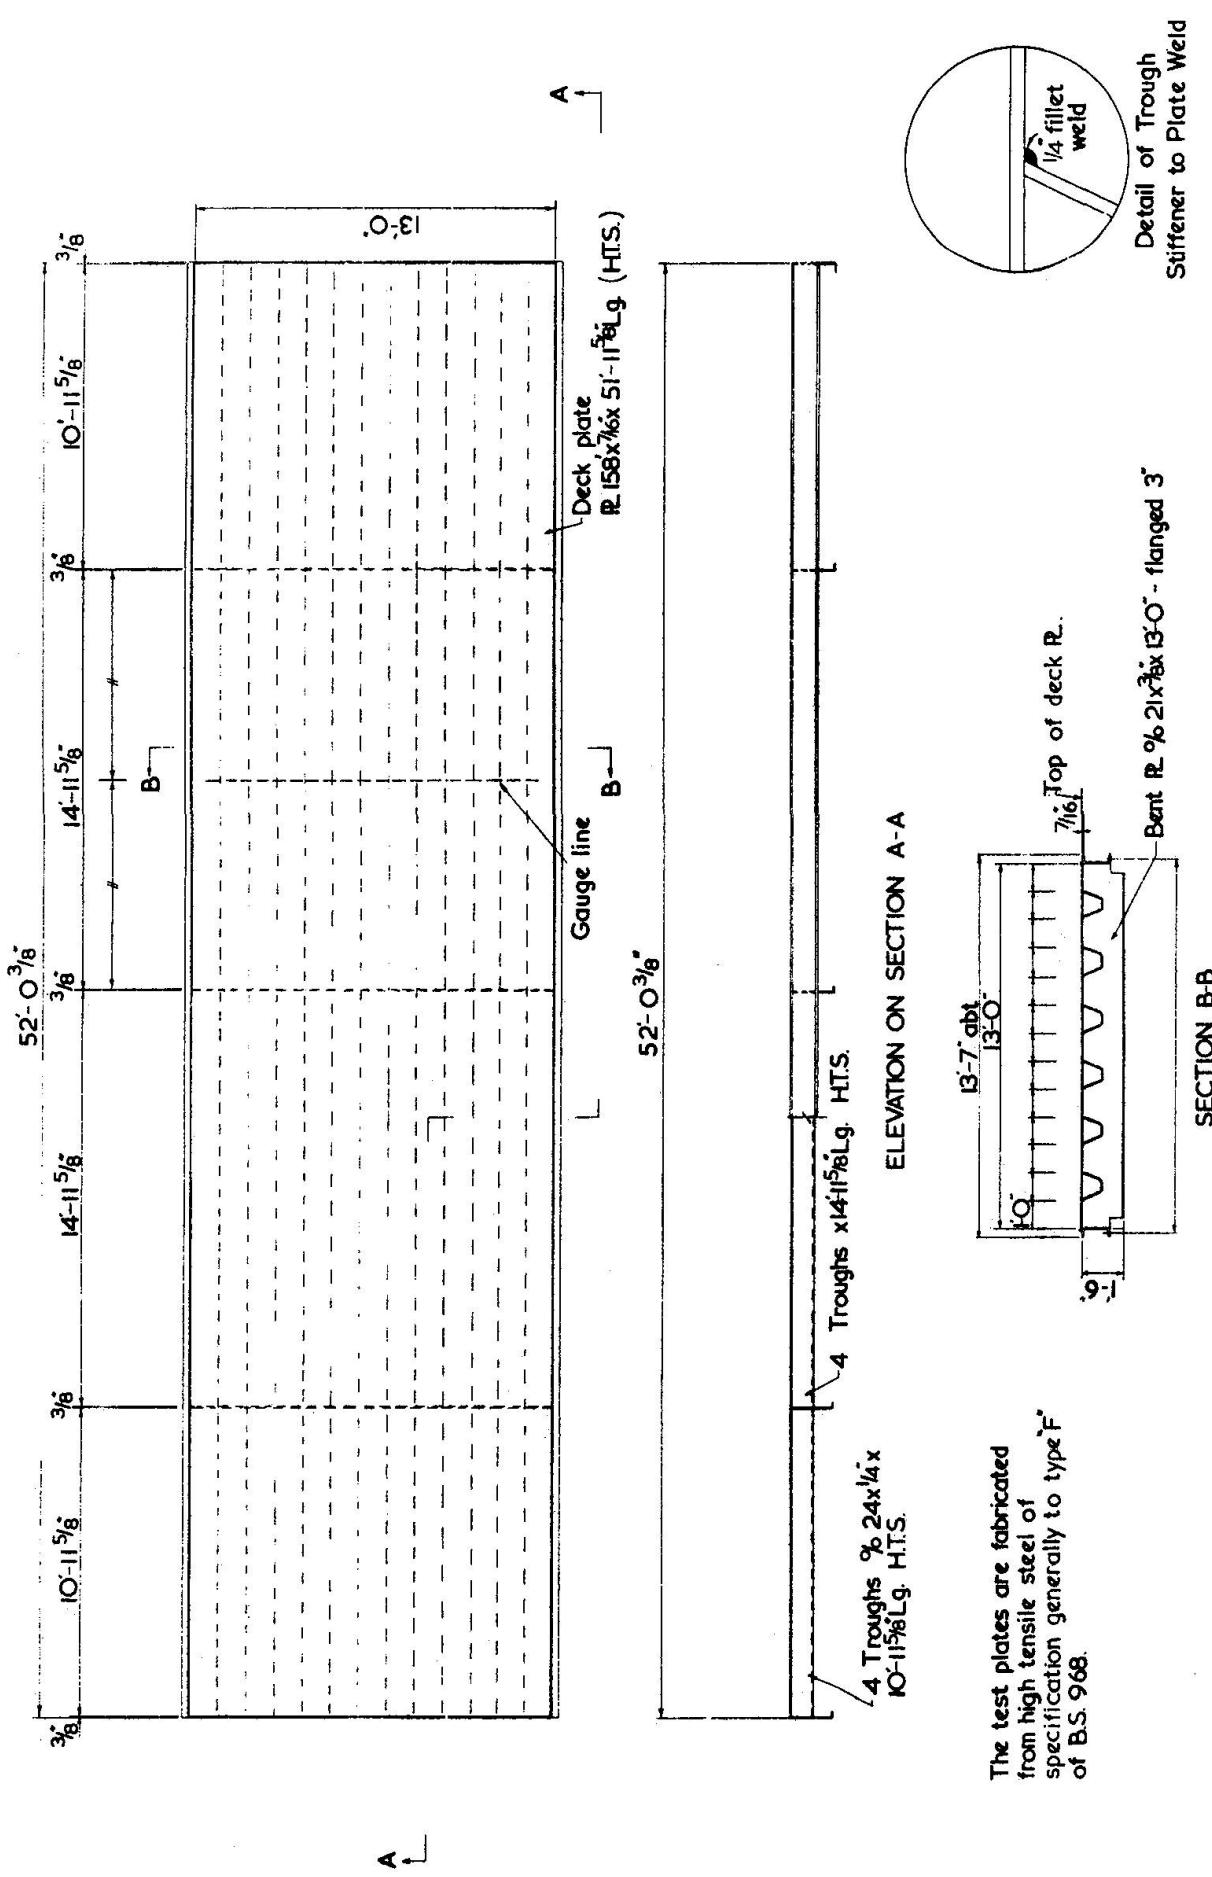
Fig. 2 DETAILS OF DECK PANELS INSTALLED ON TEST SITE

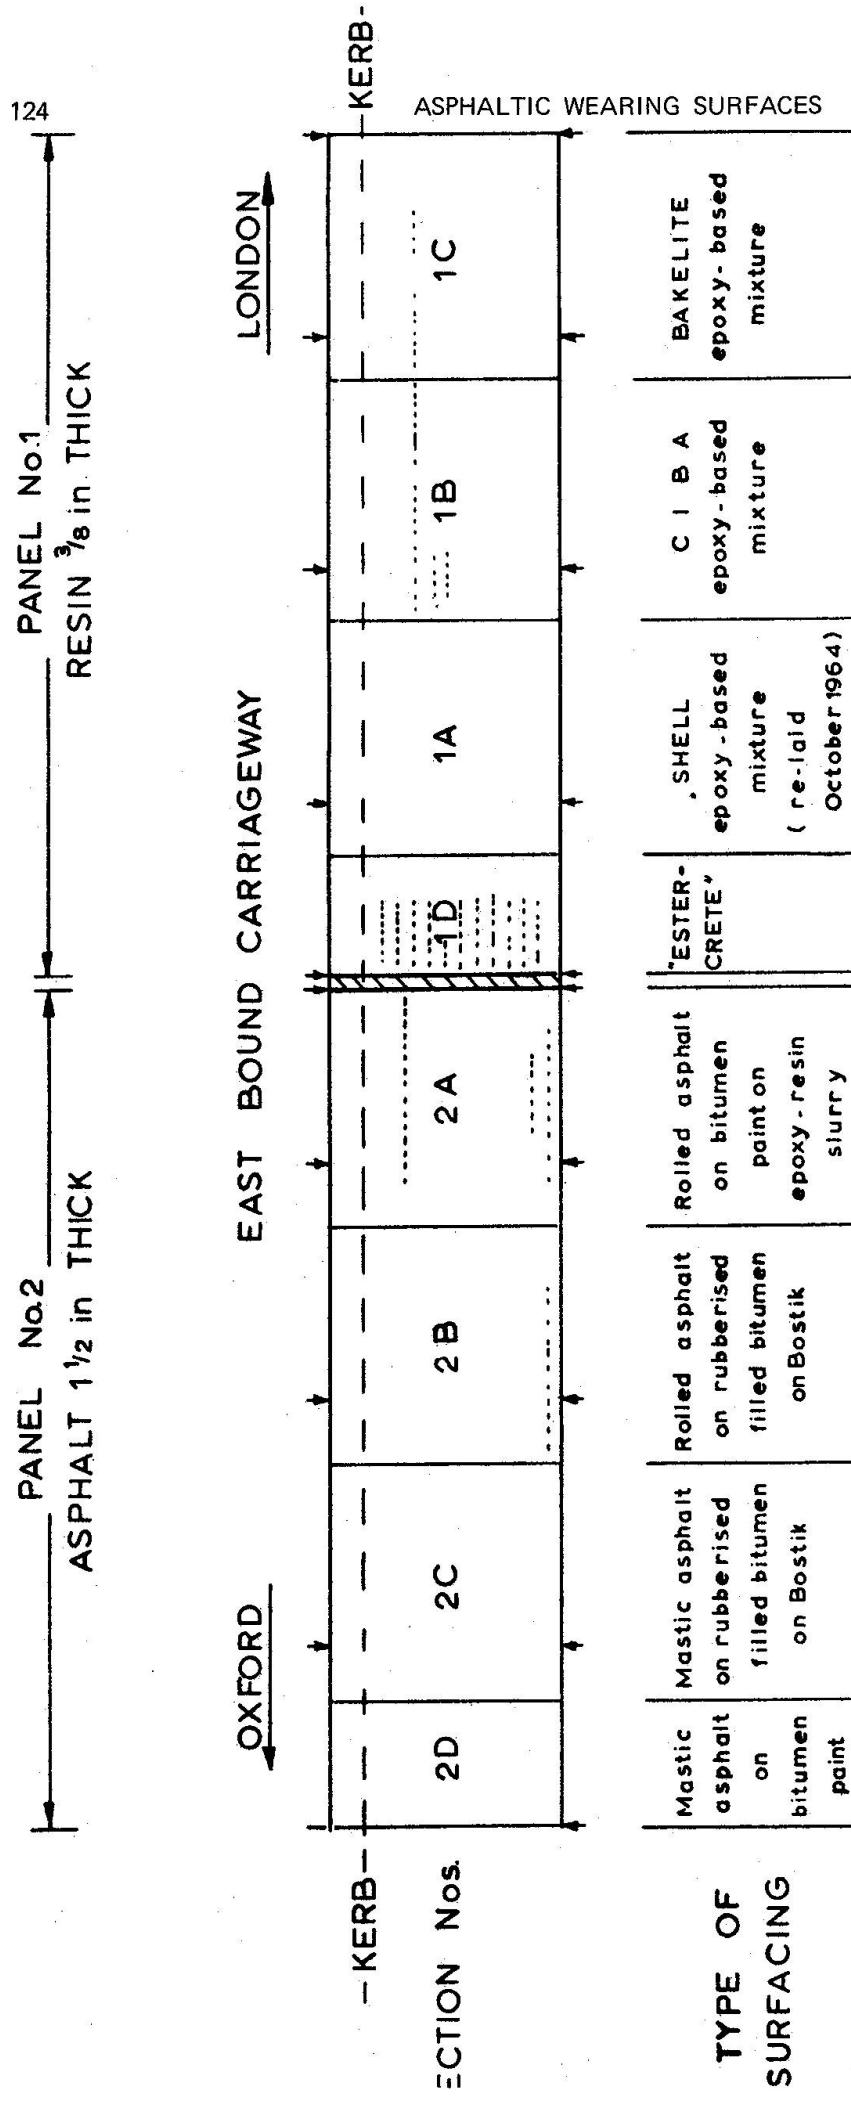
NOTE: The small arrows show position of the transverse stiffener.
The cracks visible in the surfacings in April 1965 are shown thus.....

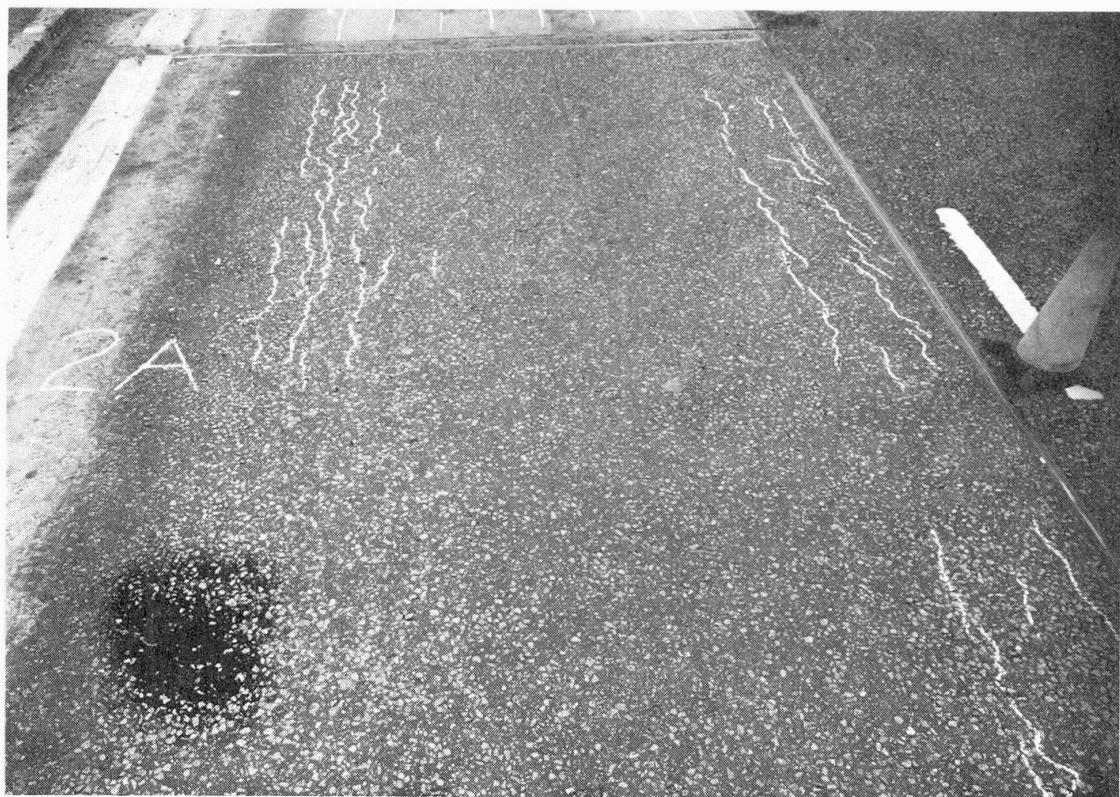
FIG. 4 CRACKING ON ROLLED ASPHALT OVER GRITTED EPOXY RESIN, NOVEMBER, 1967

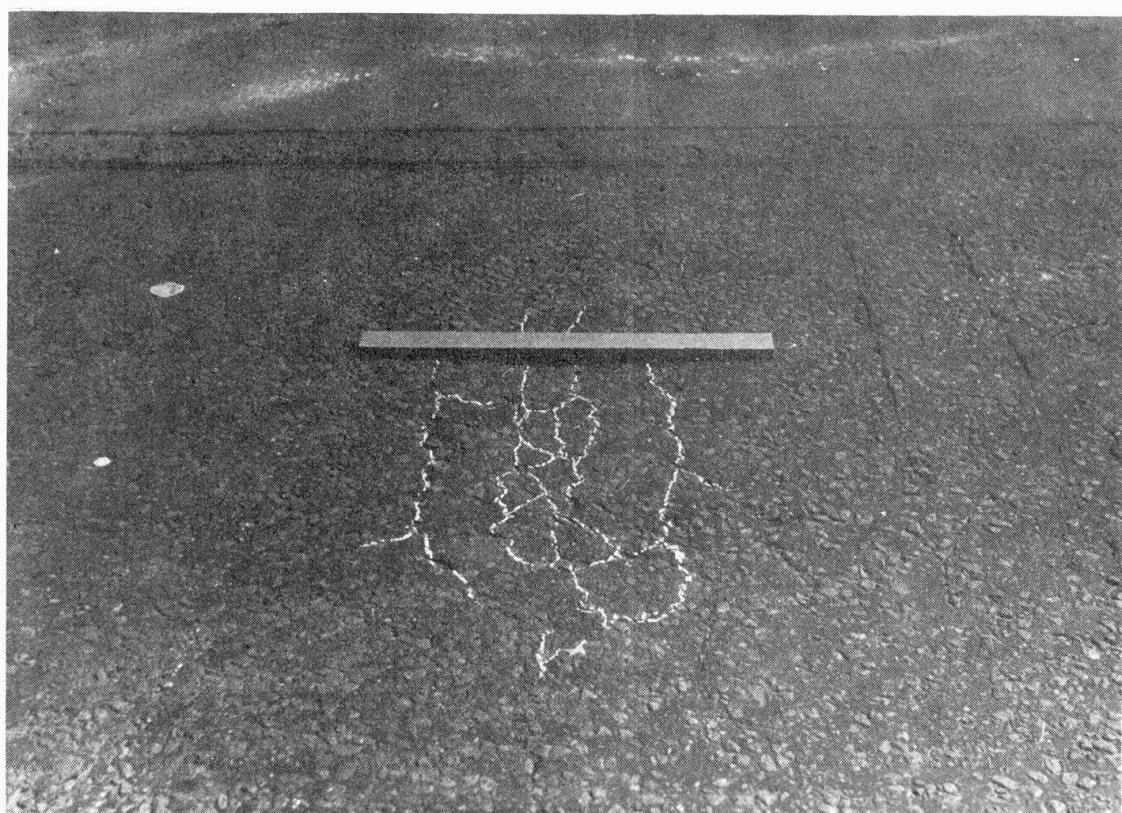
FIG. 5 DEFORMATION AND CRACKING IN ROLLED ASPHALT OVER GRITTED EPOXY RESIN,
(SECTION 2A) JULY, 1968

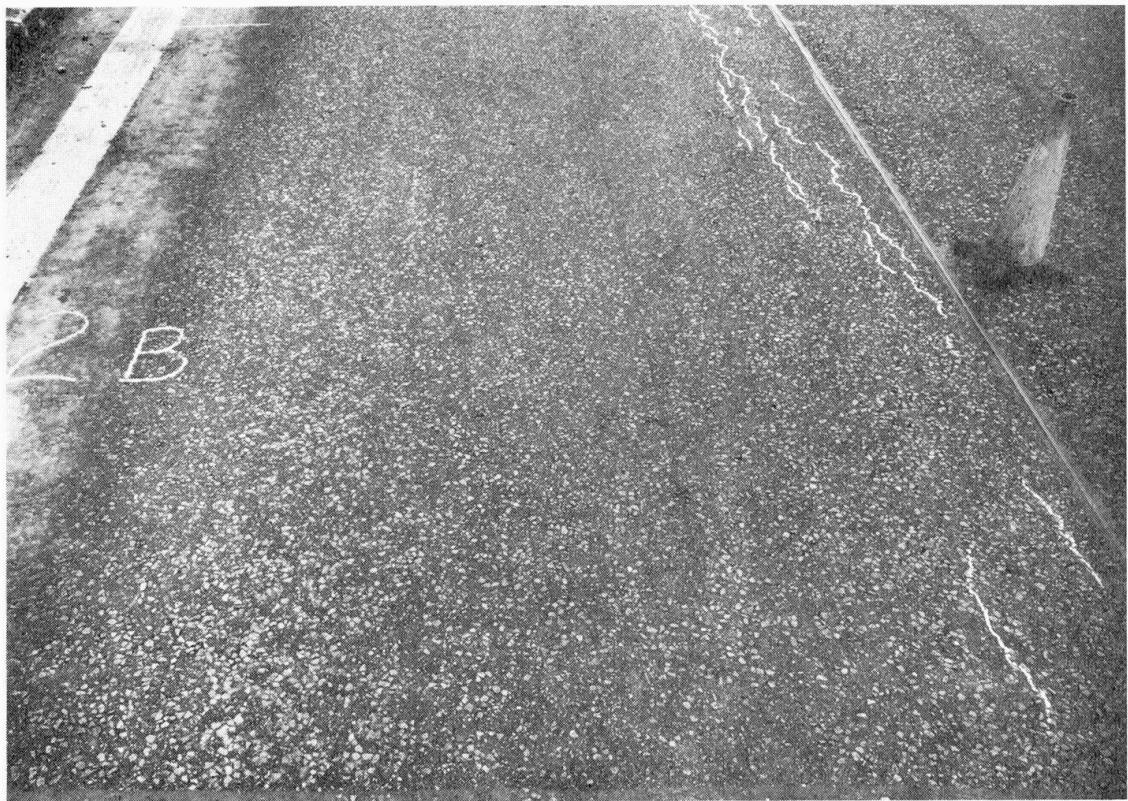
FIG. 6 CRACKING IN ROLLED ASPHALT ON FILLED RUBBER BITUMEN, NOVEMBER, 1967
