Zeitschrift: **IABSE reports of the working commissions = Rapports des commissions de travail AIPC = IVBH Berichte der Arbeitskommissionen**

RECENT EXPERIENCE ON WEARING SURFACES FOR STEEL BRIDGE DECKS OF LIGHTWEIGHT CONSTRUCTION

K.H. BEST
Great Britain

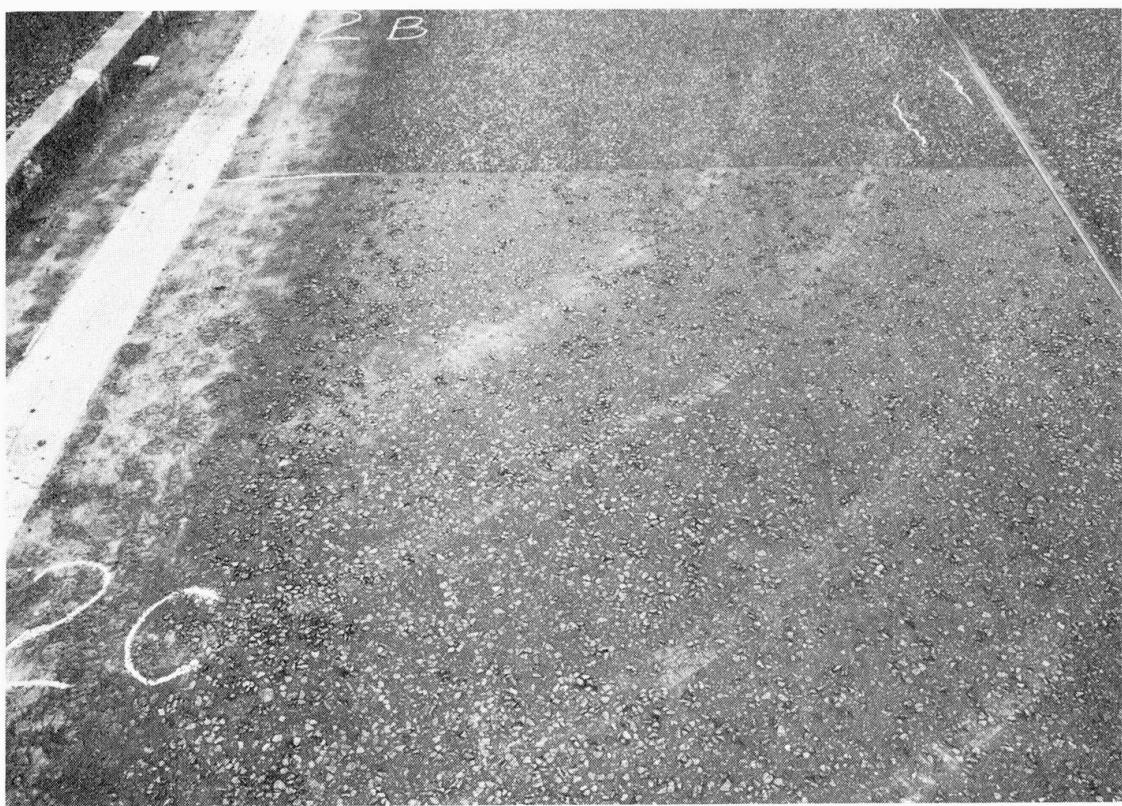
FIG. 7 MASTIC ASPHALT ON FILLED RUBBER BITUMEN, NOVEMBER, 1967
