Damage to bridges during the North Caucasus earthquakes

DAMAGE TO BRIDGES DURING THE NORTH CAUCASUS EARTHQUAKES

by G. S. Shestoporov

TsNIIS, Ministry for Transport Construction, USSR

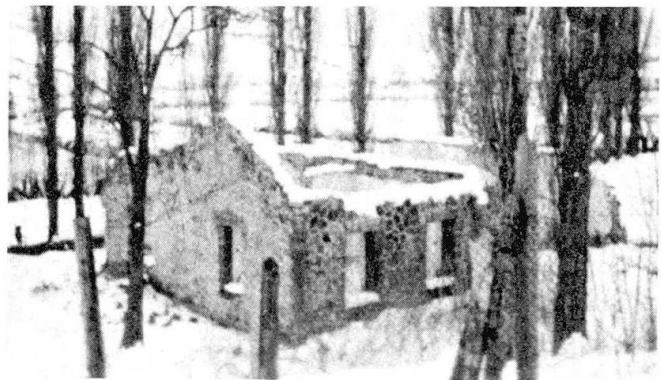
The earthquake of 1970 with magnitudo $M = 6.6$ and focal depth $H = 13$ Km spreaded over an area of about 600 Km^2 with intensity 8 (MSK scale). It was accompanied by rockfalls and landslides along river banks and steep mountain slopes. The volume of landslides in some places exceeded 1 million m^3 , the extent of the breaches reached several hundred meters [1, 2]. Some of the stone buildings in the settlements, located on the epicentral area, were collapsed (fig. 1). The quake of 1975 had intensity 7. It caused heavy damages to rubble buildings (fig. 2).

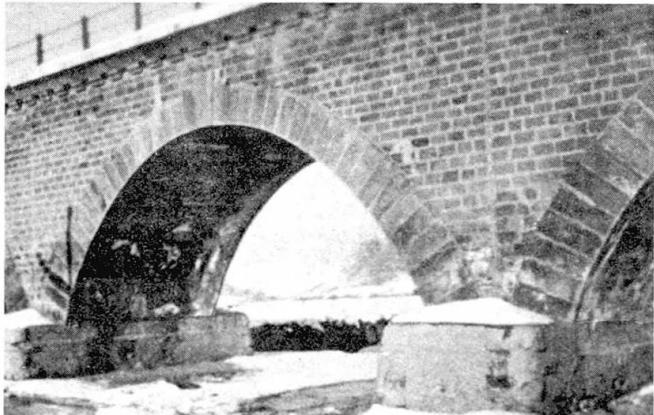
In 1970 most of girder and arch railway bridges, constructed in 1914 (fig. 3), suffered moderate damages such as deep cracks in wing walls of abutments (fig. 4), ice-breakers (fig. 5), bridge seats and concrete arches. Among massive structures the least damages were received by simple-span bridges with reinforced concrete slab superstructures, anchored in the abutment masonry.

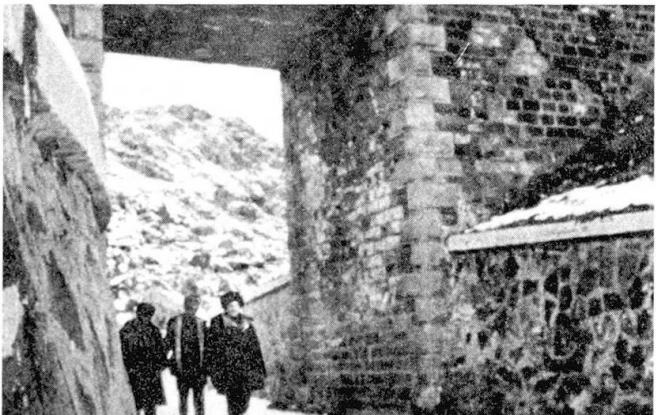
As a rule the damages of stone and concrete bridges in 1970 didn't create dangerous conditions for service of the structures. The quake of 1975 caused the development of the initial cracks and considerable decrease of the bearing capacity of these structures. In some cases stone and concrete bridges needed reinforcing.
