A FIRST GEOTECHNICAL ASSESSMENT OF THE RECENT PATTI EARTHQUAKE
(SICILY)

Michele Maugeri, Professor of Soil Mechanics Faculty of Engineering, University of Catania.

On Saturday 15th April 1978, at about half an hour after midnight, a 5.4 magnitude earthquake occurred near Patti, making 312 houses uninhabitable and 712 people homeless.

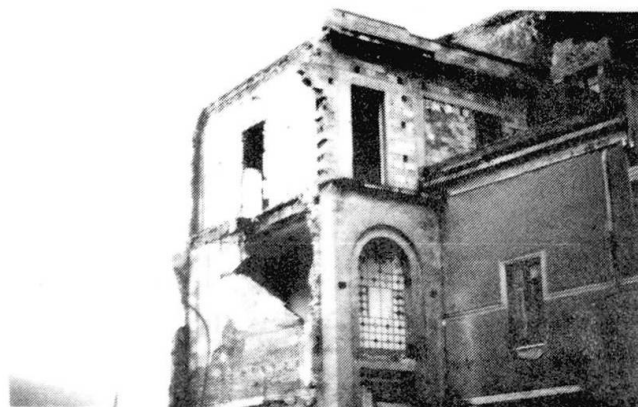
The worst damaged houses in Patti were those founded on sandstone, built of masonry and rarely cemented, in the old centre of the town.

On that site the sandstone formation assumes a hill configuration, which could produce an amplification on maximum ground acceleration (Maugeri, 1976), which can explain, together with the poor construction quality, the severe destruction of some houses.

In fig. 6 the damage suffered by one wing of Patti Cathedral is visible and in fig. 7, the damage at the corner of the main nave is evident.

Fig. 6: Patti Cathedral: the left wing.

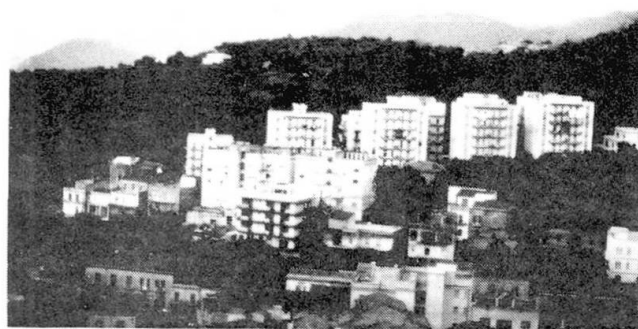
The new concrete buildings in Patti, shown in fig. 8, are built on fissured clay and were apparently damaged on the buffer walls only, mainly at the lower levels.

Fig. 8: Concrete buildings at Patti virtually undamaged.
