Artikel: Measurement of service stress and fatigue life evaluation of bridges
Autor: Yamada, Kentaro / [s.n.]
DOI: <https://doi.org/10.5169/seals-45709>

Measurement of Service Stress and Fatigue Life Evaluation of Bridges

Kentaro YAMADA

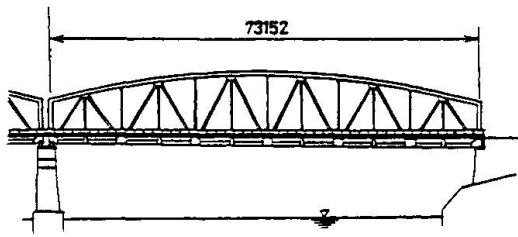
1) Bridge A: It is a 60-year old riveted Warren truss bridge, as shown in Fig. 1, with a span of 73 m and a 16 m wide roadway. The bridge is daily subjected to about 250 trains at a speed of about 10 km/h and about 10,000 vehicles, in which 11 percent are trucks. The traffic is considered rather light in Japan.

Fig.1 Bridge A: Riveted truss bridge

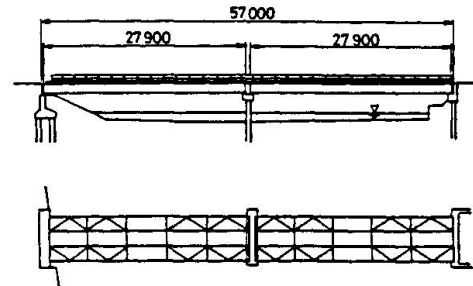
2) Bridge B: It is a welded plate girder bridge built in 1967, with a span of 27.9 m and a 7.0 m wide roadway for two lanes, as shown in Fig.2. The spacings of main girders are 2.0 m and the sway bracings are placed at 5.58 m intervals. The reinforced concrete deck was originally 23 cm thick, and was later added by a 12 cm thick steel-fiber reinforced concrete in 1979. It is a private bridge in a steel works. Although about twenty special trucks of more than 785 kN (80 tons) pass on it daily, the number of daily truck traffic is very small.

Fig.2 Bridge B: Composite plate girder bridge

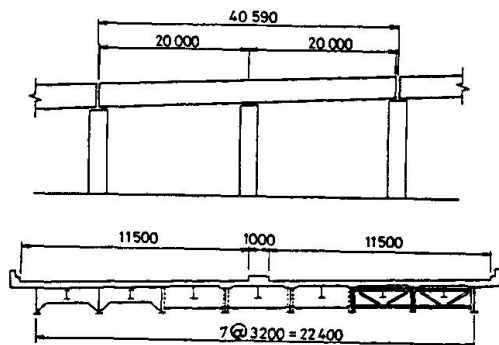
3) Bridge C: It is a two-span continuous plate girder bridge built in 1964, with eight main girders spaced at 3.2 m intervals, as shown in Fig.3. The total length is 40 m with two spans of 20 m each. The roadway is for six lanes, three lanes for each direction. The deck is made of 19 cm thick reinforced concrete slab. The bridge situates in an industrial area and carries about 100,000 vehicles daily. About half of the passing vehicles are trucks and it is considered to be under severe traffic condition. The bridge was repaired and retrofitted in 1982, when cracks were found in the fillet weld at the upper end of vertical stiffener. The stress measurement was carried out in 1984 [4].

Fig.3 Bridge C: Non-composite plate girder bridge

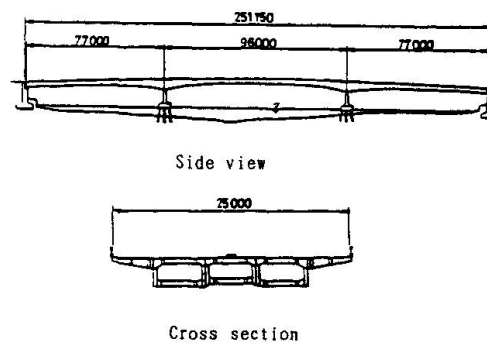
4) Bridge D: It is a three-span box girder bridge with orthotropic steel decks, built in 1964. It has a 96 m center span and two 77 m side spans, as shown in Fig.4. It is situated on the same route as Bridge C, and is also subjected to severe traffic condition. Several fatigue cracks were found in the corner of diaphragms, and rehabilitation works were carried out in 1989.

Fig.4 Bridge D: Three span continuous box girder bridge

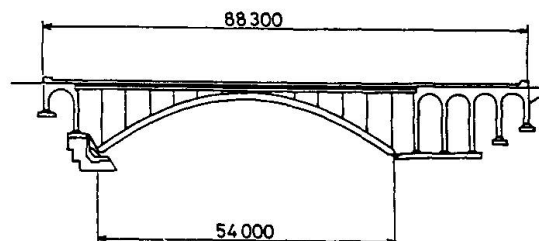
5) Bridge E: It is a two-hinge deck type arch bridge built in 1964. The arch has 54 m span and the width of roadway is 9.9 m, as shown in Fig.5. The bridge is subjected to about 80,000 vehicles every day, and 26 percent of them are trucks. The bridge is also subjected to severe traffic condition. Fatigue cracks were found in stringers of floor system and vertical members of arch. The cracks of the stringers were repaired and the cracked parts were stiffened. Further repair and strengthening of the arch and replacement of concrete slab into orthotropic steel deck are underway.

Fig.5 Bridge E: Deck type arch bridge

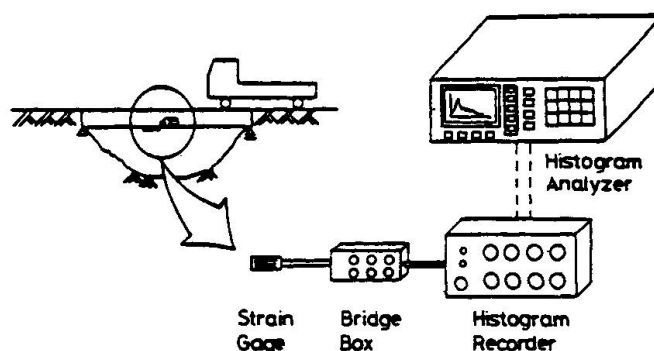
shown in Fig.6 [9]. It analyzes the strain waves in real time and records the stress ranges and the number of their occurrence. The analysis may be based on rainflow counting method, peak counting method, level crossing counting method, and so on. The rainflow counting method was used in this study to obtain stress range histogram. The Histogram Recorder has some advantages as that it requires no traffic control, and the disadvantage is that it distinguishes neither the type of trucks nor their axle weight. Therefore, stresses under model vehicle with controlled weight are often measured and used as reference values.

Fig.6 Measurement of stress histogram

Stresses under service condition are important to evaluate the durability of structures. Service stresses can be measured by using a Histogram Recorder, as

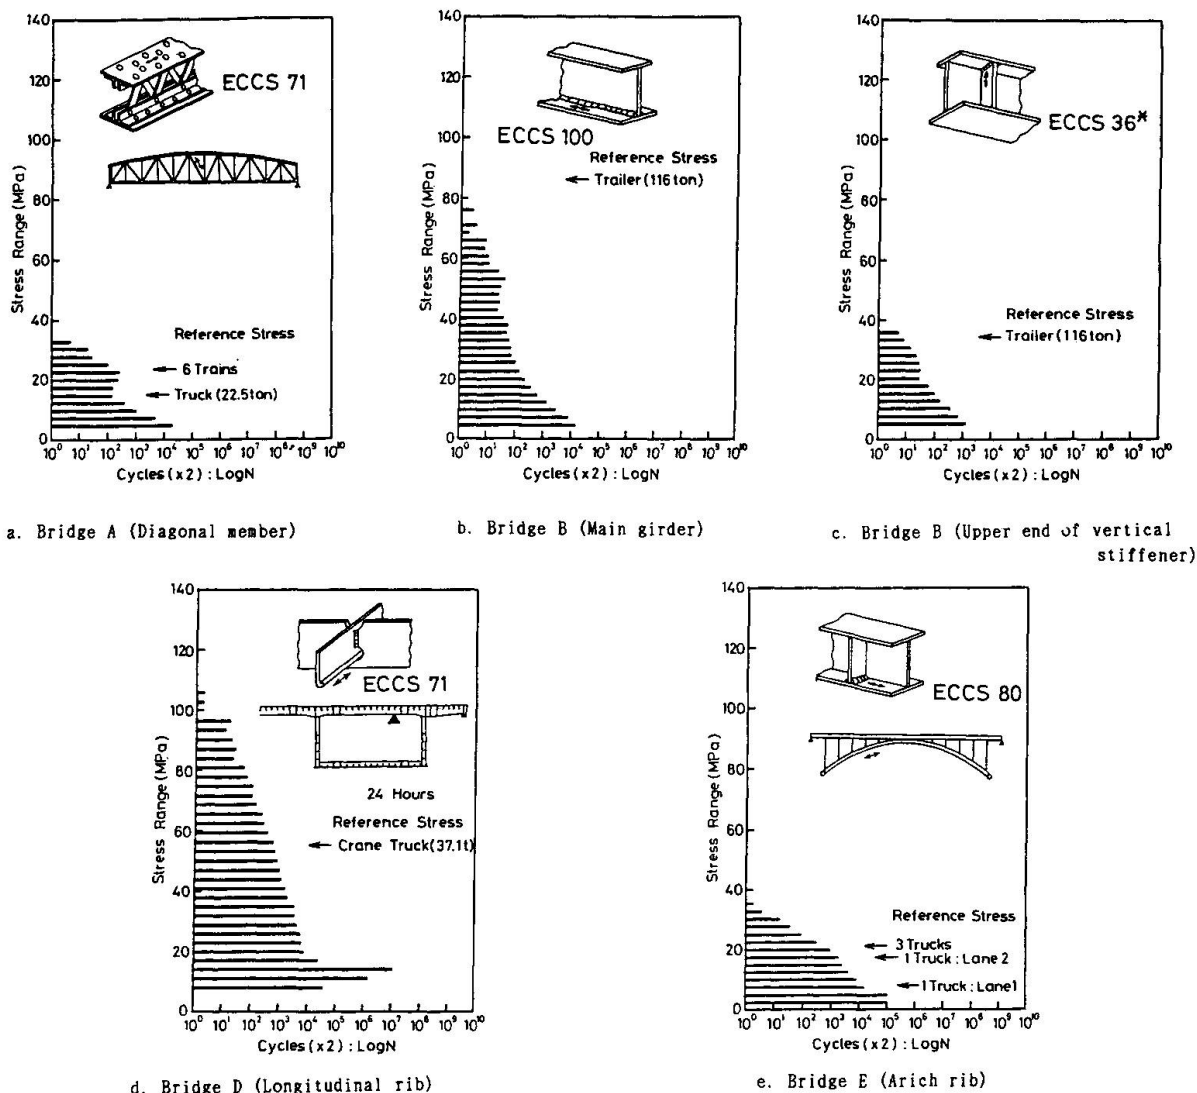
Examples of the stress range histogram measured for 24 hours are shown in Fig. 7, where the ordinate indicates stress range and the abscissa shows the number of half stress cycles in logarithmic scale. The stress ranges corresponding to the model vehicles are also shown as reference values.

The stress histogram of a diagonal member of the Bridge A is shown in Fig.7a. The model vehicles are a 22.5-ton dump truck with 3 axles and a train with 6 cars. It seems that the upper peak of stress cycles is caused by the trains. The stress cycles below the reference value by the model truck may be caused by lighter trucks and the other vehicles and that above the reference value by the train is considered to be caused when the trucks and the train passed on the bridge simultaneously.

Figs.7b and 7c show stress range histograms measured at a lower flange and the upper end of a vertical stiffener of Bridge B, respectively. The measured maximum stress range in the lower flange is close to reference stress range by the 1140 kN (116 tons) trailer truck. And that in the lower flange of Bridge B is about 80 MPa, about twice of that in the diagonal members of Bridge A.

Fig.7d shows stress range histogram measured at bottom of longitudinal rib in the orthotropic steel deck of Bridge D. The model vehicle was a crane truck of 364 kN (37.1 tons). The maximum stress range was about 105 MPa, about twice of stresses due to the model vehicle. It is either because the trucks weigh more than the model vehicle, or because heavy trucks crossed the bridge simultaneously. There was extremely large number of low stress ranges. This may be explained by the frequent passage of small trucks or vibration in the orthotropic steel deck due to the passing traffics.

Fig.7e shows stress range histogram measured at the arch rib of passing lane side of Bridge E. The reference stress ranges due to a truck of 206 kN (21 tons) passing on the slow lane or on the passing lane, or three same trucks are also shown in the figure. The measured stress range were larger than the stresses by the three trucks. It implies that vehicles weighed more than the model trucks frequently passed on the bridge.

Fig.7 Example of stress range histogram records

The stress range histograms of Bridges D and E were different from that of Bridges A and B. This is because the volume of traffics is much greater in Bridges D and E than in Bridges A and B. For example, about 250 trains and 10,000 vehicles passed on Bridge A, while over 100,000 vehicles passed on Bridge D and about 80,000 vehicles passed on Bridge E for 24 hours.

In this study the design S-N diagrams specified in the ECCS Recommendation for the Fatigue Design of Steel Structures [8] were used to evaluate the fatigue strength of weld details. Since the design S-N diagrams correspond to the mean-2xs (s:standard deviation) S-N diagrams, the computed fatigue life is the lower bound fatigue life. The design S-N diagrams are given for classified structural detail. The detail categories evaluated for fatigue life in this study are also shown in Fig.7.

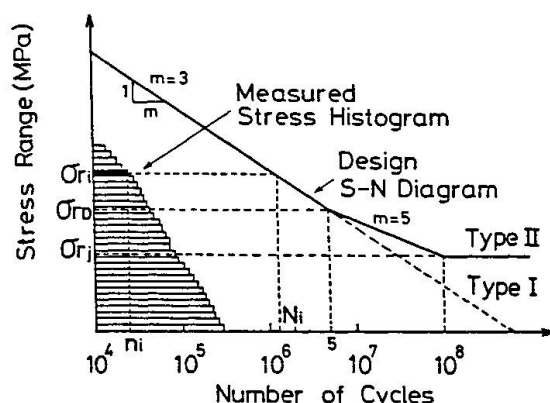
Two types of design S-N diagrams specified in the ECCS Recommendation are used to evaluate the fatigue damage based on the stress range histogram, as shown in Fig.8.

Fig.8 ECCS design S-N diagram

- 1) Type I (Modified miner's rule): The S-N diagram of slope of $m=3$ is extended linearly.
- 2) Type II (Three line method): The slope of the S-N diagram m is equal to 3 for N less than 5 million cycles, and 5 for N between 5 million and 100 million cycles. Stress ranges below the cut-off limit are neglected.

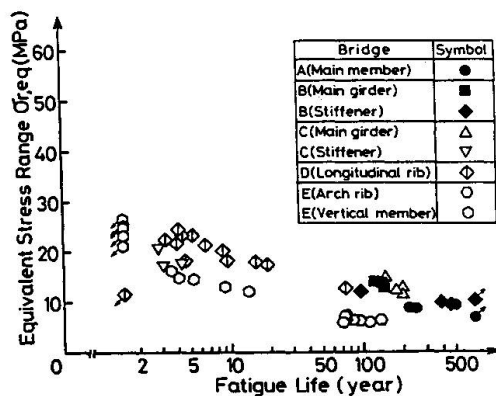
Fatigue lives of the above-mentioned structural details in the Bridges A and B computed from the measured stress histograms are plotted in Fig.9. The two bridges were subjected to relatively light traffics, and their fatigue life are shown by the solid symbols in Fig.9. The fatigue life of the main members of Bridge A yields to more than 220 years, and that of the tension flanges of Bridge B are between 120 and 140 years. Even the upper end of vertical stiffeners of Bridge B showed the life longer than 90 years. Considering that the evaluated fatigue life is the lower bound because of the use of the lower bound S-N diagrams, it may be safe to concluded that fatigue cracks would hardly occur in these details, provided that traffic condition will remain unchanged and structural deterioration such as corrosion will not take place.

Fig.9 Equivalent stress range and fatigue life for Bridges A and B

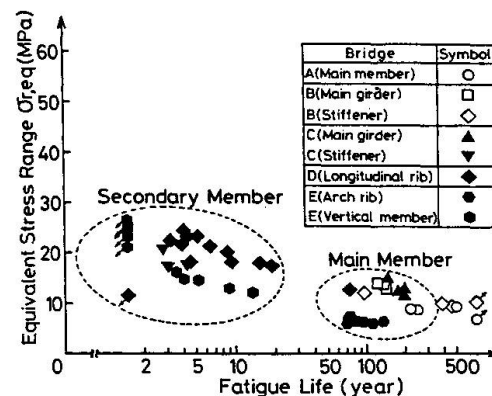
Fig.10 Equivalent stress range and fatigue life for Bridges C, D and E

Bridges C, D and E were subjected to severe traffic condition, and their fatigue lives are plotted by the solid symbols in Fig.10. If the structural details are grouped into main members and secondary members, the computed fatigue lives can be also grouped accordingly. For example, the fatigue lives of the tension flange of Bridge C are more than 100 years, and that of the arch ribs of Bridge E is between 70 and 130 years. On the contrary, the fatigue lives of the vertical members of the arch are less than 4 years, that of the longitudinal ribs in Bridge D are less than 20 years, and that of the upper and lower ends of the vertical members of Bridge E are below 15 years. Actually, the welded details in these secondary members were found susceptible to fatigue cracking previously [2,3,4]. Therefore, the fatigue lives obtained from the measured stress range histogram are a good

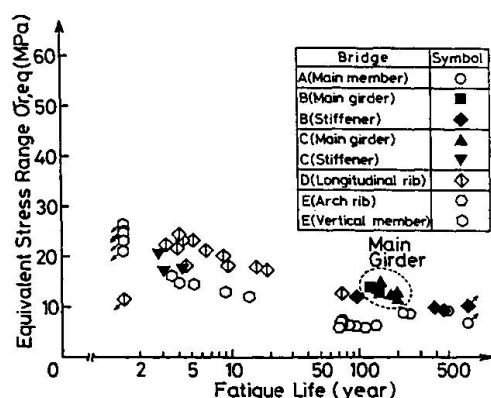
Bridges B and C are both plate girder bridges with similar structural details, and their fatigue lives are plotted by the solid symbols in Fig. 11. It is noted that the main girder of Bridge B showed shorter fatigue life than Bridge C, although Bridge C are subjected to about 100,000 vehicles daily. This may be because Bridge B carries special vehicles of over 785 kN (80 tons). However, the upper ends of the vertical stiffeners in Bridge B showed long fatigue lives. This may be due to the 35 cm thick concrete slab and the 2.0 m girder spacing in Bridge B. They reduced the stresses and hence increased the fatigue life. On the contrary the Bridge C has a 19 cm thick concrete slab and 3.2 m girder spacings.

Fig.11 Equivalent stress range and fatigue life for Bridges B and C

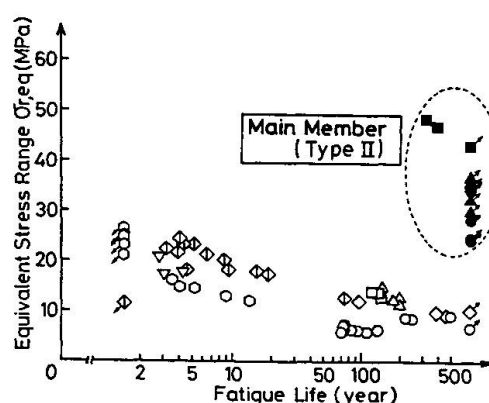
Fig.12 Equivalent stress range and fatigue damage for main members

The type II S-N diagram (Three line method) was also used to evaluate the fatigue life of each detail, and the results are plotted in Figs. 12 and 13. In Fig. 12, computed fatigue life of the main members (the tension flanges and the arch ribs) using the type II S-N diagram are shown by the solid symbols. They are over 300 years, longer than that evaluated by using the type I S-N diagram. This is because most of the stress ranges in the histograms are below the cut-off limit and they are neglected in the type II S-N diagram. In the case of the arch ribs of the

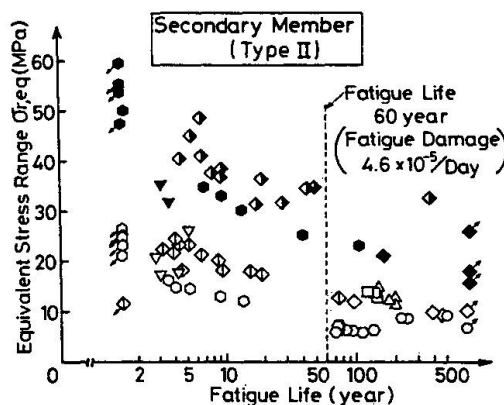
Fig.13 Equivalent stress range and fatigue damage for secondary members

The fatigue lives of the secondary members are shown by the solid symbols in Fig.13. Although the equivalent stress ranges increase, the computed fatigue lives are similar to the lives computed based on the type I S-N diagram. A good part of the stress ranges in the histogram were above cut-off limit and contributed to the fatigue damages of the secondary members. Some secondary members actually experienced fatigue crackings, and therefore this trend can also be used to evaluate the severeness of stresses against fatigue.
