**Artikel:** Diagnosis of damage in a wooden vaulted structure  
**Autor:** Ronca, Paola  
**DOI:** <https://doi.org/10.5169/seals-53294>

## **Diagnosis of Damage in a Wooden Vaulted Structure**

The present work illustrates this kind of methodology used to understand the excessive deflection of the wooden vaulted roof of the Palazzo della Loggia in the city of Brescia. After a primal phase of inspection, monitoring and in situ non destructive tests able to give informations about the actual state of the materials and structure [1],[2], it has been necessary to make some ingegneristic interpretations, and to verity them or to search a different response by means of numerical models and experimental tests. In particular it was necessary to understand the efficiency of the joints of the principal truss arches of the vault. Some prototypes of wooden joints have been constructed in the laboratory of the Departement of Civil Engineering to calibrate in a realistic way the parameters necessary to estimate the stiffnes of the connections for the numerical non-elastic analysis. As a matter of fact the actual joints of the truss wooden arches are made by different series of bolts. The effi

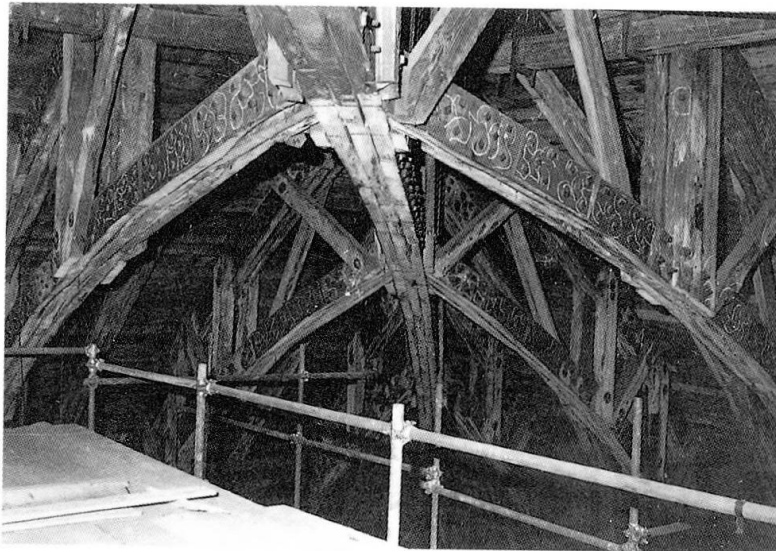
Fig.5 The view of a diagonal arch

The semiarches of the short side of the roof end on the diagonal arches, to which are connected (fig.5). The principal arches, made as the entire structure, of hoak wood, are trussed structure, as shown in figure 4, made of two longitudinal curved beams a1 and a2 (the intradoss and the extradoss of the arch) connected by diagonal and straighth elements. The two curved beams a1 and a2 converge to forme a unique monolitical element at the base, which ends at two different levels.
