Diagnosis, maintenance, retrofitting, repair

Zeitschrift: **IABSE reports = Rapports AIPC = IVBH Berichte**

Stud Arrangement to Reduce Fatigue Cracks and Application of Drilled Holes

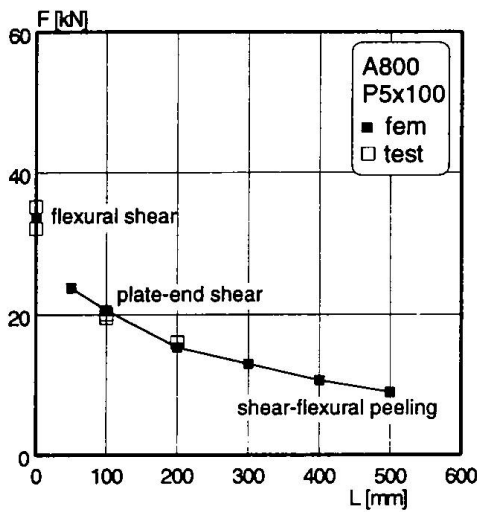
Fig. 2 Influence of unbonded length L on shear capacity

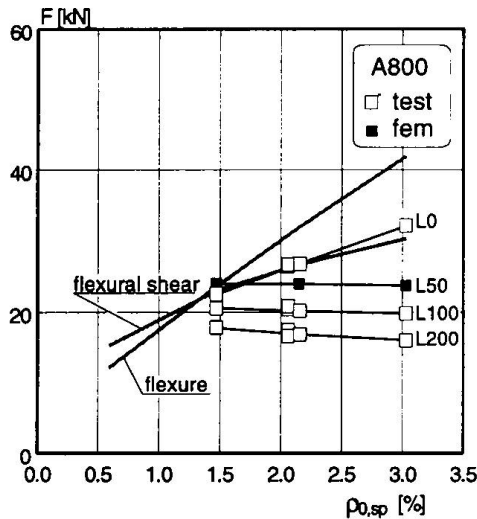
Fig. 4 Influence of reinforcement ratio $\rho_{n,sp}$ on shear capacity as function of L

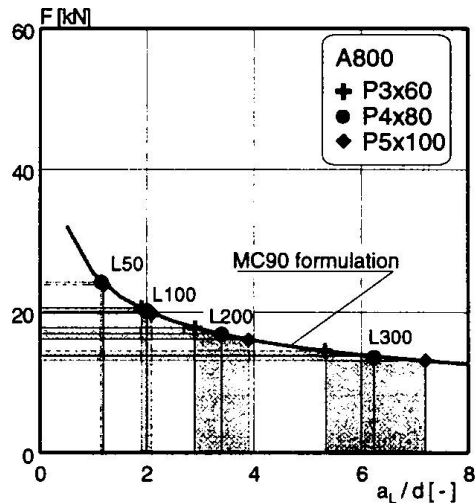
Fig. 5 Fictitious a_l/d according to tests and calculations on basis of MC90

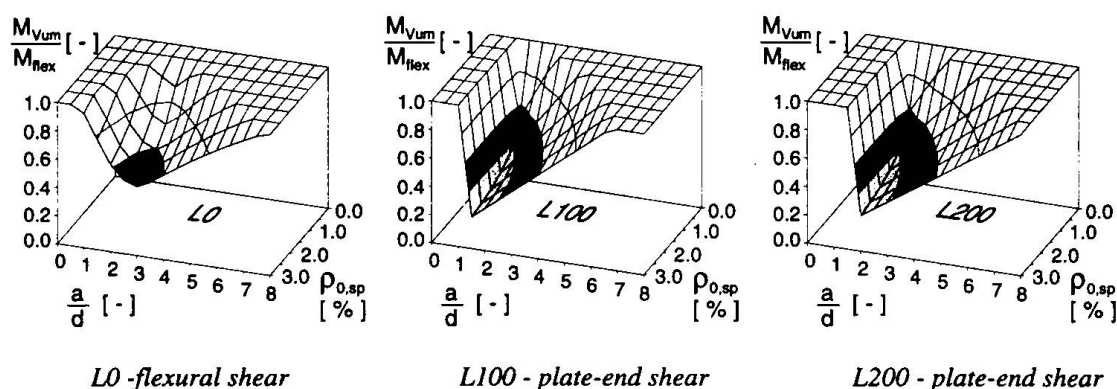
Fig. 8 Kani's shear valley for fully plated members and calculated Kani's shear valley for partially plated members with external steel plate stopped 100 and 200 mm short of the support

Both flexural shear for fully plated members (L0) and plate-end shear for partially plated members (in this case study $L = 100$ and 200 mm) are graphically represented by Kani's shear valley in Fig. 8. It is clearly seen that for plate-end shear Kani's shear valley has much more depth than for flexural-shear failure. Particularly for shear-span-to-depth ratio's $a/d < 4$ or 5 plate-end shear dominates flexural shear. For shear spans smaller than approximately $a < L+d$ an arch can be formed between the load and the support because the plate-end-shear crack does not intersect the compressive-load path. Thus, a plateau is visible as in the original shear valley. The valley of the L200 member has less depth than that of the L100 member, see also Fig. 3. The L100 and L200 graphs further indicate that with increasing unplated length plate-end-shear also governs failure for larger a/d -values. The graphs clearly indicate that one should be careful with strengthening short deep beams. The reduction of the bearing capacity by plate-end shear may be considerable, specially for small a/d -values.

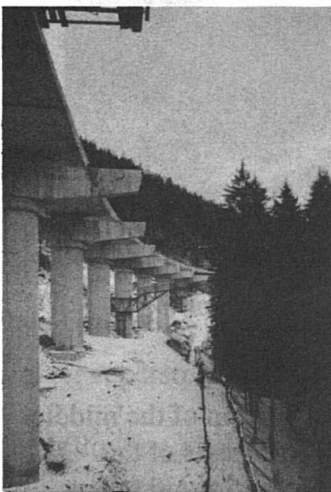
Fig. 4 Destruction outer deck slab

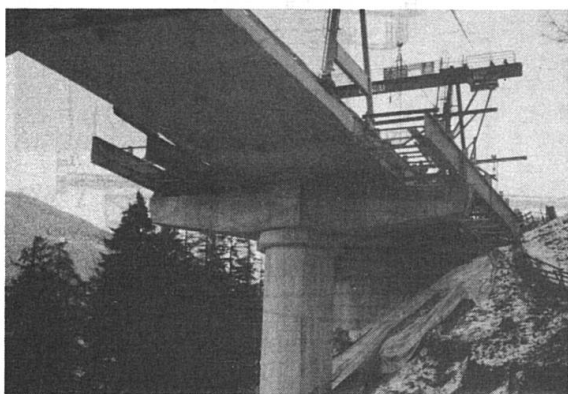
Fig. 7 Setting of steel units at outer structure

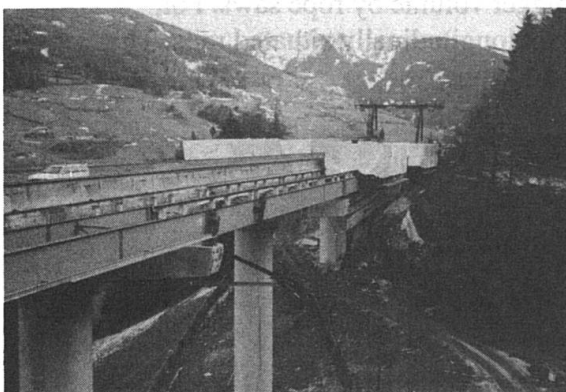
Fig. 9 Concreting at outer structure
