**Artikel:** Compression membrane action in composite slabs  
**Autor:** Peel Cross, R.J. / Rankin, G.I.B. / Gilbert, S.G.  
**DOI:** <https://doi.org/10.5169/seals-999>

## Compression Membrane Action in Composite Slabs

### Summary

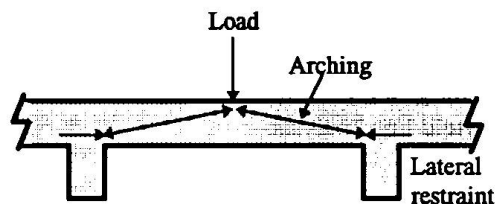
Fig.1 Arching action

Compressive Membrane Action is the two way arching effect which occurs when a laterally restrained slab is loaded (1). The load is resisted by a compressive force which extends through the slab from the load to the supports (see Fig 1). The greater the element depth/length ratio is, the greater is the amount of arching which occurs. CMA is already used to justify a reduction in the amount of reinforcing steel used in certain beam and slab bridge decks (2), but has not yet been applied in practice to other structures (3). The purpose of this research was to find out whether CMA contributes to the strength of composite metal decking/concrete slabs in buildings, and whether it helps to sustain load in a composite slab which has been badly damaged by fire (4).

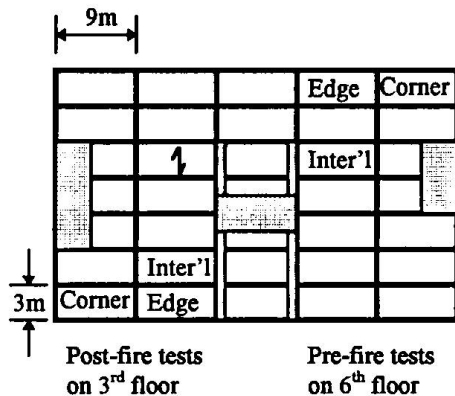
Fig.2 Cardington test panels

The tests were carried out in two phases, the first on undamaged slabs (pre-fire tests) and the second on fire damaged slabs (post-fire tests) at the locations indicated in Fig 2. Each set of slabs underwent two tests, the first being a proof load test and the second an ultimate load test. Loads were applied along the quarterpoints of the slab in order to simulate the bending moments due to a uniformly distributed load. The load was applied hydraulically using ten 30 tonne jacks (Fig 3), except for the service load on the fire damaged slabs which was applied incrementally with 1.1 tonne sandbags. This was mainly because the panels were so distorted by the fire that it would have been difficult to line up holes for the Macalloy bars over two floors. In addition, it was known that the slabs had sustained a superimposed load of about 2.4kN/m<sup>2</sup> during the fire test and it was decided not to load the slab more than this in case the beam connections failed.

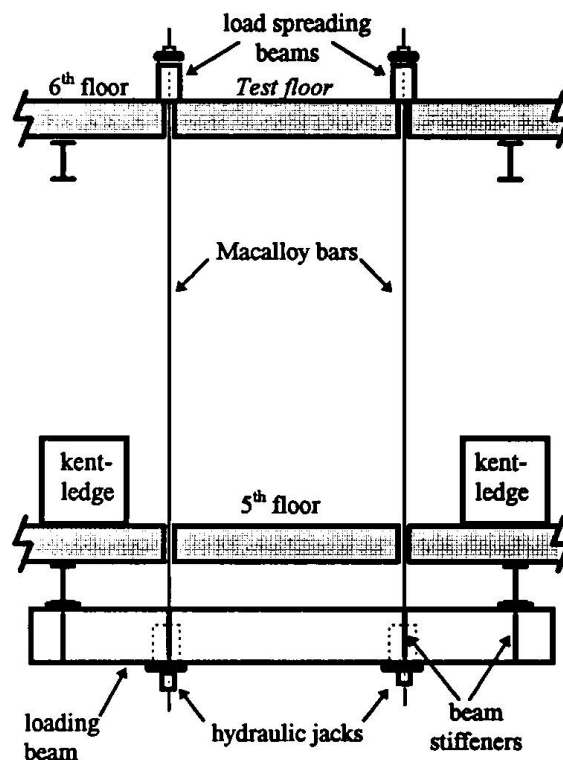
Fig.3 Hydraulic floor loading system

The test rig set up was slightly different from the proof load tests (Fig 3), because only the slab was to be loaded to failure. As it was imperative that the steel frame did not fail, the test rig was moved up one floor so that it was immediately under the slab being tested. This created a self-straining system whereby the load on the slab was resisted by the reactions of the loading rig against the steel beams.

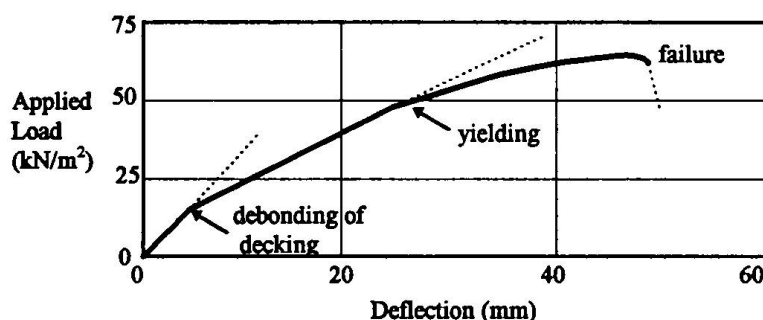
Fig. 4 Pre-Fire Load/Deflection Results for Internal Panel

The slabs were loaded in 1.2kN/m<sup>2</sup> intervals, until they approached failure when the loading increments were reduced to 0.6kN/m<sup>2</sup>. At a load of about 15kN/m<sup>2</sup>, the decking began to debond noisily from the concrete. It is likely that this was the point at which the concrete began to crack as well, but this was impossible to see with the decking in place. At this point, the stiffness of the slab reduced by about 60%. At about 2/3 of the ultimate load level, yielding of the decking began to occur and the rate of deflection progressively increased until failure.

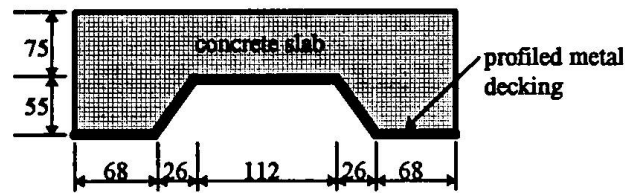
*Fig.5 Cross-section of composite slab strip*

Four tests were carried out to assess the effect of fire on a slab. Two of the slabs were simply supported and two were laterally restrained using a rig that had been built for the purpose. The specimens were designed to be similar to the slabs at Cardington, so were made 3000 mm long and 130 mm deep. Comflor CF70 metal decking was used, as at Cardington, and a typical decking profile is shown in Fig 5. Debonding of the decking due to fire damage was simulated by greasing the decking with a release agent before casting the slab. The results of the tests are shown in Table 3.
