**Zeitschrift:** Swiss express: the Swiss Railways Society journal

Artikel: Clearing-up on the CJ

Autor: Stolz, Theo

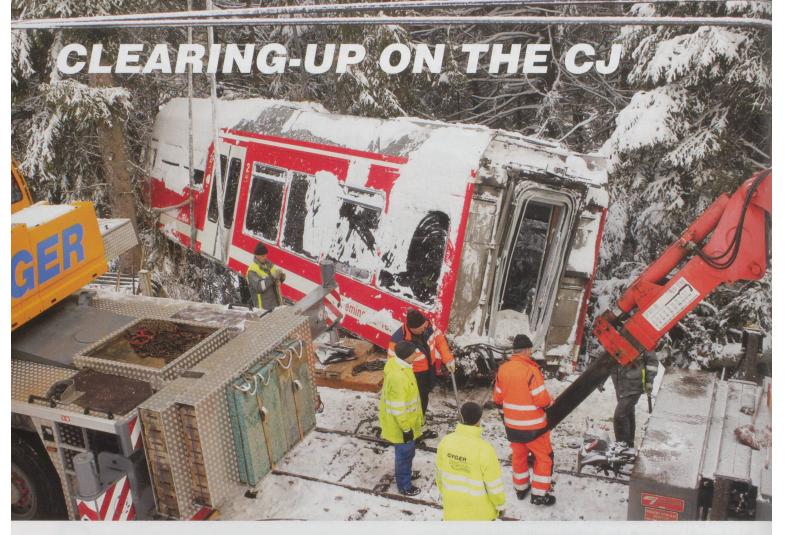
TOP: The crane recovering the front section during a snow storm.

rear end still remaining on the alignment. Traction current failed as the train took a supply mast with it. The driver and two of the twelve passengers were just slightly injured, a minor miracle, and all were quickly evacuated from the precariously balanced unit. The breakdown train with a team of CI staff and the emergency services set-off from Tramelan just 3km away, headed by CJ Gem4/4 No.401 a dualpower diesel and electric unit, and dropped down the gradient to the site and re-railed the rear end of No. 631. Then it started to snow. The recovery of the leading car and the central power section of the GTW which were down the embankment needed use of heavy lifting equipment. A massive crane mounted on a 5-axle truck was brought-in to undertake this task. It had to reverse in heavy snow for over 1km along the railway alignment, straddling the track and avoiding the overhead (but not live) power cables, from the nearest road crossing. By 18.00 on Saturday it had completed its work and the three parts of No 631, all damaged to a greater or lesser degree, were in Tramelan yard, and the road crane had returned to its base. On Monday, in the deep snow, repairs began to the track; supply mast; catenary; signal cables; etc whilst many

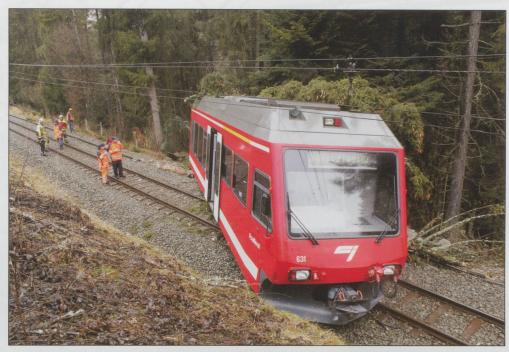
at 06.30 for Tramelan and started to climb, at the line speed of 70kph (40mph), the 3% (1.33) gradient up the side of the valley of the La Birse stream. At a point 6.5km from Tavannes, a lonely spot some 875m high and surrounded by forest, it hit the crown of a fir tree which was lying across the single track. The ABe 2/6 GTW articulated railcar No 631 'Pouillerel' ramped off the track to the right, and down a bank, with just the

TOP: The rear end of ABe 2/6 No. 631 following the incident. Photo: Theo Stolz MIDDLE: The rescue loco Gem 4/4 No. 401 waiting at Saignelégier with a works train on a warm day in August 2011. Photo: Jakob Jägetz RIGHT: Another cab shot of the CJ line through the Jura forests. Photo: Jakob Jägetz
