Artikel: Corrosion of lead sheathed cables in plastics multiway ducts : Part I

Corrosion of Lead Sheathed Cables in Plastics Multiway Ducts (End)¹

Armin BRUNOLD, Berne

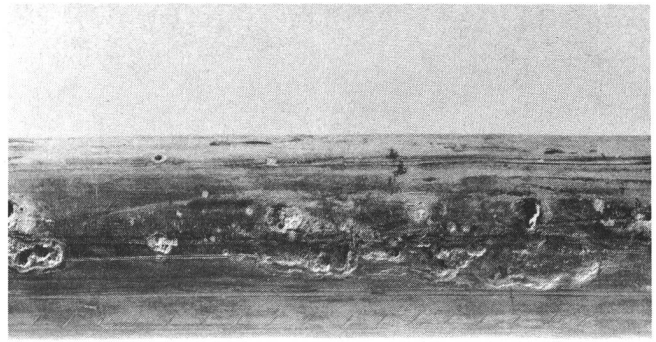
Fig. 19
Fault site in JC 20006 in a duct between Vesenz and La Capite
 In the region of the resting surface, in addition to flat, round troughs, some small areas of corrosion are present which are similar to electrolysis craters, and annular traces of white deposits can be discerned around some holes (three quarters natural size)

- Occasionally however corrosion patterns appear which at first glance are comparable to patterns arising from external current electrolysis. For example, JC 80056 in the plastics multiway duct at Altdorf and JC 20006 in a multiway duct between Vésenz and La Capite, illustrated in *Figures 19...21*, were corroded in this fashion. The corrosion rupture occurred in 1976 after six years of operation within the duct section. The cable sheath has been eaten away in round patches at several points in the region of the resting surface along a length of about 1 m. As is shown in *Figure 19*, in addition to flat, round troughs there are some small perforations present which are like electrolysis craters and still contain some corrosion products. However, electrolysis processes caused by external currents are scarcely imaginable in plastics ducts so that we assume that the electrolytic corro-
