# Replacement of Natural Stone on the Royal Palace in Stockholm

## A Technical and Ethical Dilemma

Andreas Heymowski

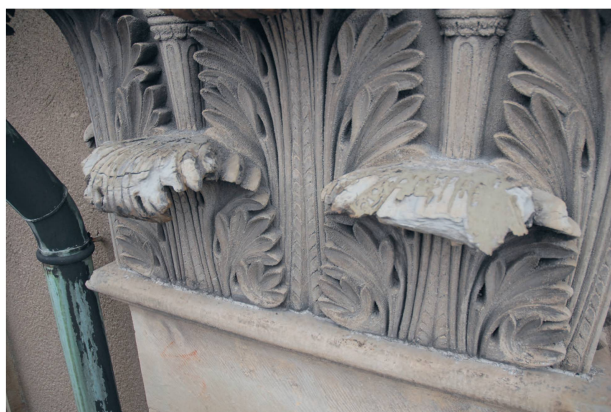
2 *A Corinthian capital, bearing traces of a vain attempt around 1970 to preserve its protruding acanthus leaves by coating them with fibreglass reinforced plastics (Photo Mikael Traung).*

Essentially this is something very positive but for the Royal Palace some of the consequences were not altogether favourable. I am here speaking about the very strong appreciation of the authentic material. In most cases this interest in the material authenticity aspect of the heritage has lead to a better understanding of the functioning of old buildings. It has also lead to refraining from the previous, extensive use of unsuitable modern materials in conservation (fig. 2).

But in the case of the Palace this wish to preserve the authentic material at any cost, lead to extensive conservation – with modern chemical substances – of decayed stone, instead of the traditional replacement. As a result, today the stone had disintegrated even further. In the process, Sweden's many skilled stone-masons became a more or less extinct species, due to lack of job opportunities within the country.
