Zeitschrift: Swiss express : the Swiss Railways Society journal
Herausgeber: Swiss Railways Society
Band: - (2012)
Heft: 110

Artikel: Clearing-up on the CJ
Autor: Stolz, Theo
DOI: <https://doi.org/10.5169/seals-854351>

CLEARING-UP ON THE CJ

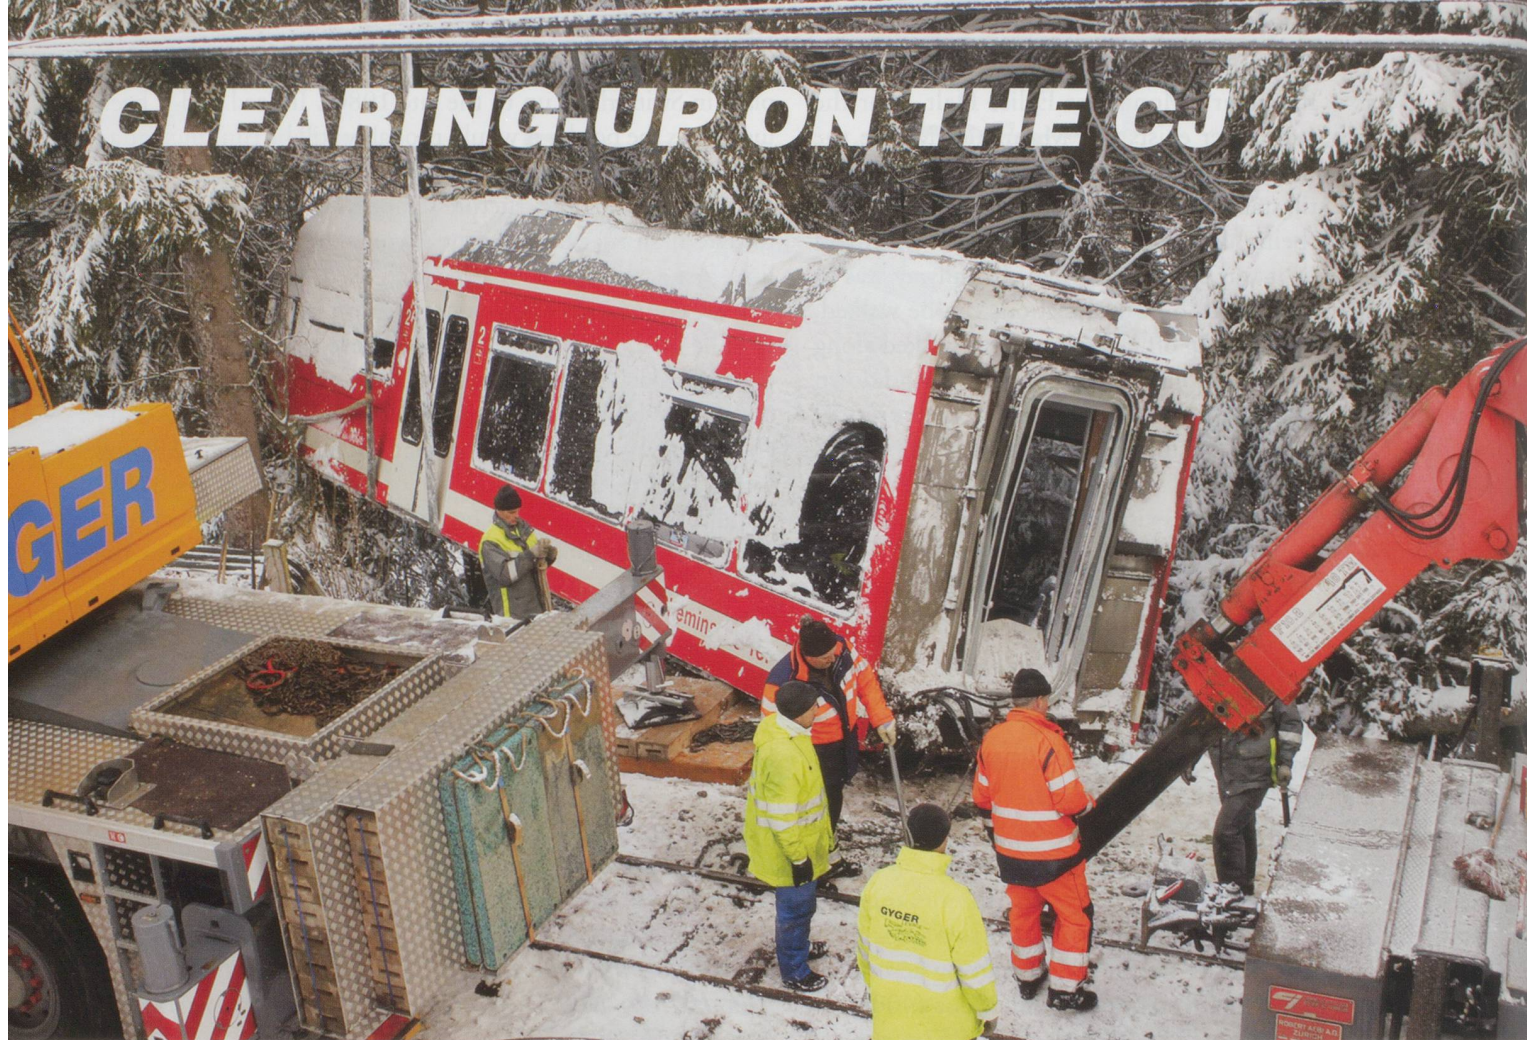
TOP: The crane recovering the front section during a snow storm.

rear end still remaining on the alignment. Traction current failed as the train took a supply mast with it. The driver and two of the twelve passengers were just slightly injured, a minor miracle, and all were quickly evacuated from the precariously balanced unit. The breakdown train with a team of CJ staff and the emergency services set-off from Tramelan just 3km away, headed by CJ Gem4/4 No.401 a dual-power diesel and electric unit, and dropped down the gradient to the site and re-railed the rear end of No. 631. Then it started to snow. The recovery of the leading car and the central power section of the GTW which were down the embankment needed the use of heavy lifting equipment. A massive crane mounted on a 5-axle truck was brought-in to undertake this task. It had to reverse in heavy snow for over 1km along the railway alignment, straddling the track and avoiding the overhead (but not live) power cables, from the nearest road crossing. By 18.00 on Saturday it had completed its work and the three parts of No 631, all damaged to a greater or lesser degree, were in Tramelan yard, and the road crane had returned to its base. On Monday, in the deep snow, repairs began to the track; supply mast; catenary; signal cables; etc whilst many trees, heavy with snow, were cut back. Traffic resumed with the first train on Wednesday. In the meantime the new snowplough of the CJ had been hard at work elsewhere on the 72 km system that supplies the main transport links in Canton Jura. It was a busy, cold, wet and sleepless few days for the dedicated CJ workforce during the pre-Christmas week.

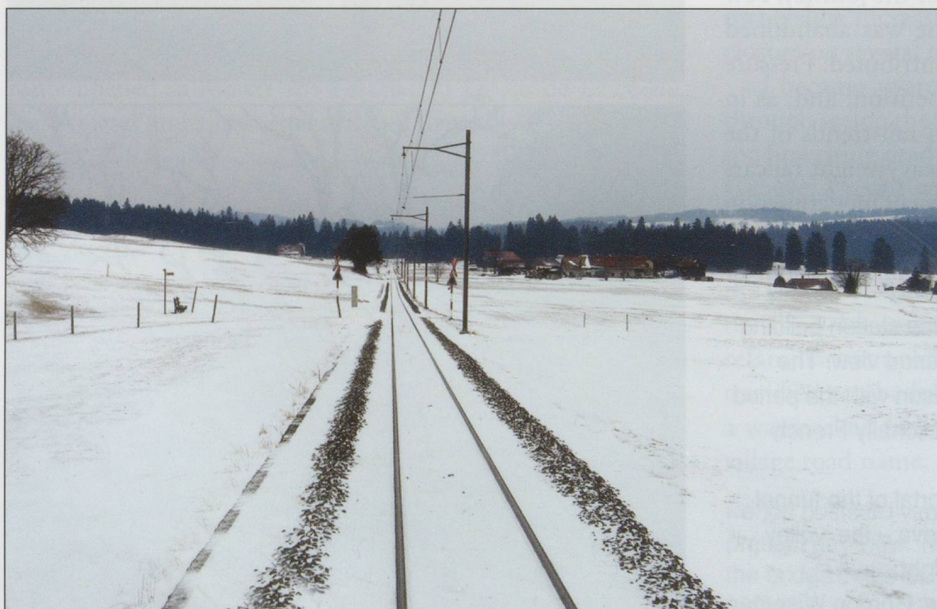
LEFT: This cab shot shows the bleak nature of this line in winter.

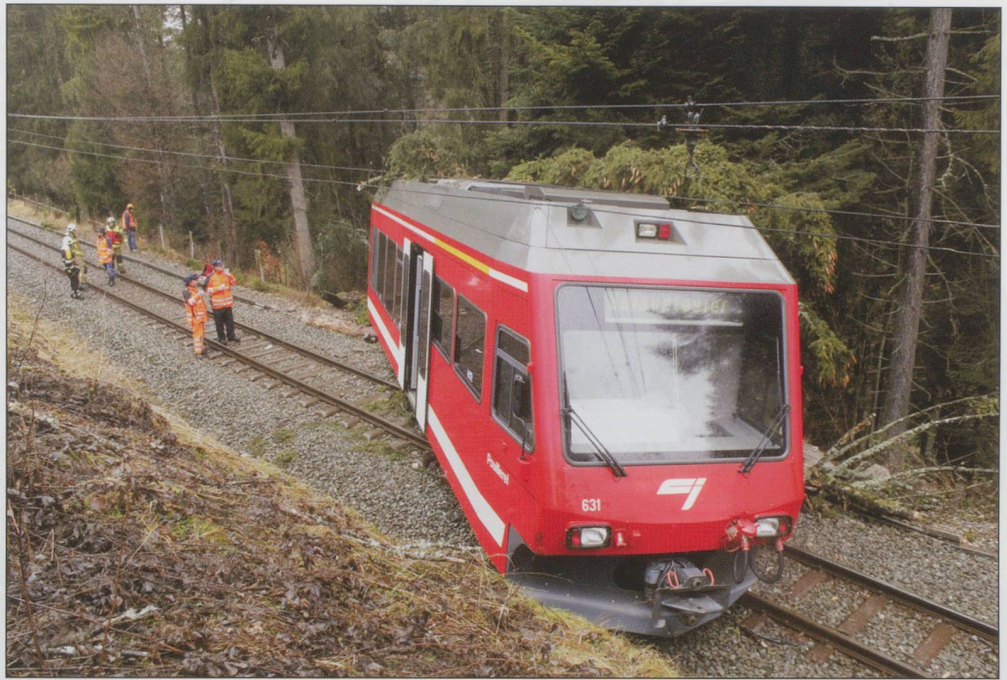
TOP: The rear end of ABe 2/6 No. 631 following the incident. *Photo: Theo Stolz*
 MIDDLE: The rescue loco Gem 4/4 No. 401 waiting at Saignelégier with a works train on a warm day in August 2011. *Photo: Jakob Jägetz*
 RIGHT: Another cab shot of the CJ line through the Jura forests. *Photo: Jakob Jägetz*

at 06.30 for Tramelan and started to climb, at the line speed of 70kph (40mph), the 3% (1.33) gradient up the side of the valley of the La Birse stream. At a point 6.5km from Tavannes, a lonely spot some 875m high and surrounded by forest, it hit the crown of a fir tree which was lying across the single track. The ABe 2/6 GTW articulated railcar No 631 'Pouillerel' ramped off the track to the right, and down a bank, with just the
