Crossed wires – and surviving the consequences

John Jesson is intrigued by some complex electrical engineering

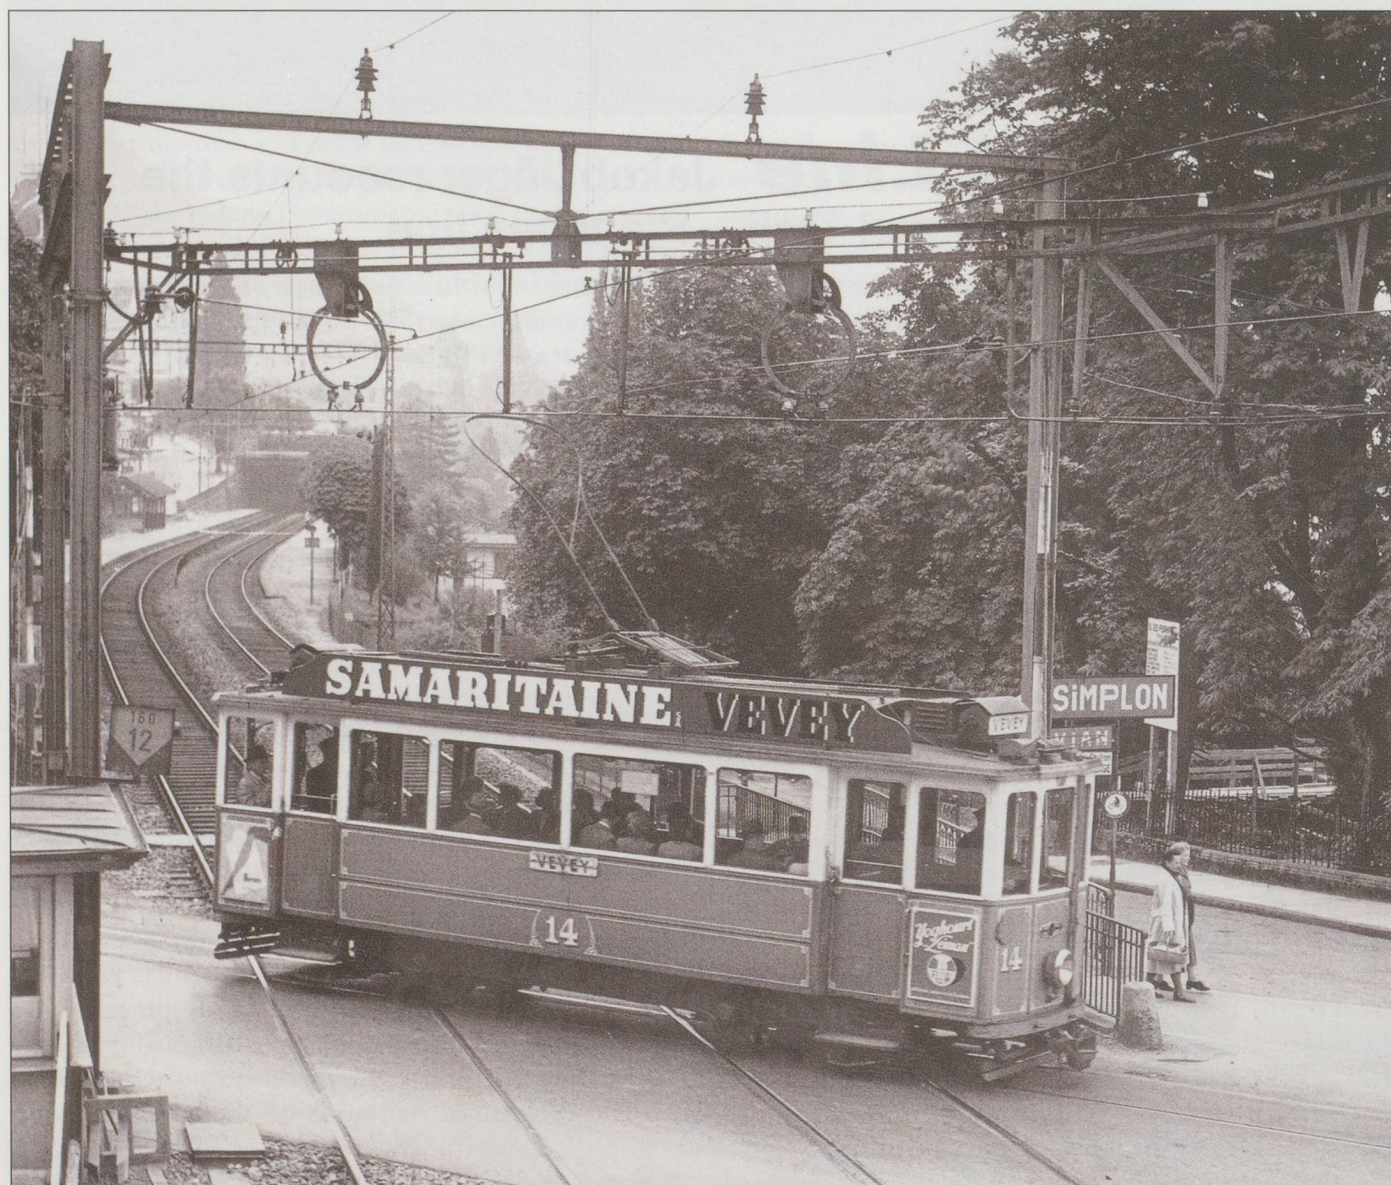
Tramways crossing railway lines are not particularly common, but this old photograph taken of a Vevey-Montreux-Chillon-Villeneuve (VMCV) tram at Territet, shows the problem that arises when the railway line is electrified. On the one hand, there is the CFF main line railway with 15,000V ac running through its wires, on the other the tram route that was electrified at 600V dc with its overhead providing the power. In this case some engineering ingenuity solved the problem by installing a moveable tram wire.

There is quite a lot of ironmongery involved in the whole set-up, something that would not please today's environmental lobby! The high-voltage lines for the railway are supported by a cross girder, itself carried by two masts on opposite sides of the road. There are two additional masts (one out of the picture) at the other two corners of the junction. These are connected to the other masts on the same side of the railway by other girders and these, in-turn, support a long diagonal girder, supported halfway by supports from the first cross-girder. There seems to be additional ironwork across the road at the left of the picture and this is probably for the operating mechanism. The small cabin on the left probably contains the controls.

The tramline at this point was re-electrified in 1913 to the system shown, when the complex original 1888 electrical system of the Vevey-Montreux-Chillon tramway was replaced at the time of its merger with the Chillon-Byron-Villeneuve tramway to form the VMCV. This was some eleven years before this section of the CFF main line through Montreux went under-the-wires in 1924, so this photograph must have been taken after this latter event.

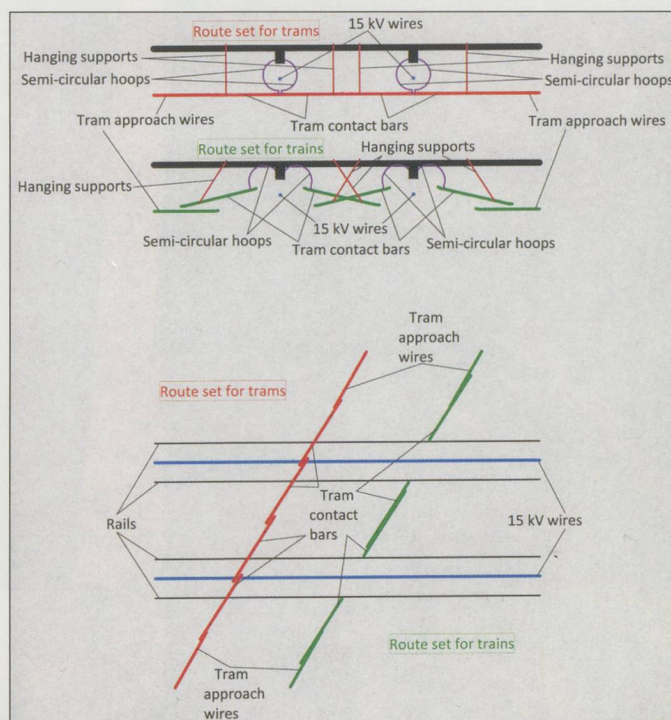
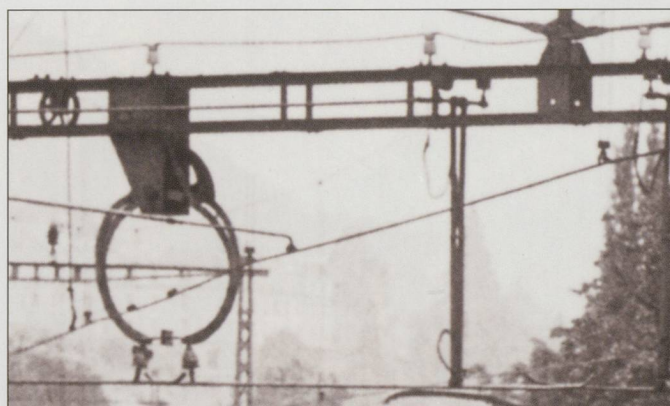
Across the level crossing, the tram overhead contact is not a wire, but four contact bars, each bent up at both ends to allow a smooth transition by the tram current collector. Two semi-circular hoops that are pivoted at their top ends surround each of the railway overhead contact wires. When the crossing is required for railway use, the hoops can be pivoted so that the tram contact bars are raised away from and above the railway contact wire. The four contact bars are each supported at one end by the semi-circular hoops and at the other by a long hanging support. From here on though the operation is less clear. The action of pivoting the hoop pushes one end of the contact bar away from the 15 kV contact wire and raises it above the level of the railway pantograph. The hanging support at the other end appears to be pivoted so that the bottom end (connected to the contact bar) is also pushed away from the 15 kV wire. However, as this hanging support is nearly twice as long as the depth of the hoop, the end result is that the end of the contact bar is dropped below its normal level. There seems to be some sort of operating mechanism connected to the hanging supports, but what this does is unclear. Although there is another known photograph of a tram using the crossing, it would be very helpful to see what the tram contact bars looked like when the crossing was set for trains. I have tried to show the complex layout on the accompanying diagram.
