**Artikel:** Brienz Rothorn Bahn : a Swiss heritage railway goes searching for old skills  
**Autor:** Ellis, Michael  
**DOI:** <https://doi.org/10.5169/seals-854030>

# BRIENZ ROTHORN BAHN

A Swiss Heritage Railway goes searching for old skills

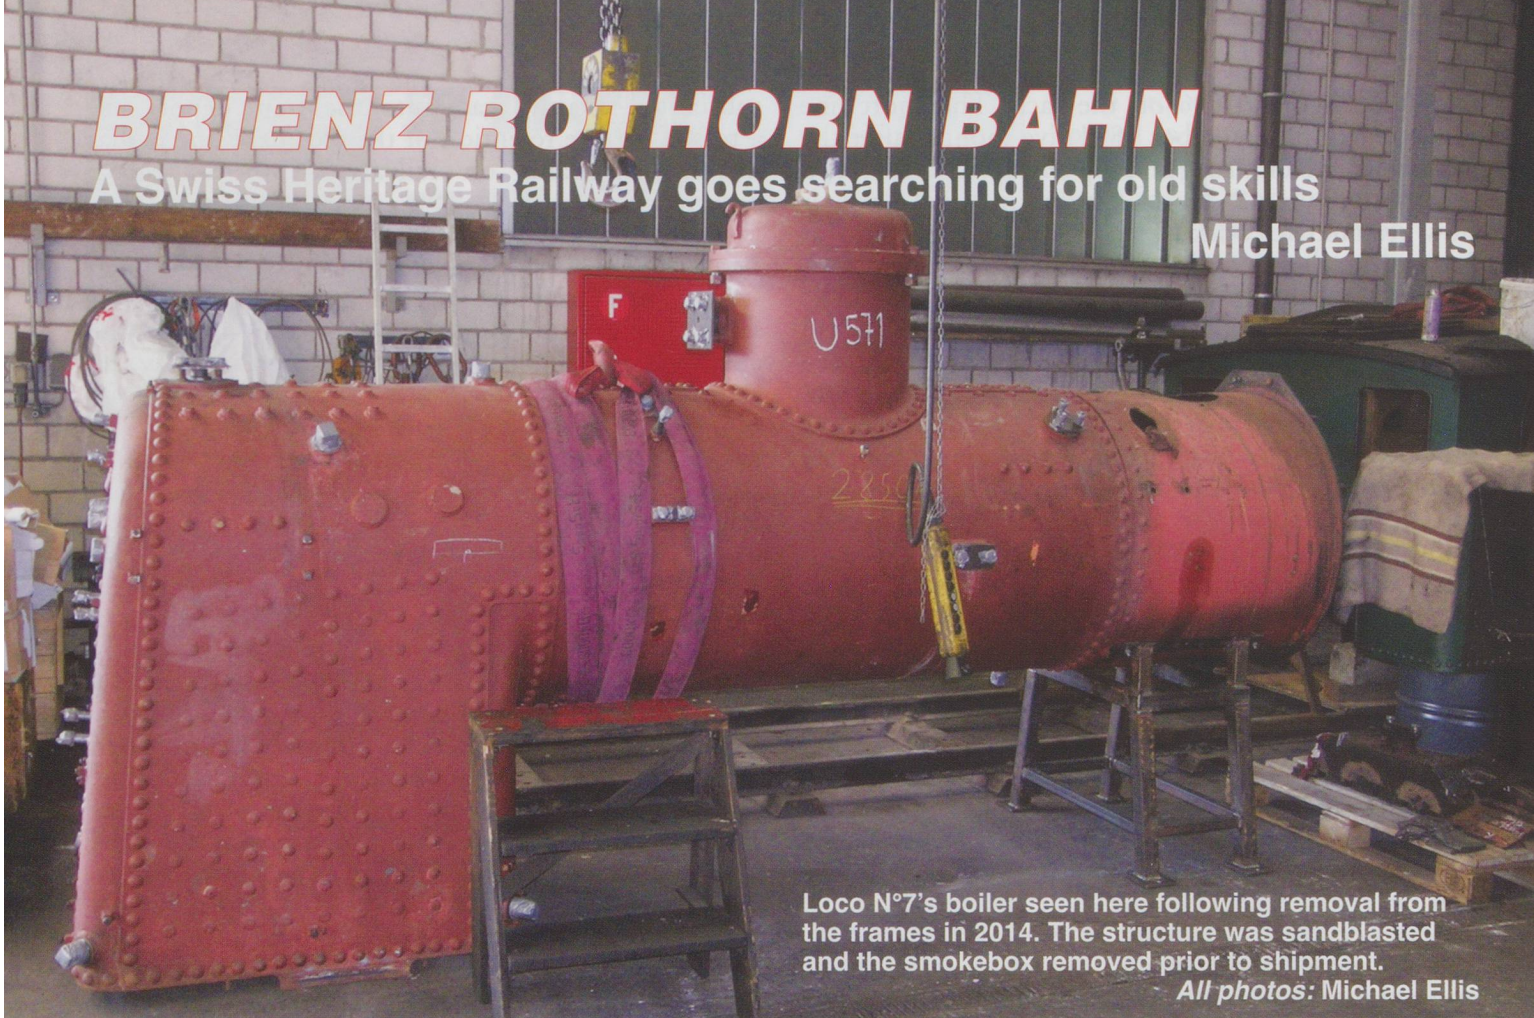
Loco N°7's boiler seen here following removal from the frames in 2014. The structure was sandblasted and the smokebox removed prior to shipment.
