Zeitschrift: Swiss express : the Swiss Railways Society journal
Herausgeber: Swiss Railways Society
Band: - (2017)
Heft: 132

A 'Railway' Bridge with a difference

John Jesson

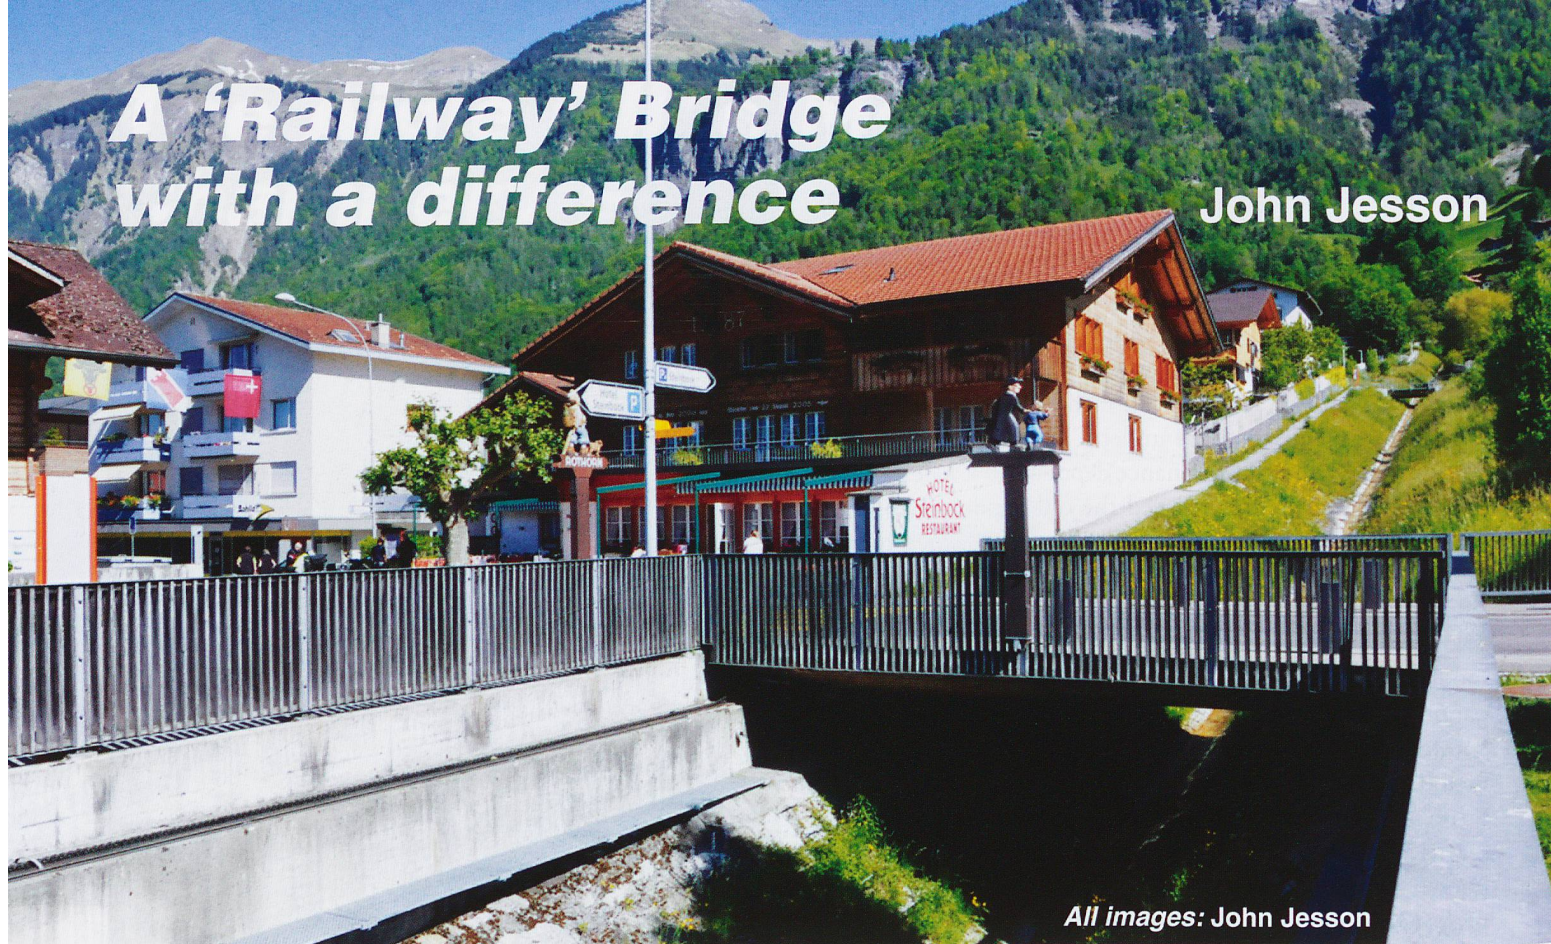
From the lake side of the bridge, showing one of the rails and the steepness of the drop of the Trachtbach.

work in the severely damaged areas much more difficult. The chosen solution to guard against any future inundation is the new bridge, which can be moved 'downstream' towards the lake, thus allowing a much larger aperture (more than double) for the water and debris to flow through and into the lake. As it runs on steel wheels on steel rails, that surely makes it a "railway". Movement of the bridge is by electric power and the bridge moves 25 metres. There is open space on each side of the new bridge position with removable guardrails, so that diverted road traffic can still run through. However, on one side the open space is grassed, with a tree in what, would become, the middle of the carriageway!

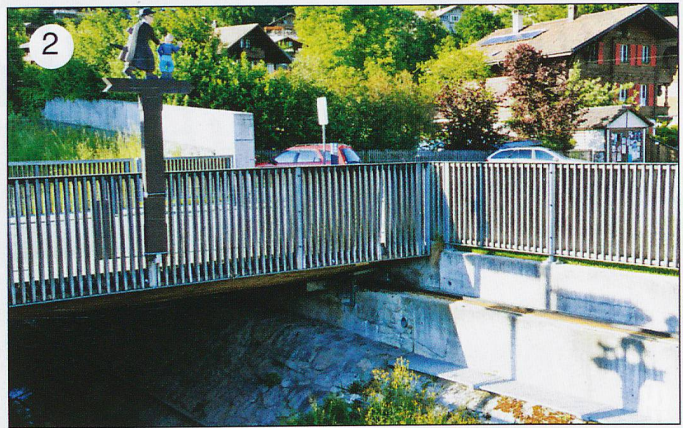
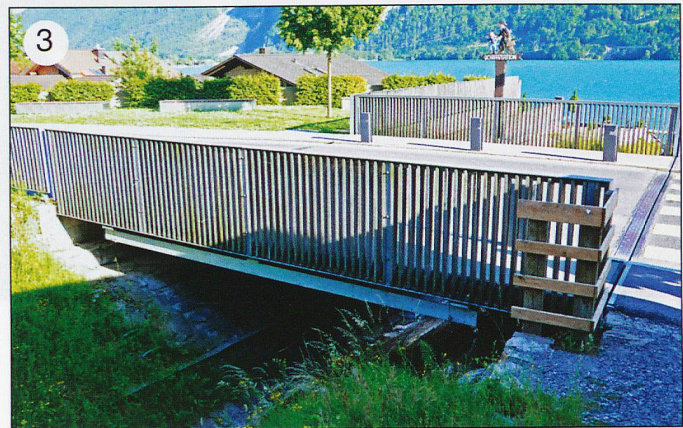
LEFT: The panel alongside the bridge, describing its operation. FAR LEFT: The main text in German.

Alongside the bridge is a panel that describes the operation, and the otherwise functional bridge has a decorative wooden arrow directing visitors to the quay for lake steamers. It does not show the Zentralbahn, whose tunnel beneath the village was filled in 2005 with floodwater to a depth of 60cm. At the time the railway line was closed for several weeks. Between Brienz and Meiringen, the Aare broke its banks in several places; the railway disappeared. The Glyssibach, long considered harmless, carried away road and railway bridges on the east side of Brienz village. These have been heavily rebuilt; the great scar of the new streambed is slowly being reabsorbed on the hillside, and the destroyed homes were replaced on safer ground. The Brienz Rothorn Bahn's Trachtbach Bridge further upstream, was also severely damaged and later restored. In 2005 there were few tourists in Brienz after 23rd August! However the locals are courageous and resourceful people. Today they sit outside the Steinbock Hotel, originally dating from 1797, on which is carved 'Rebuilt 2006 after severe damage in August 2005'. Living with nature and the mountains was never safe, and still makes its demands. 🇨🇭

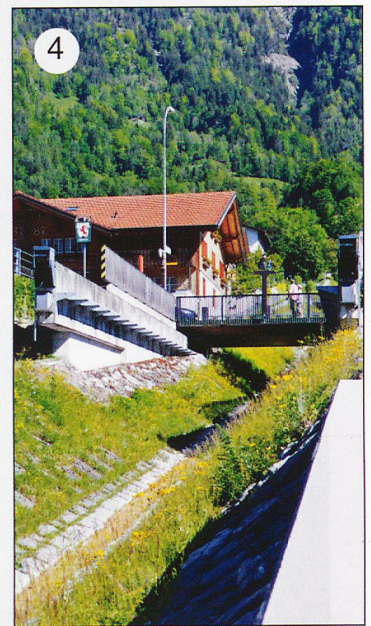
3. The bridge from the upstream side, showing the restricted clearance, as well as the decorative sign and the obstructing tree.

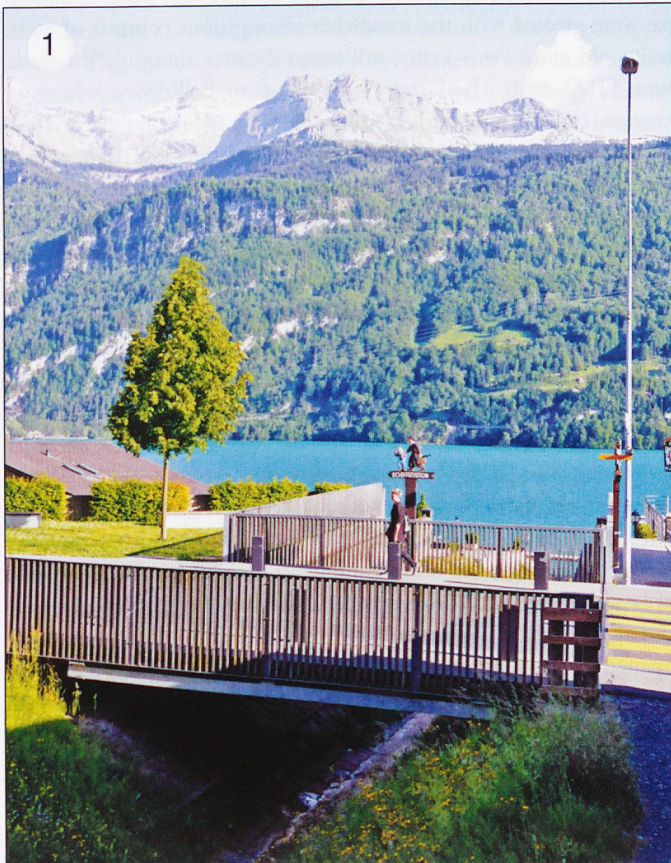
5. The memorial plaque to the 1870 flood. "This building stands as the last witness to the Trachtbach catastrophe of 1870, during which the surrounding land was inundated. This door led into the well-known tavern 'Schnäggloch', the meeting place for coaches and travellers".

The Trachtbach burst-out when flood water caused a build-up of mountain debris and rocks against the road bridge, so that the dammed-up water cascaded onto the road and through the village streets, causing major damage. Prior to this, in 1870, a similar Trachtbach flood is said to have been even worse, and is remembered on the old tavern door beneath the Weisses Kreuz Hotel.
