Systems Approach in the Inspection of Suspension Bridges

Ranganatha R. RAO Associate Steinman Consulting Engineers New York, NY, USA

Manhattan Bridge, New York, USA 1.0 INTRODUCTION

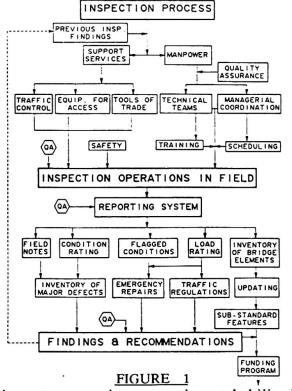
A scientific and systematic approach for bridge inspection is outlined in figure 1. It is critical to 3.0 recognize inspection as a process and not as an isolated event that takes place on a periodic basis. By doing so, the need based attitude, which normally has short term applications only, can be traffic and 4 tracks of New York City transit trains. transformed to a wider spectrum that encompasses several short and long term applications. example, the quantitative elements allows tracking of their conditions over a uncompromising period of time so as to monitor the overall allotment of time for inspection and rehabilitation. condition of the bridge; inventory of bridge

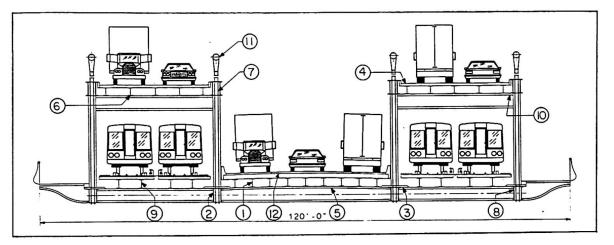
FIGURE 2: CROSS SECTION OF MANHATTAN BRIDGE, NEW YORK - Major Defects Reported

- 5. Corrosion of top flange 1. Cracks in stringers
- 6. Uplifted Stringer brg. 2. Corrosion
- 3. Cracked continuity 7. Suspender wear/
 - Striking top chord angle
- 8. Cracked chord splice 4. Deck defects

- 9. Track Stringer Brg.- Displaced/cracked
- 10. Cracked floorbeam end
- 11. Corroded Cable Wrapping
- at lower saddle
- 12. Leaky deck joints

than 1200 defects were recorded and 615 of them were flagged demanding immediate attention. Prompt corrective actions were taken by the New York City Department of Transportation in terms of performing emergency repairs, reviewing the load rating and temporarily closing of one lower roadway lane and two tracks of NYC transit, pending repairs. Some of the major defects are highlighted in the bridge cross-section in Figure 2
