Autor(en): **Croci, Giorgio**

Zeitschrift: **IABSE congress report = Rapport du congrès AIPC = IVBH  
Kongressbericht**

## Preservation of Newly Built and Historical Buildings

This paper deals with the preservation of existing buildings. The main problem is the evaluation of the safety level, taking into account the crack patterns, the deterioration of materials, etc. As a result of this analysis, decisions can be taken about the opportunity and the criteria for intervention. The paper illustrates some cases, referring especially to historical buildings in Italy and Spain.

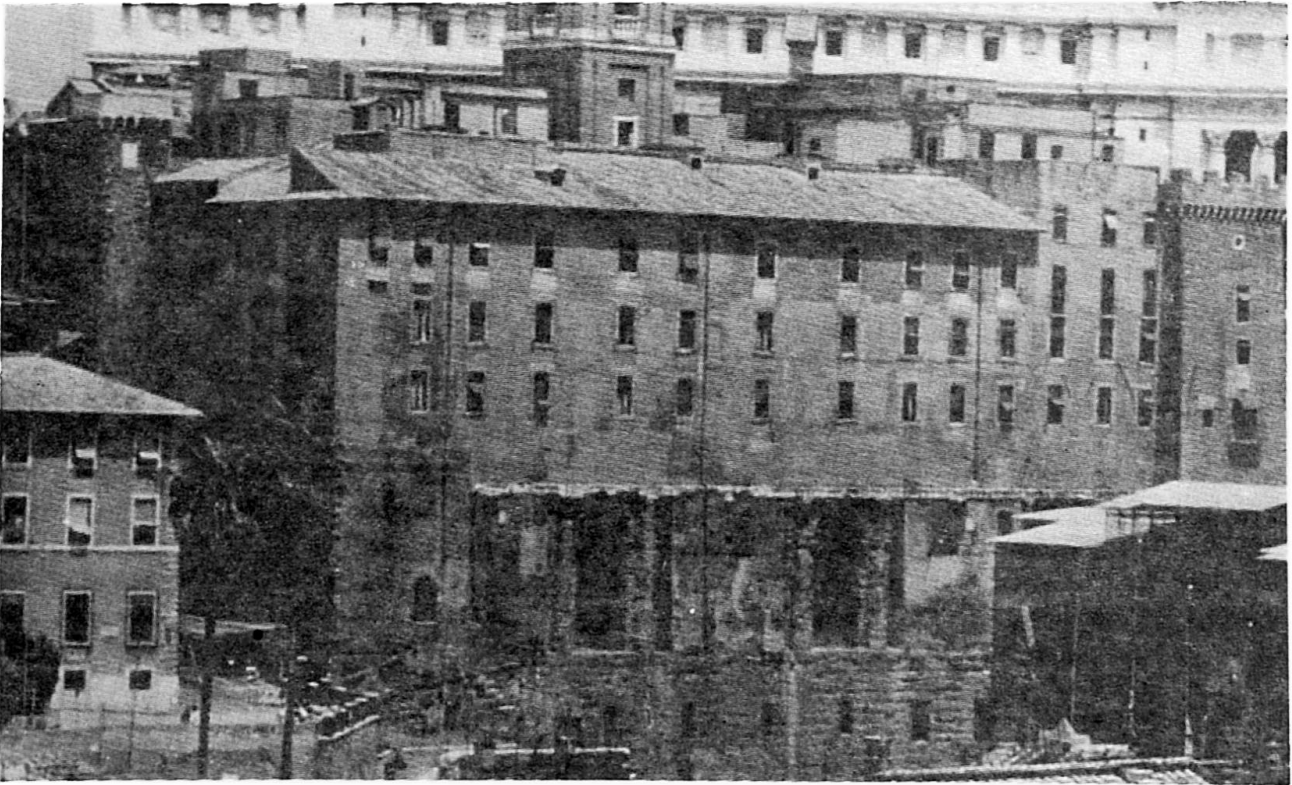
Pic.1: General view of Palazzo Senatorio and Tabularium in Campidoglio from the side of the Roman Forum

The first point to examine in the preservation of a structure is the analysis of the deterioration of the materials. This deterioration in the oldest buildings is linked not only to the chemical and physical phenomena, but also to the countless alterations, that, as in the case of Palazzo Senatorio in Campidoglio, Rome, (fig. 1) have occurred during the centuries (fig. 2), sometime stressed by incorret reinforcements (fig. 3).

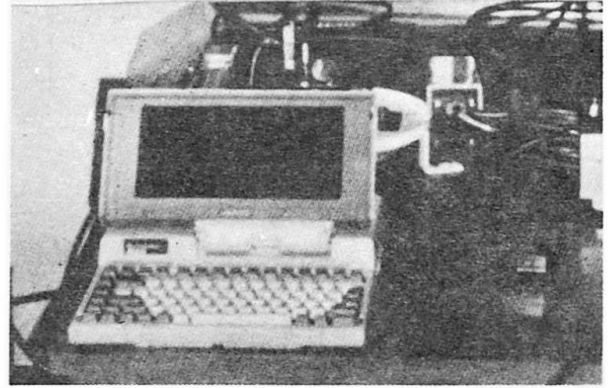
Pic.23,24: Excavation works under the foundation and monitoring system

This is the case of Palazzo di Istituto Massimo in Rome, where it was necessary to make important excavation works to obtain new space for a permanent museum, containing old coins of the Roman Empire (fig. 23); a monitoring system has been set up in order to control the settlements of the foundations and, if necessary, to take corrective measures (fig. 24).
