Zeitschrift: IABSE congress report = Rapport du congrès AIPC = IVBH
Kongressbericht

**Welding experiences
at the construction of the newest Danube and Tisza bridges
in Hungary**

Dr CH. SZÉCHY

Chief engineer, Highway-bridge Department in Hungary

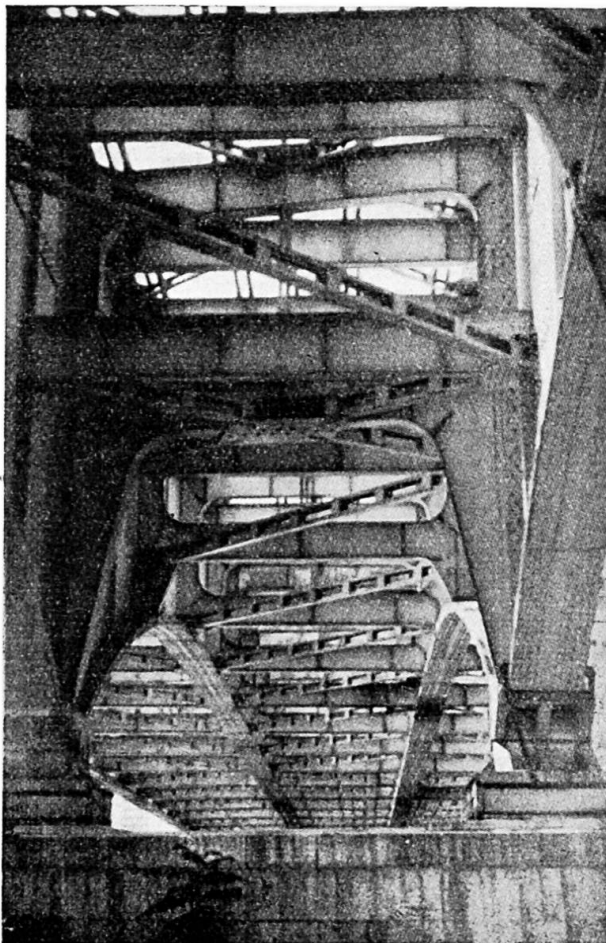
Fig. 2. View of the steel construction of the Arpád-bridge showing welded elements from underneath.

The process has secured perfectly uniform and smooth weld-surfaces, reliable fusion at the root of the weld ⁽³⁾ and the welded structure altogether made a pleasing appearance, inspite of the skew lay out of the steel construction (fig. 2).

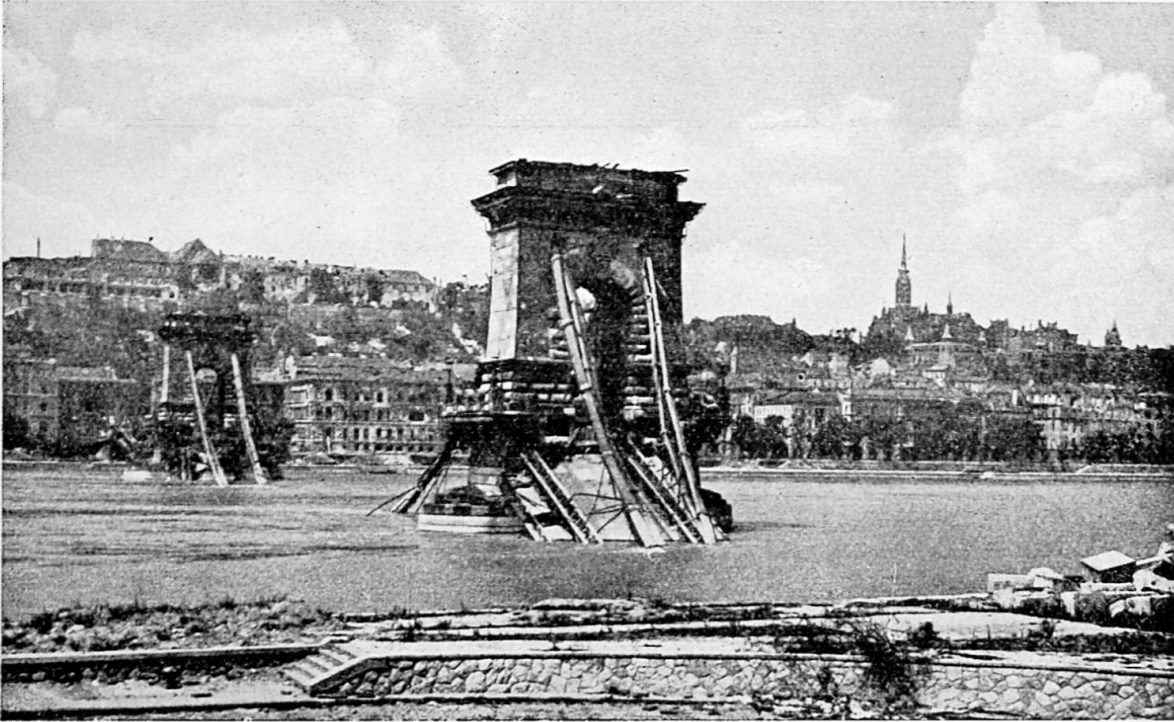
Fig. 4. View of the blown up « Chain-bridge » Budapest.

Budapest the German troops have blown up the left side anchoring chambers of the bridge, inducing so a mighty slip of the chains (16 meters = 53 ft 0 in over the left pylon and about 3 meters = 10 ft 0 in over the right pylon) which tremendous deformation led to the entire collapse of the bridge. Although many of the chains broke and many again suffered plastic torsion or buckling still it was evident, that a considerable part of them might be reutilized (fig. 4).
