# V. Building under extreme conditions

#### **Building under Extreme Conditions**

**V****Der Bau der Bergstation der Seilbahn Klein Matterhorn**

The Construction of the Upper Cable Car Station Klein Matterhorn

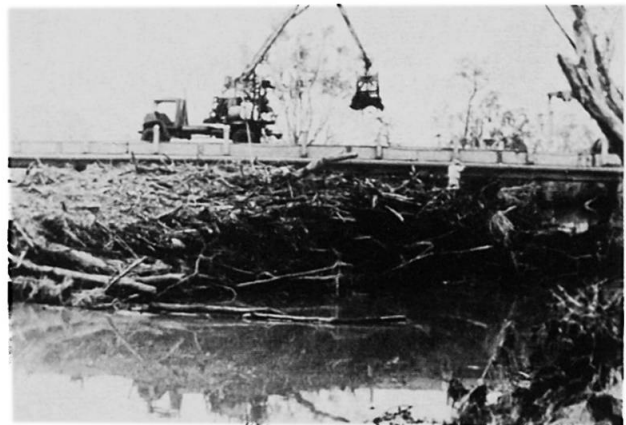
Figure 2  
Spans too small  
Deck at flood peak

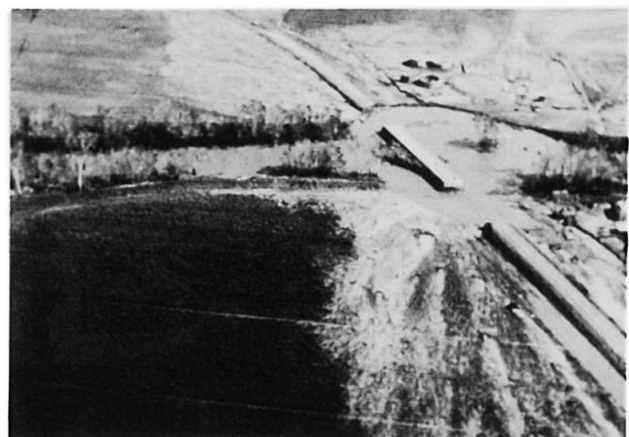
Figure 3  
End scour after waterway blockage.

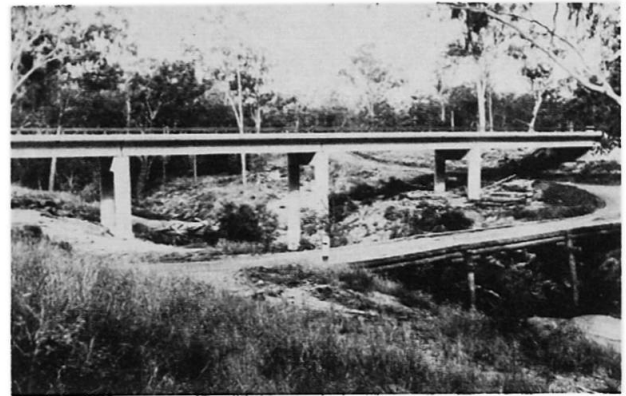
Figure 4  
Submersible bridge replacing  
lower timber bridge

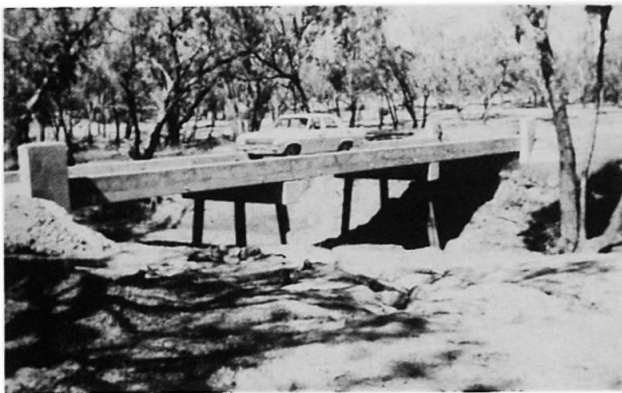
Figure 5

The type of bridge that results is frequently a small span (6-20m) reinforced cast insitu concrete slab; or a deck of prestressed concrete precast slabs (Fig.5,6) or a composite reinforced concrete deck with plated universal beam girders. Piers are frequently headstocks on steel or reinforced concrete piles or reinforced concrete columns. Geometric complications are avoided, and site construction details are as simple as possible.

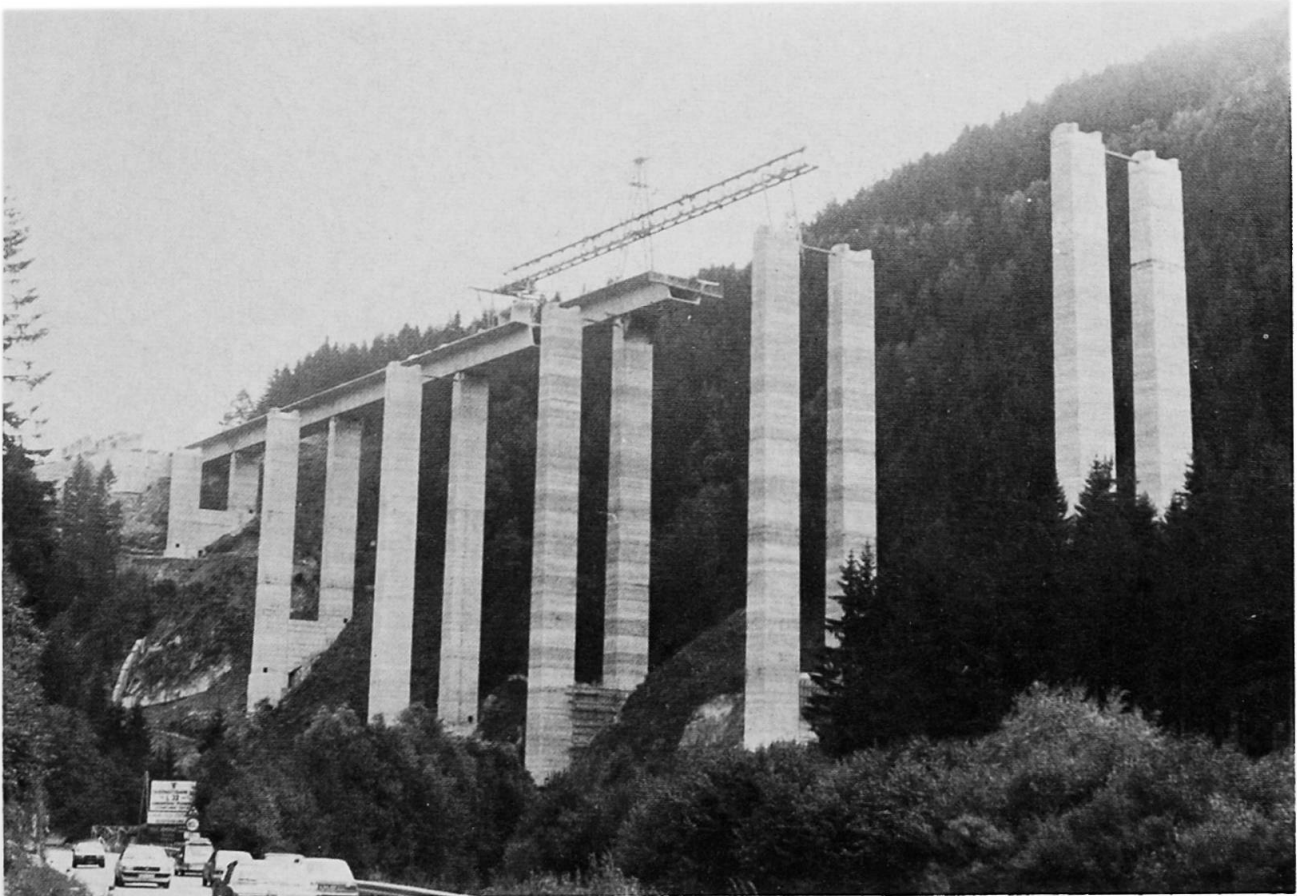
Bild 3 Montage der Brückenfertigteile (Segmente)

Als der Unterbau den nötigen Vorlauf erreicht hatte, wurden die Fertigteile nach dem Prinzip des Freivorbaues mit einem oben fahrenden Versetzgerät montiert.

Auf diese Weise wurden bis zu 83 Elemente, d.h. 268 m Tragwerk in einem Monat hergestellt.
