# Installing prestressing tendons in arduous conditions

**V****Installing Prestressing Tendons in Arduous Conditions**

Prestressing operations require care and expertise even in the best working conditions. This article describes such activities afloat, 24 hours a day, in the winter months and in conjunction with slipforming operations during the construction of the 67 m high towers of the Cormorant 'A' oil production platform.

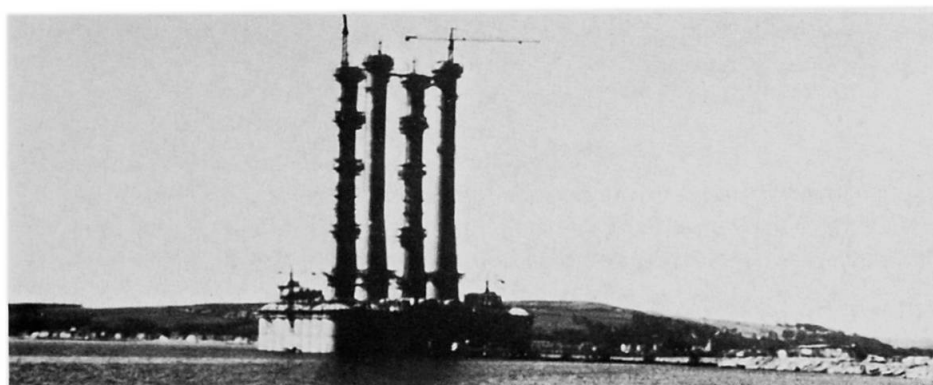
Fig. 1 The Cormorant 'A' Oil Production Platform.

The Main Contract was for the construction by Sir Robert McAlpine & Sons Ltd., and Sea Tank Company of Paris of the North Sea oil production platform Cormorant 'A' for Shell Esso, fig. 1. The Main Contract programme required that the platform was completed and delivered to suit the North Sea weather window, i. e. a limited period in the summer months. Failure to meet this "window" would mean that oil production from the Cormorant 'A' platform would be delayed by 12 months, which possibility was unthinkable.
