# Fatigue of cross beam connections in steel bridges

Zeitschrift: **IABSE congress report = Rapport du congrès AIPC = IVBH  
Kongressbericht**

## Fatigue of Cross Beam Connections in Steel Bridges

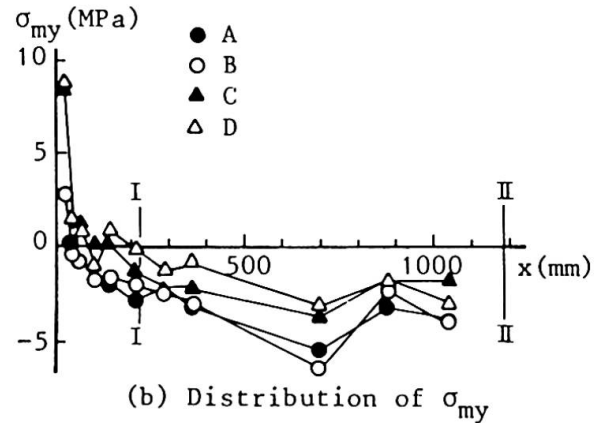
Referring to Fig.6, the components of plate-bending stress  $\sigma_{by}$  and membrane stress  $\sigma_{my}$  are significant for Type 4 fatigue crack, because they act perpendicularly to the direction of the propagation of the crack. Figure 7 shows the distributions of  $\sigma_{by}$  and  $\sigma_{my}$  along the x-axis at  $y=16$  mm from the bottom surface of the flange plate. The plate-bending stress  $\sigma_{by}$  takes the large values between the connection plate at  $x=0$  and the tip of the top flange of the cross beam at the section I-I ( $x=225$  mm), and increases gradually toward the connection plate. The membrane stress  $\sigma_{my}$  changes sharply from compressive to tensile stress in the very vicinity of the connection plate. The ratios of  $\sigma_{my}$  to  $\sigma_{by}$  at the point of  $x=24.5$  mm and  $y=16$  mm where the strain gauges were glued nearest to the connection plate, vary from 20 % to 26 % depending on the loading cases.

(a) Distribution of  $\sigma_{by}$

(b) Distribution of  $\sigma_{my}$

Fig.7 Distributions of  $\sigma_{by}$  and  $\sigma_{my}$  along the x-axis at  $y=16$  mm of  $G_1$  girder web
