# Cardiff Arms Park Stand (United Kingdom)

## 8. Cardiff Arms Park Stand (United Kingdom)

*Owner: Welsh Rugby Union, Cardiff*

*Completion: 1st Phase: 1969 2nd Phase: 1978*

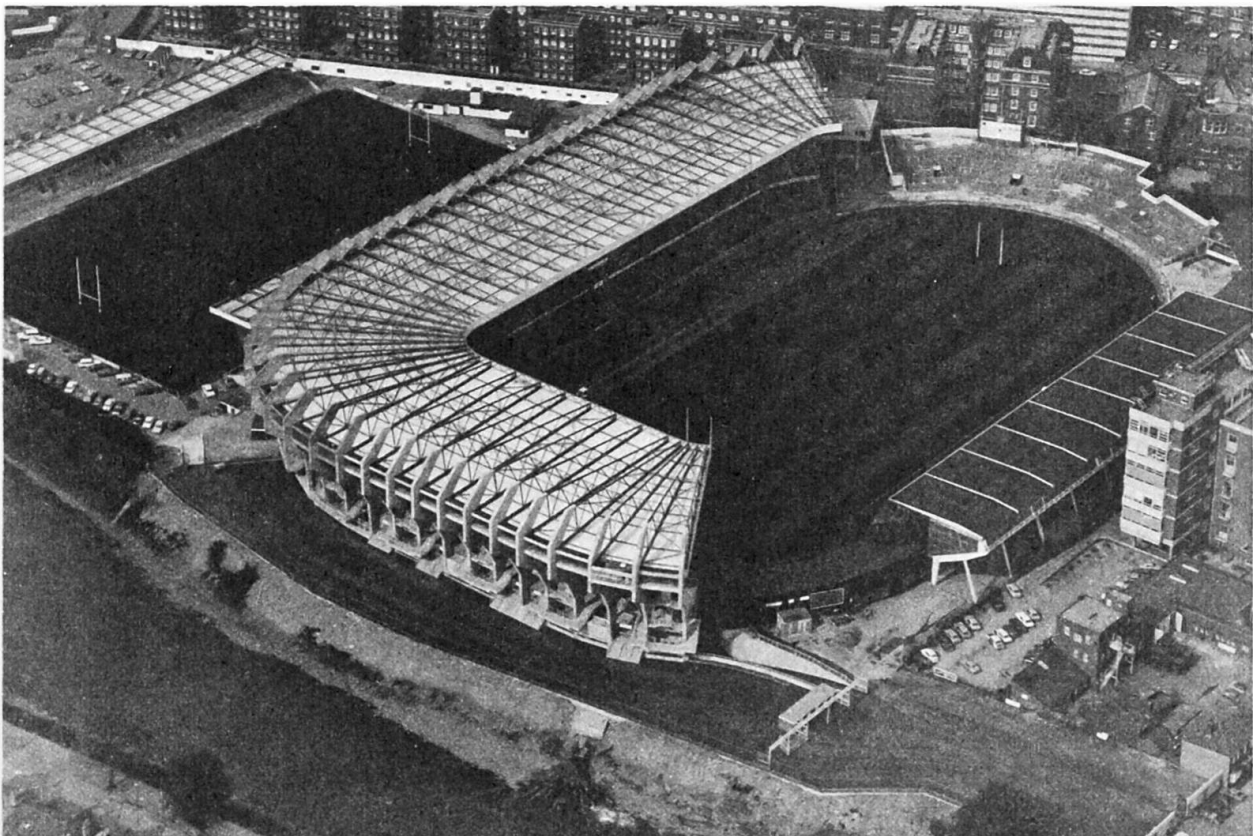
*Aerial photograph of the Stadium taken in 1978*

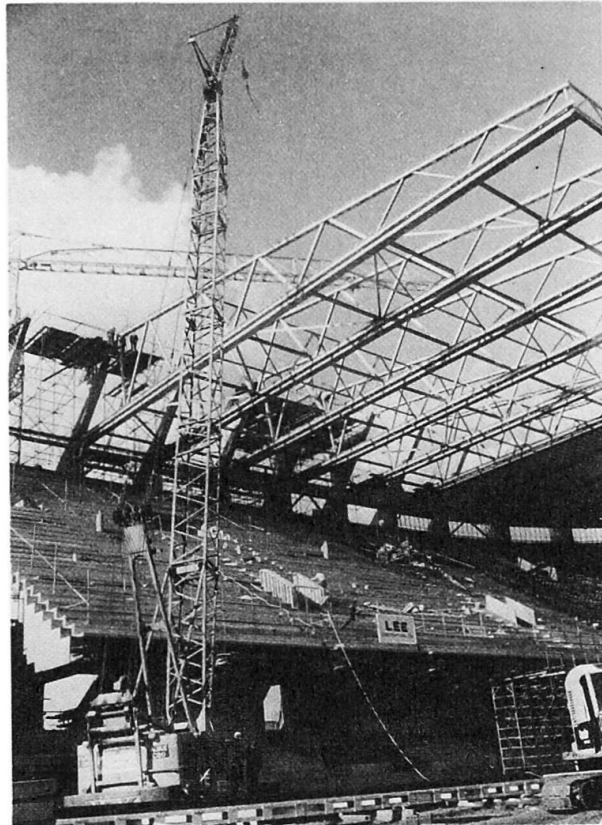
Construction: photograph taken in Dec 1977

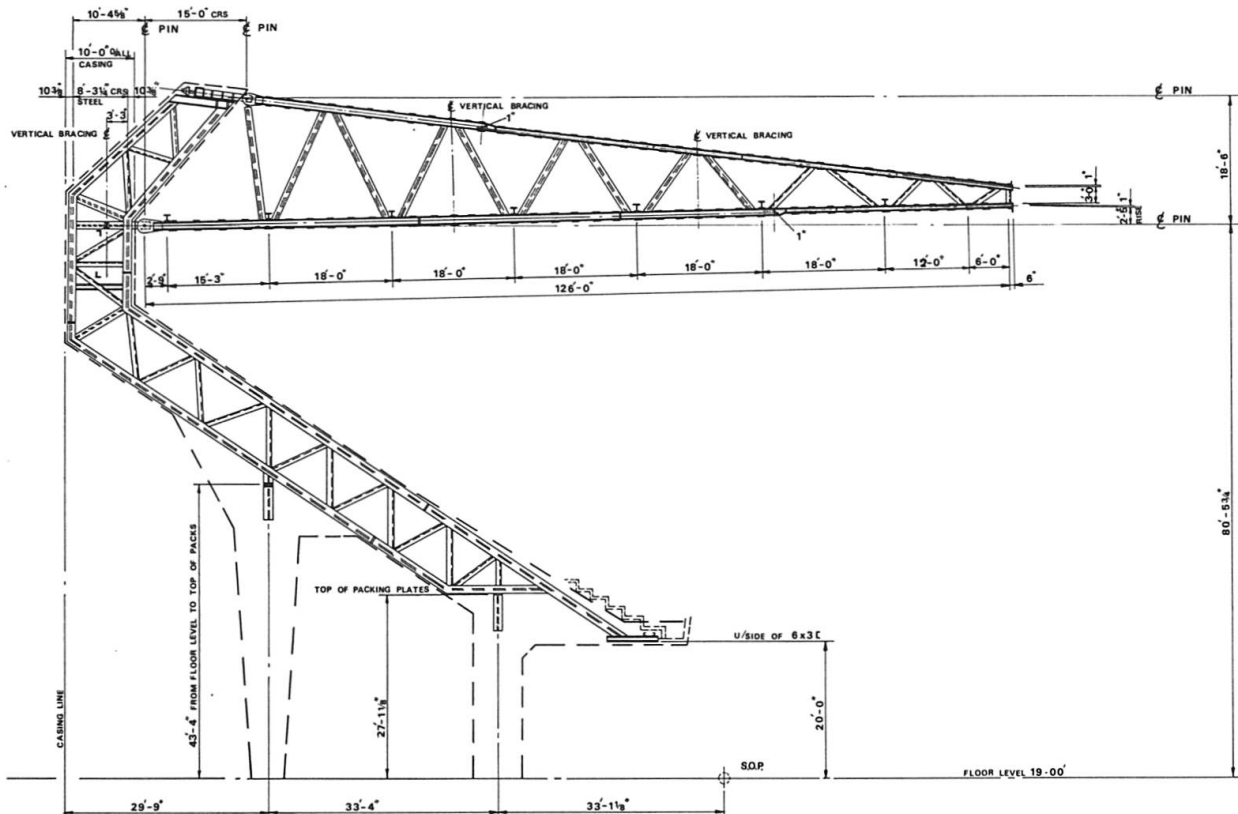
**WELSH RUGBY UNION  
EXTENSION TO WEST END NATIONAL STADIUM**

As shown, the works consist of forty-five frames at 6.1 m centres, each frame being of:

- a) Two vertical reinforced concrete columns on independent foundations 9.1 m apart. At the top of each concrete column, structural steel stub-columns and plates to receive the Main Raker Beams are fixed at 11.6 m and 8.2 m levels respectively.
- b) Structural steel Main Raker Beams comprising 14×14.5 U.C.s booms and U.B. and U.C. lacings 30.5 m long.
- c) Structural steel Vertical Mast 12.2 m in length monolithic with the Raker Beam.
- d) Cantilever Roof Truss 38.4 m long and 24.4 m above ground level measured to the underside of the Truss.
- e) Horizontal and vertical bracing to the cantilever trusses and associated U.B. ties.
- f) Vertical bracing and longitudinal ties to the Mast Section.
- g) Longitudinal ties to the bottom of the Raker Beam Section.
- h) Gutters and gutter supports.
- i) Glazing supports at high level.
