The Sioux Narrows Bridge, Ontario (Canada)

Heft C-46: **Repair and rehabilitation of bridges: case studies I**

1. The Sioux Narrows Bridge, Ontario (Canada)

Owner: Ministry of Transportation of Ontario
Design: Structural Office and Research and Development Branch
Work Duration: 6 months
Completion: 1982

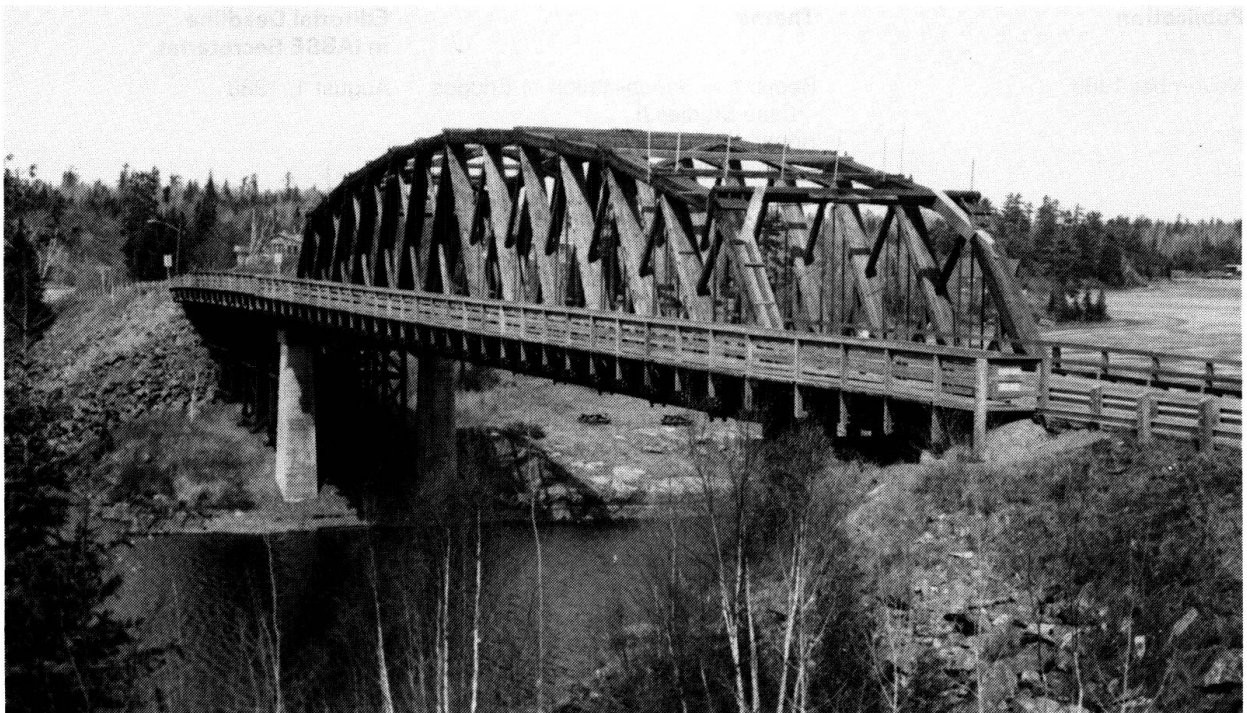
Fig. 1 General view of bridge

The Sioux Narrows Bridge is on Highway 71 linking Fort Frances and Kenora in northwest Ontario. The bridge was constructed in 1936 with a wooden Howe truss main span of 64 m, Figure 1. It is believed to be the longest single span wood highway bridge in North America.

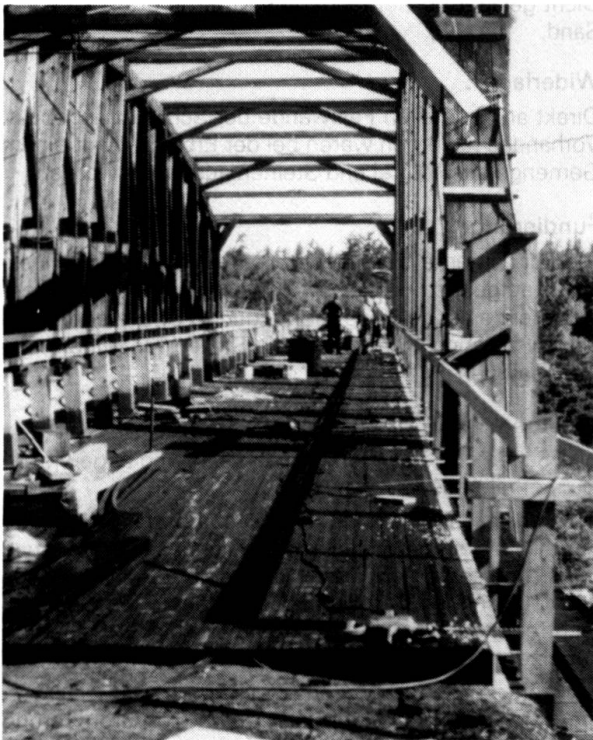
Fig. 3 Placing prestressed wood deck

The deck was replaced one lane at a time, Figure 3, so the bridge could remain open to traffic. The prestressing bars were coupled together for construction of the second lane. A new asphalt wearing surface was then applied to the wood deck.

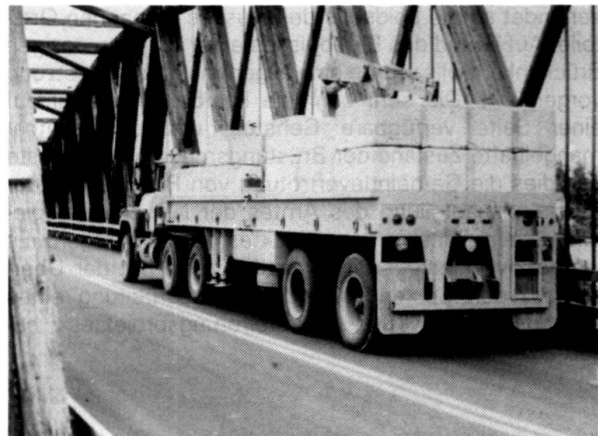
Fig. 4 Load testing the rehabilitated bridge

Full scale bridge testing using custom designed load vehicles, instrumentation and mobile laboratory for the computerized data acquisition system is a regular feature of the Ministry's evaluation procedures. Load testing of the deck system was carried out before deck replacement and after, Figure 4. Eight floor beams were instrumented by attaching strain gauges to the steel tie bars. The greatly improved longitudinal distribution characteristics of the prestressed deck was confirmed by a reduction of 35% in the truss bar strains for the same tests as carried out on the old deck. No further strengthening of the floor system is needed. The only other members that may need replacing are the main truss hanger bars, which will be tested shortly.
