# TIG arc remelting as a repair method for steel railway bridges (Japan)

## 5. TIG Arc Remelting as a Repair Method for Steel Railway Bridges (Japan)

**Owner:** Central Japan Railway Co.  
**Engineer:** Central Japan Railway Co.  
 Railway Technical Research Institute  
**Date of Construction:** 1964  
**Date of Repair:** 1987

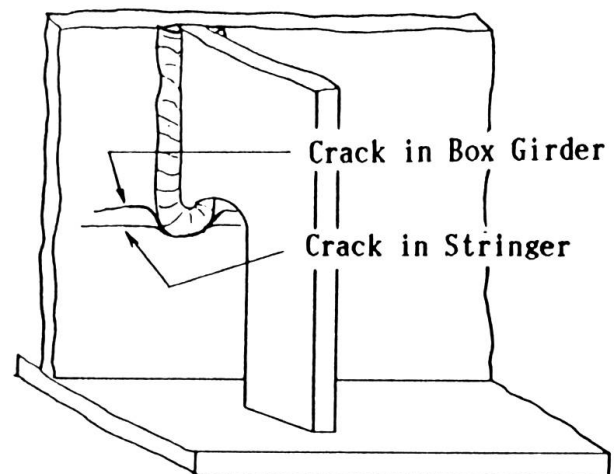
Fig. 2 Schematic of Crack Propagation

All these cracks were initiated at the stiffener end and the schematic of crack propagation was shown in Fig. 2.

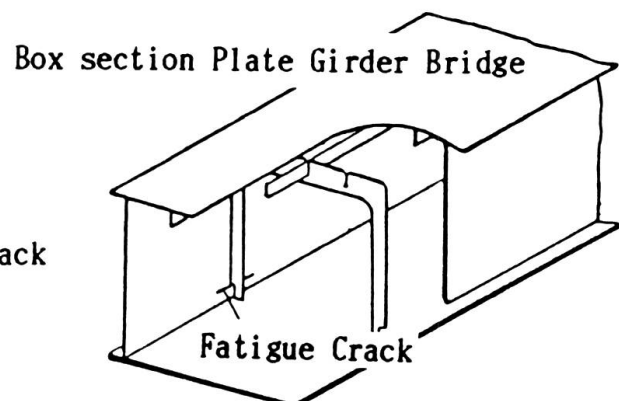
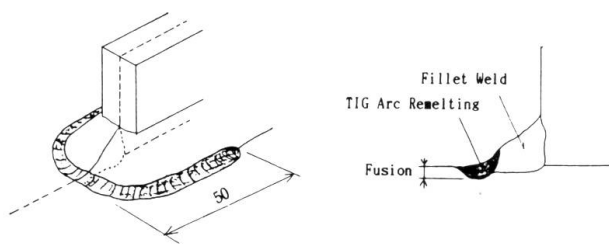
Fig. 3 TIG Arc Remelting

Even if the fatigue crack is not formed at these parts, it is desirable to decrease the possibility of initiation of crack by increasing the fatigue strength of filled welded joint. The TIG arc remelting method shown in Fig. 3 is adopted for the above-mentioned reasons.

The TIG arc remelting is a method of melting the toe of filled welded joint with nonconsumable tungsten electrodes. In order to repair the fatigue crack by TIG arc remelting, it is necessary to obtain the deep fusion and to smooth the toe shape. The conditions for TIG arc remelting, as shown in Table 1, were set up based on the results of preliminary tests.

Electrode diameter	3.2 mm
Current	240 A
Voltage	13 ~ 14 V (arc length 0 ~ 1 mm)
Speed	4.5 ~ 6.0 s/100 mm
Aiming position	0 to 1 mm from the toe of weld
Torch angle	90°

In the repair work, toes of fillet welded joints were inspected first with the magnetic particle testing. If no crack was indicated or the crack size was indicated as less than 10 mm, TIG arc remelting was simply performed. When the crack size was more than 10 mm, the cracks were firstly removed by arc air gouging and re-welded, then the toes of the re-welded joints were remelted by TIG arc. If the crack size was very large, additional steel plates were attached after re-welding.

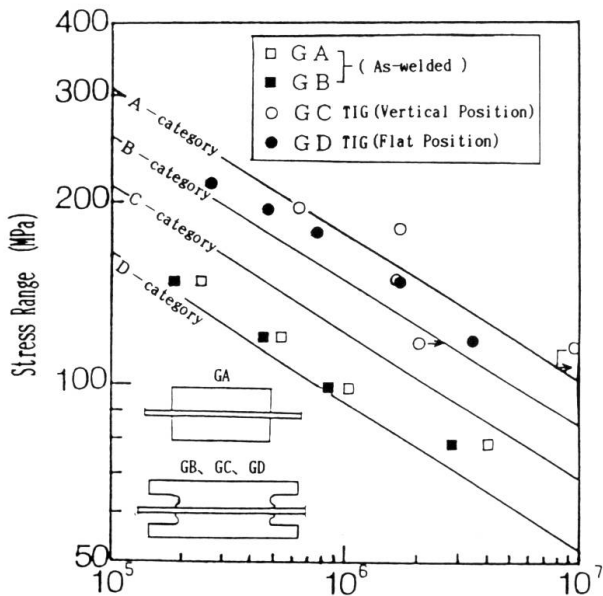
Fig. 4 Results of Fatigue Test

Fatigue tests were performed to confirm the effect of this treatment on improvement of fatigue strength. The fatigue strength of a joint subject to TIG arc remelting was much higher than that of an as-welded joint as shown in Fig. 4.
