Rehabilitation of a Lenticular steel truss in New Jersey (USA)

9. Rehabilitation of a Lenticular Steel Truss in New Jersey (USA)

Engineer: A. G. Lichtenstein and Assoc.
Fair Lawn, NJ

Date of repair: September 1983 – April 1984

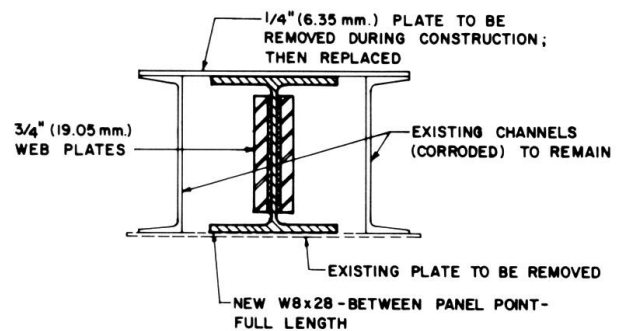
Fig. 2 Section through top chord

An indepth inspection of the bridge was conducted by the Consulting Engineer including non destructive testing of the eye bars, pins and other main connections of the bridge. All the elements of the trusses have been found to be in good condition except the *top chord*. The existing channels in the upper chord have completely corroded (holed through in many places) so that the bridge could barely support its own weight. The bridge was closed to traffic.

The assignment then was how to reconstruct the upper chord economically without changing the historic appearance of the bridge. This challenge was met by the interesting idea of installing new high strength steel beams between the existing corroded channels in the top chord and transferring the stresses from these channels to the new beams via specially designed web plates and bolts. A new steel beam was hoisted in this space between the channels and kept in place by bolting to the top cover plate of the upper chord. The contractor then installed the web plates which were detailed to have a perfect half round contact surface on one side, abutting the existing pin. After these web plates were bolted to the new beam on both sides, the contractor jacked these web plates in a horizontal direction so that contact between web plates and the pins was as tight as possible. In this way, a new upper chord was created, hidden within the confines of the old deteriorated upper chord without changing the distinctive appearance of the parabolic Lenticular Truss.

replaced; the sidewalk timber planking was replaced where necessary and hand railing repaired; tensioning of the tie rods in the King Posts of the floor beams; and reinforcing the tower legs at the piers and abutments. The entire bridge was sandblasted and painted with two coats of paint. Fig. 1 and 2 describe the Repair details of the upper chord, and Fig. 3 the King Posted Floor Beams.

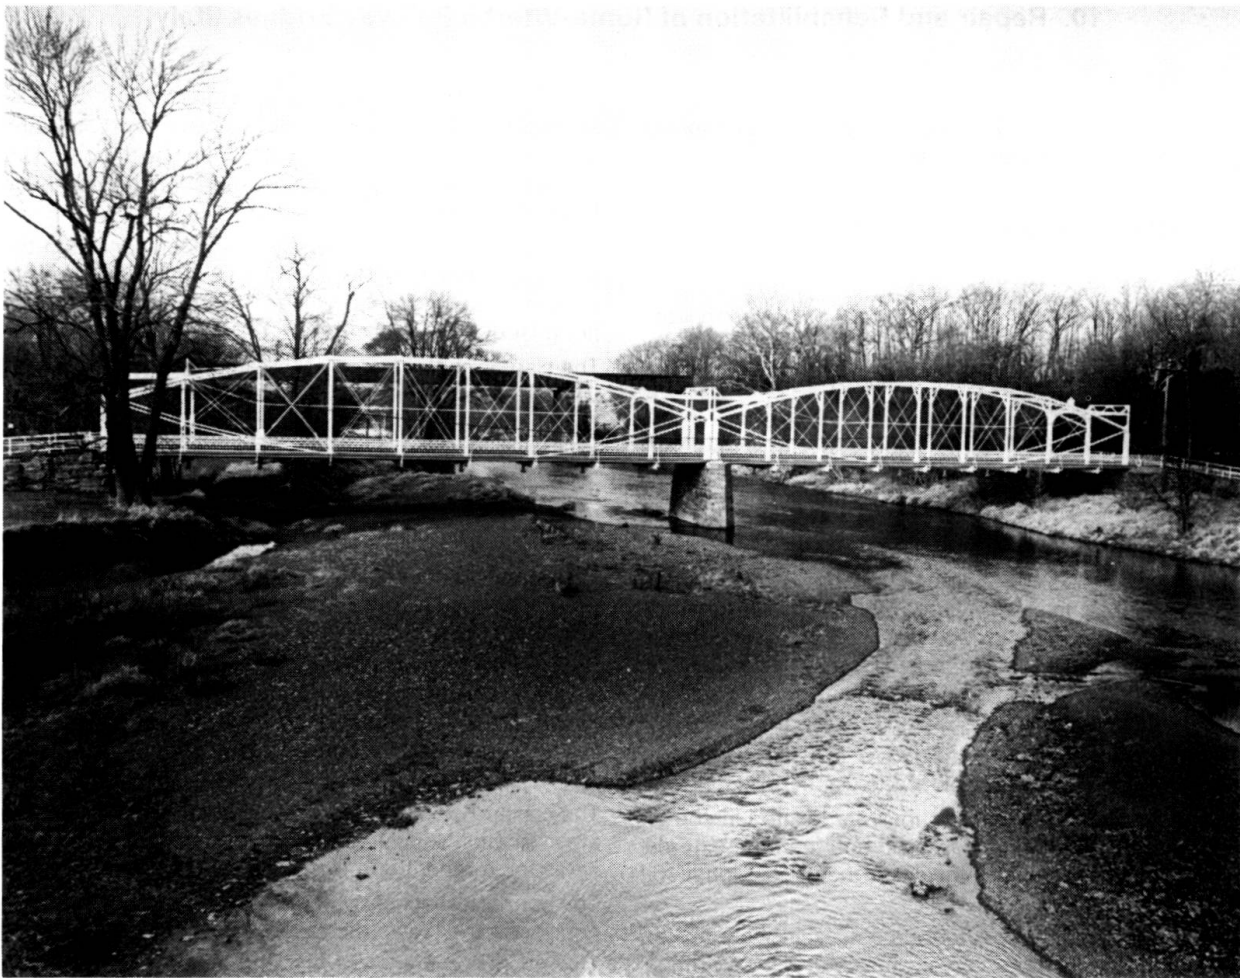
Fig. 4 General elevation

Neshanic Station is a small town in Somerset County, New Jersey. In this community there exists Bridge No. CO 601 which is composed of two spans 44.20 m (145 feet) each, over the South Branch of the Raritan River. The bridge accommodates one traffic lane in two directions and one sidewalk.

The bridge was constructed in 1986 by the Berlin Bridge Company of Berlin, Connecticut as a patented system and still retains its original configuration as a lenticular parabolic truss supported on the original stone abutments and piers. The structure has been judged a Historic Bridge by American Standards and the community of Neshanic Station indicated a desire to preserve and rehabilitate the bridge in lieu of replacement.
