# Repair of the Todsburg Bridge (Fed. Rep. of Germany)

## 11. Repair of the Todsburg bridge (Fed. Rep. of Germany)

<i>Owner:</i>	<i>Federal Republic of Germany</i>
<i>Year of construction:</i>	<i>1936/37</i>
<i>Repairs carried out in:</i>	<i>1983</i>
<i>Under the supervision of:</i>	<i>Heidenheim Motorway Authority</i>
<i>Contractors:</i>	<i>Weidle and Ludwig Fischer</i>

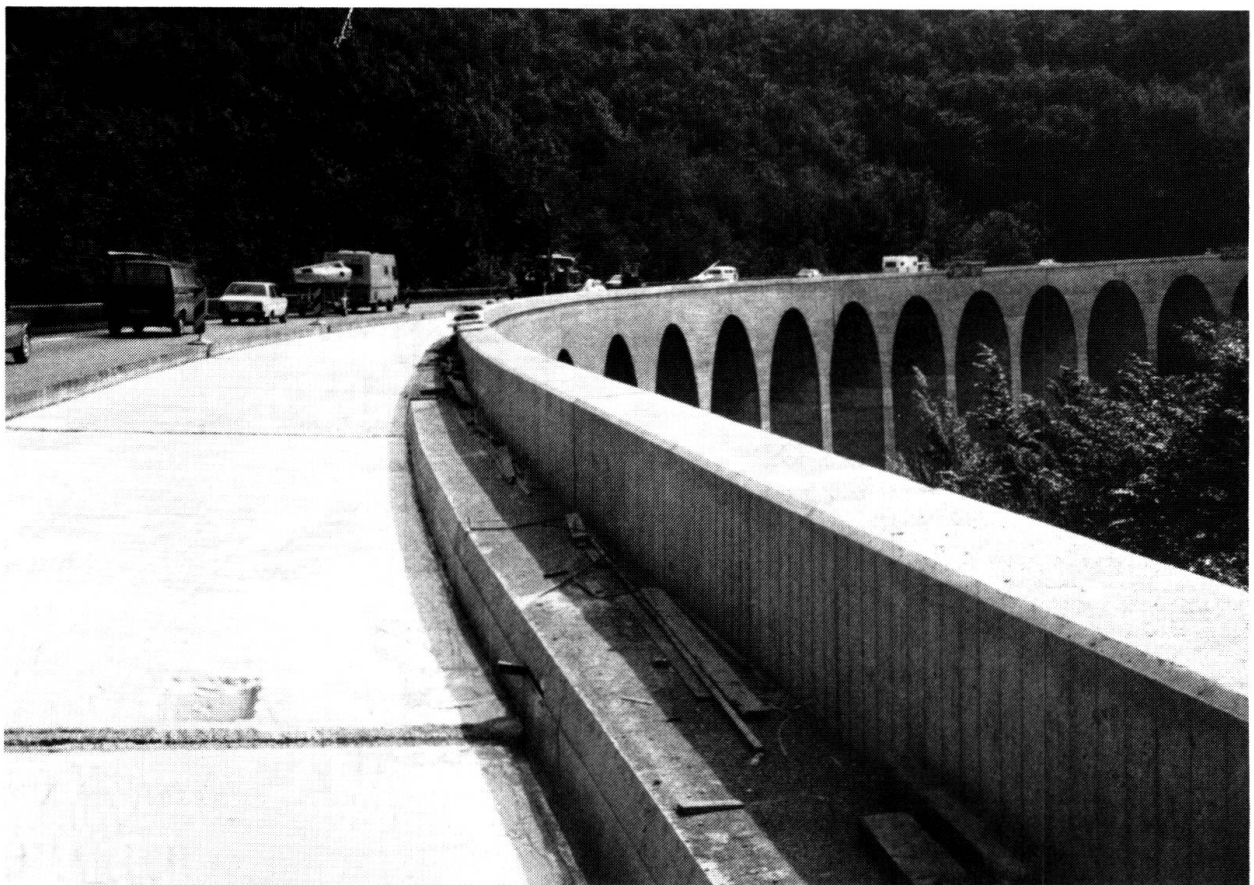
Fig. 1 The Todsburg bridge

The Todsburg bridge (Fig. 1) is located on the A 8 Autobahn between Stuttgart and Munich – one of the busiest sections of motorway in Germany. It stands between Stuttgart and Ulm at a point where the road climbs up into the Swabian Alb. For structural reasons, the two roadway sections are completely separate from each other. Some 30 000 vehicles pass over the bridge in each direction every day. By the beginning of the 1980's the concrete structure was in urgent need of repair – this stretch of motorway now being over 50 years old.

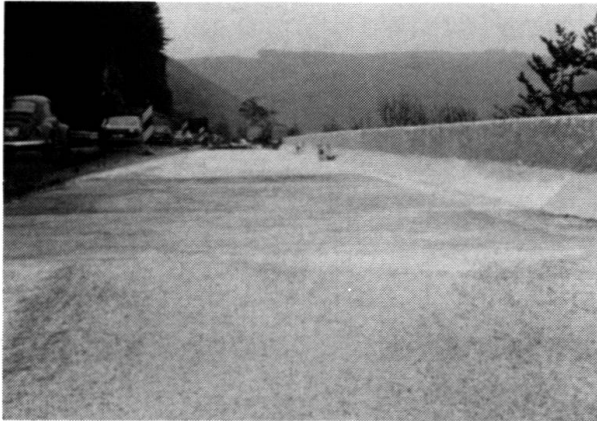
*Fig. 2 The finished waterproofing membrane*

The concrete on the old arched bridges had suffered extensive damage over the years, particularly from deicing salt. This damage resulted – as is usually the case – from failure of the conventional bridge waterproofing system, which was unable to cope with the severe stress caused by traffic, temperature fluctuations and structural movements over the years. It was therefore decided that, in addition to the normal repair work, a new type of spray-on liquid polyurethane would be applied to form a waterproof membrane.

- Seamless, homogeneous waterproofing produced in one pass
- High elasticity and elongation at break even at low temperatures
- The waterproof membrane is bonded over the entire surface of the substrate, thus preventing any moisture infiltration
- Excellent crack-bridging effect
- High water vapour permeability prevents any build-up of moisture beneath the membrane.

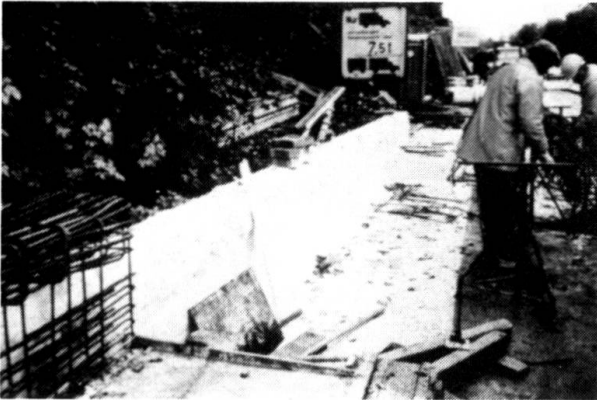
*Fig. 3 Working on reinforcements for the construction of the new parapet*

1. Removal of the frost-resistant masonry and defective concrete from the bridge parapets
2. Tearing up the old bituminous layers of the roadway and the defective waterproof seal
3. Drilling away the defective concrete on the roadway platform
4. Where necessary uncovering damaged reinforcement, removing rust and applying corrosion protection

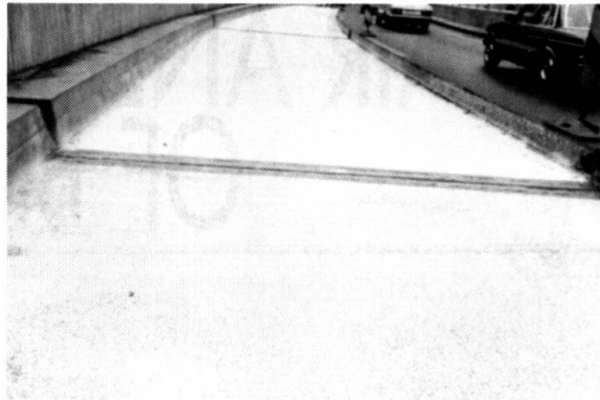
*Fig. 4 The bridge complete with its new parapet before surfacing with bituminous mastic concrete*

5. Cleaning the area with high-pressure water jets
6. Applying epoxy mortar to the roadway platform to level those areas where concrete had been chipped away
7. Applying a bonding agents (1-component PU) and covering with silica sand 0.7–1.2 mm
8. Spraying on the liquid plastic waterproof membrane to a thickness of approx. 3 mm (Fig. 2)
9. Applying a bonding agent to the plastic membrane and covering it with granules to improve the shear bond between the membrane and the asphalt layers (the bridge has a gradient of approx. 6% along its length, and 3–5% from side to side)
10. Reconstruction of the new parapet on top of the waterproof membrane (Fig. 3)
11. Applying the bituminous mastic concrete protective layer, the bituminous mastic concrete load-bearing layer and the wearing layer (Fig. 4).
