**Zeitschrift:** IABSE journal = Journal AIPC = IVBH Journal  
**Band:** 10 (1986)  
**Heft:** J-30: Renewal of the old Quaibridge in Zurich

**Artikel:** Renewal of the old Quaibridge in Zurich  
**Autor:** Fechtig, Robert  
**DOI:** <https://doi.org/10.5169/seals-28994>

## Renewal of the Old Quaibrücke in Zurich

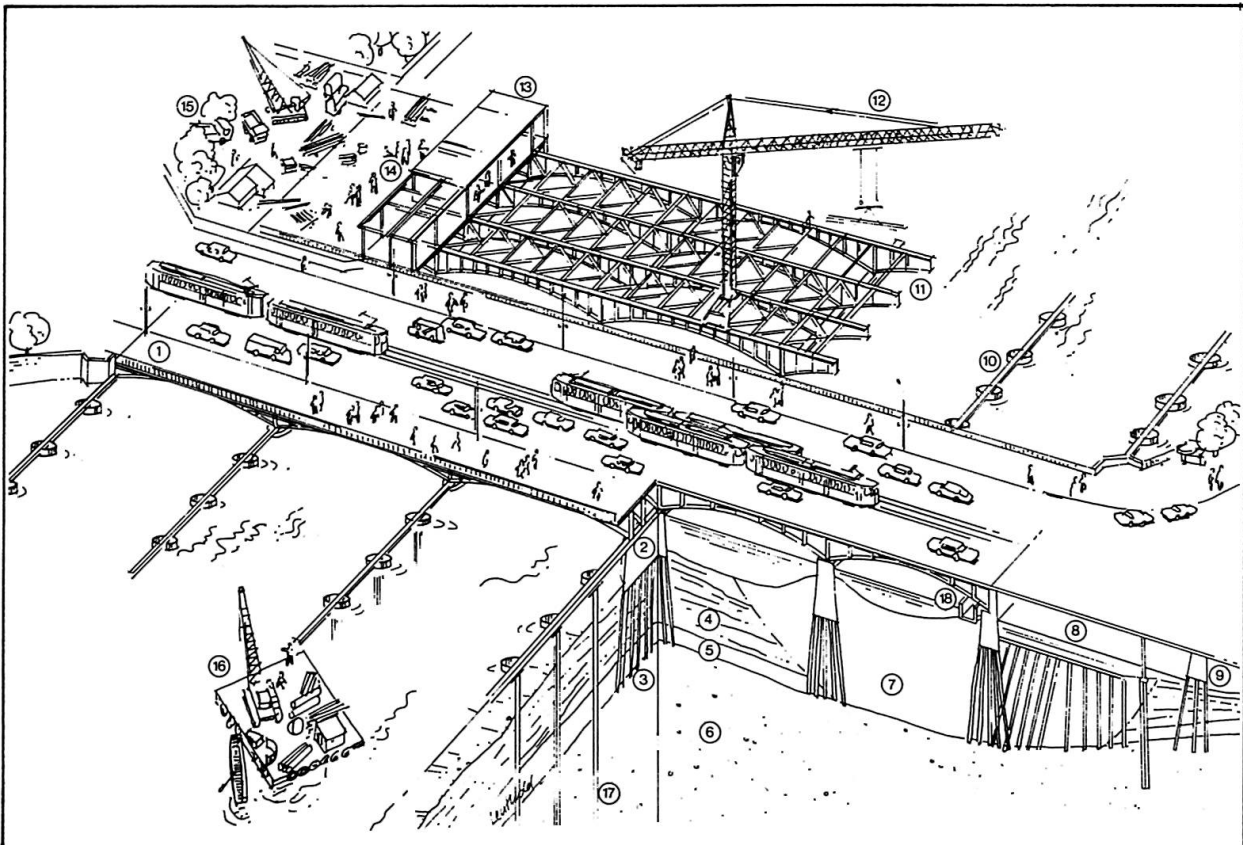
Fig. 2: General view of the work

| 1 | old Quaibrücke, built 1882-1884, widened in 1939 | 11 | four new welded steel girders Fe 510, erected on displacement tracks |
| 2 | pier, concrete with abutment of natural stone | 12 | tower crane |
| 3 | pier pile grating | 13 | removable falsework for the concrete slab |
| 4 | lakemarl | 14 | pouring section, length 12 m |
| 5 | mud | 15 | installation site |
| 6 | stratum of glacial period, foundation of the pile gratings | 16 | floating pile driver |
| 7 | slide of 1883 | 17 | piles of displacement track, quantity - 40, $\varnothing$ - 1.22 m length - 25-35 m |
| 8 | Bellevue cavern | 18 | concrete trough for pedestrian underpass |
| 9 | old embankment | | |
| 10 | displacement track | | |

New bridge spans - consisting of four new steel girders and a post-tensioned concrete slab poured on site - are built on displacement tracks and temporary piles in the River Limmat. The traffic circulates on the existing Quai-Bridge during the construction of the new bridge. In the same period, the existing bridge piers are repaired. The new bridge's girder and deck are then shifted to its definite place during a low-traffic weekend; at the same time the existing girders and deck are pushed on displacement tracks and temporary piles to the lake side of the bridge. Finally, the old bridge's girder and deck are demolished as well as the displacement tracks and the temporary piles.

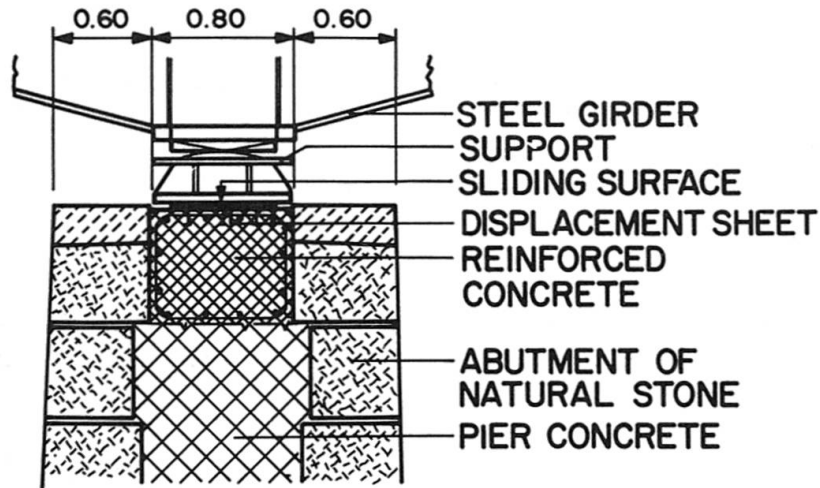
Fig. 4: Bridge support on the existing piers

The old bridge has to be put on slide supports in order to be able to displace it. The new bridge had already been erected on the tracks. The slide supports are locked onto the displacement track until the displacement starts. The upper part of the support will be used later as a part of the whole support. The old supports of the existing bridge had been exchanged against sliding bearings whereby the existing support conditions had to be followed exactly. These tasks were performed in several stages under heavy traffic flow.

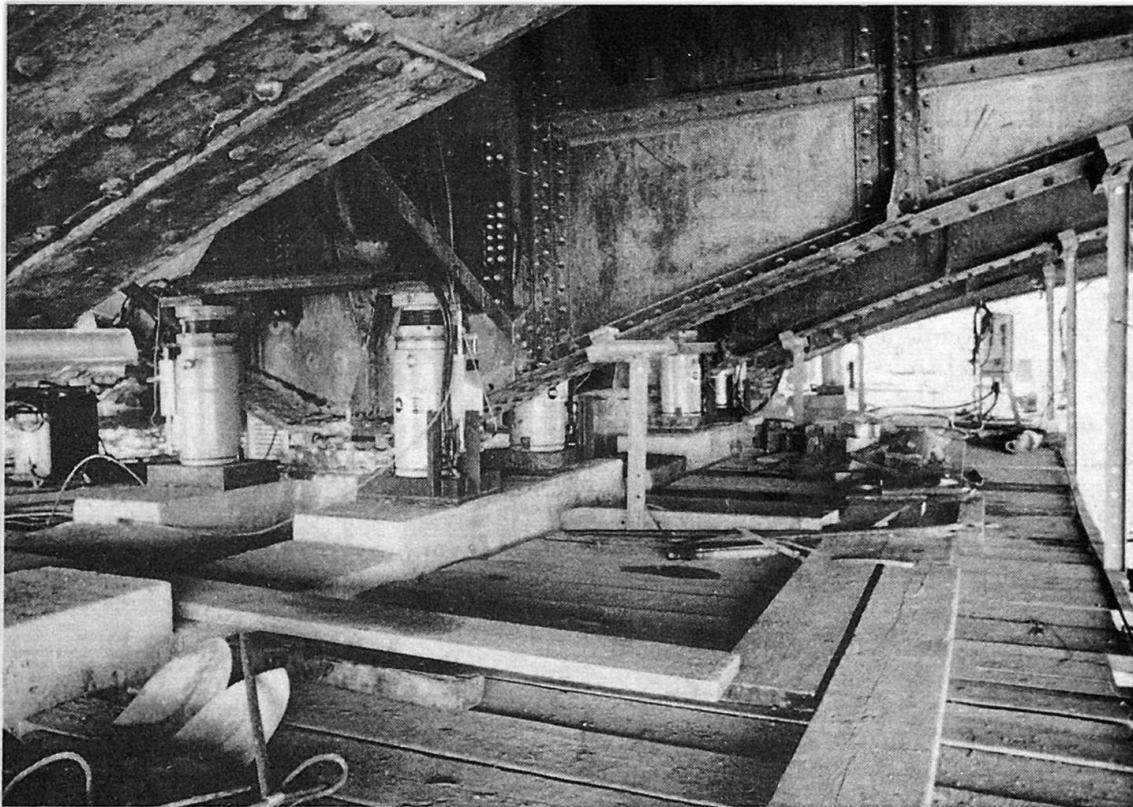
Photo 1: Exchange of the old supports with sliding supports, under traffic flow

The sliding supports are chromed on the underside. They glide on teflon coated neoprene cushions. This disposition allows a secure load-transfer if unevenness of the displacement track should arise.

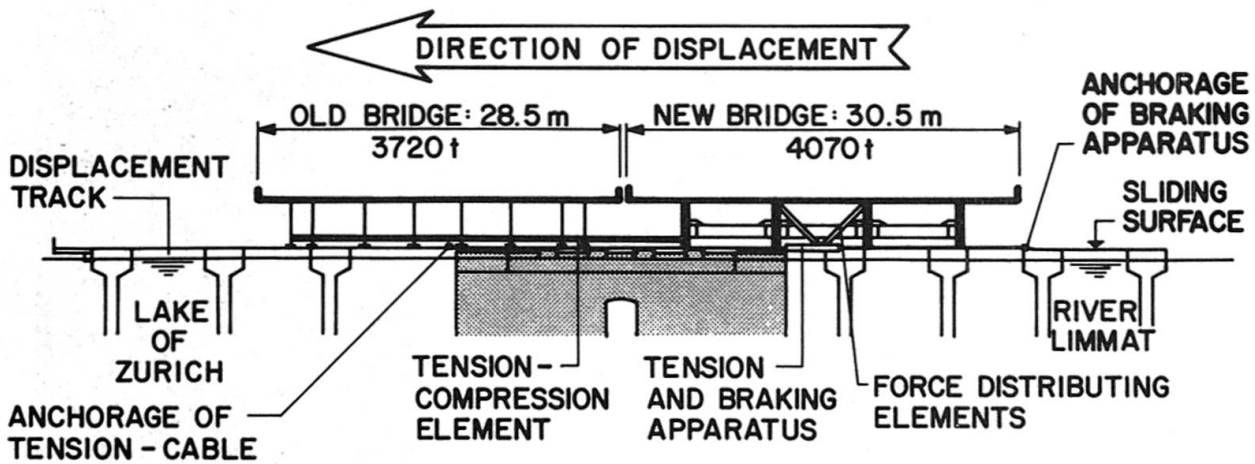
Fig. 5: Transverse section with displacement equipment

Eight VSL-strand tension apparatus will pull the new bridge on cables into the planned position. The existing bridge will be pushed ahead by the new one on to the displacement track in up-stream direction. A special structure between the second and third main girder of the new bridge takes the movement force. The cables are mounted on to anchorage points at the displacement track "Lake". A practically closed power system is produced. Piles and kentledge are stressed only moderately by horizontal power.
