Failure of stub-girders due to longitudinal shear

Autor(en): **Gosselin, G.C. / Hosain, M.U.**

Zeitschrift: **IABSE proceedings = Mémoires AIPC = IVBH Abhandlungen**

Band (Jahr): **8 (1984)**

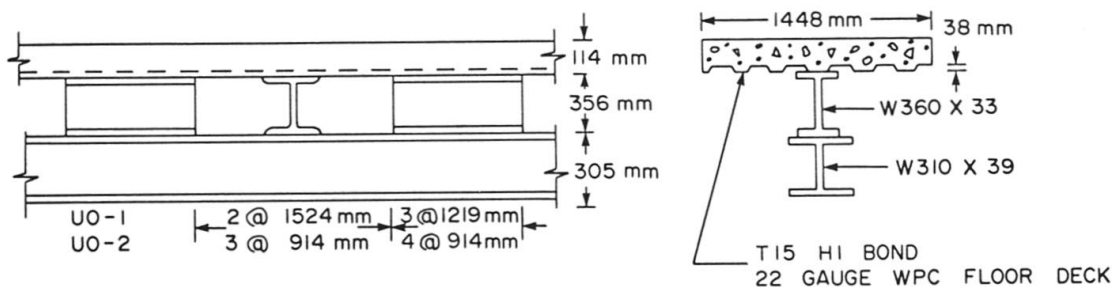
Fig.3 Specimen dimensions

A summary of the geometric properties of the two specimens is given in Fig. 3. The dimensions of the steel beams, the stubs and the concrete slab, which were identical for the two specimens, conformed to those for a stub-girder of 10 to 12 metre span. However, the span of the test beams was intentionally reduced to 7.31 m to induce failure through the stub-concrete connections. While the total length of the stubs was maintained at 3658 mm for both beams, the number of stubs was: three (1219 mm long with 24 studs) for specimen UO-1 and four (914 mm long with 18 studs) for specimen UO-2. Thus specimen UO-1 contained only two interior panels (1524 mm long) whereas three interior panels (914 mm long) were located within specimen UO-2. An 1829 mm long W360 X 33 section was placed at the midlength of each interior panel to simulate a floor beam. It was welded to the primary steel beam and connected to the concrete slab by means of eighteen studs. All headed shear studs were 76 mm long and 13 mm in diameter. For both specimens, the longitudinal reinforcement consisted of eight 13 mm diameter deformed bars whereas the same size bar at 305 mm centre to centre served as the transverse reinforcement. A clear cover of 25 mm was provided between the longitudinal reinforcement and the metal deck.

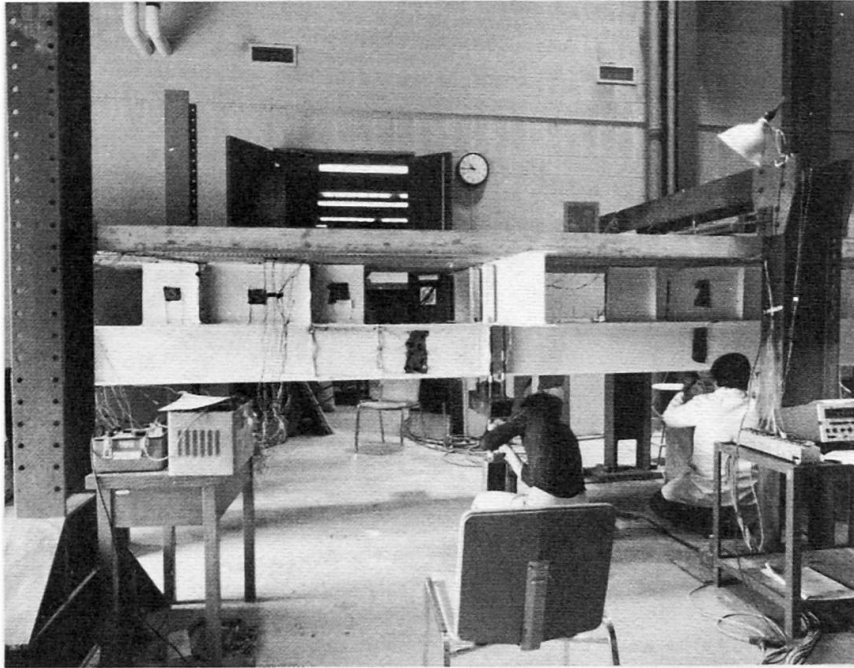
Fig.4 Test set-up

The test set-up used is shown in Fig. 4. Each stub-girder was mounted on load cells which were placed on concrete pedestals at each end of the stub-girder. The concrete slab was laterally braced at the supports and also at mid-span. The bracing system at midspan was based on Watt's mechanism [4] to permit free vertical movement. Vertical loads were applied through the floor beams in order to simulate the loading condition expected in an actual stub-girder system. This resulted in a 2-point loading arrangement for specimen UO-1 and a 3-point loading arrangement for specimen UO-2. The loads were applied by Enerpac hydraulic rams which were located below the test floor. Applied loads on each floor beam was monitored by four 25.4 mm diameter instrumented and precalibrated steel bars. Strains in the steel and in the concrete as well as deflections were recorded.

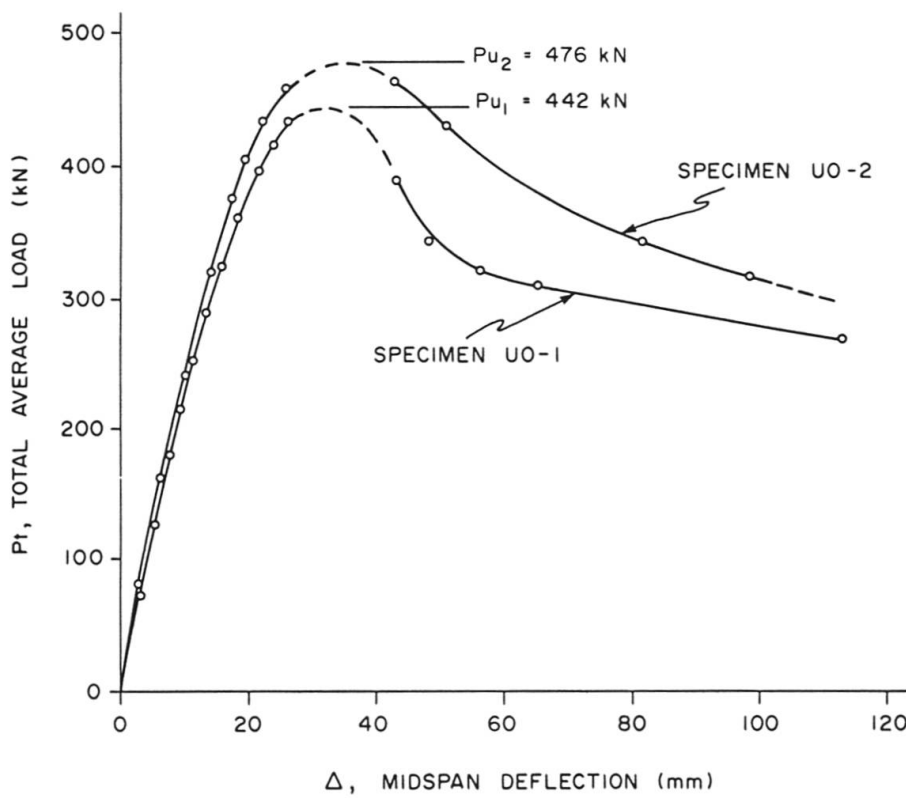
Fig.5 Load-deflection curves

The load vs midspan deflection curves for specimens UO-1 and UO-2 are presented in Fig. 5. For both specimens, the deviation from the initial elastic behavior was due to longitudinal cracking on the underside of the concrete slab on both sides of the end stubs. With increasing load these cracks widened and, eventually, a sudden drop in the load was observed. It is believed that this rapid unloading was caused by sufficient widening of the cracks to allow bending of the headed studs.

After the initial rapid drop, the load-deflection curve exhibited ductile behavior with relatively small reduction in load. This behavior is attributed to the transverse reinforcement becoming effective in restraining further splitting of the concrete. Simultaneous resistance to splitting from the concrete and transverse reinforcement steel was not achieved because the transverse reinforcement was located too high in the slab (near the head of the studs). As indicated earlier, this placement of the transverse steel was dictated by the floor deck and the clear cover requirement for the longitudinal reinforcement. This practical problem needs further study especially if the use of wire mesh is envisaged. Fig. 6 shows the slab failure region over the end stub.

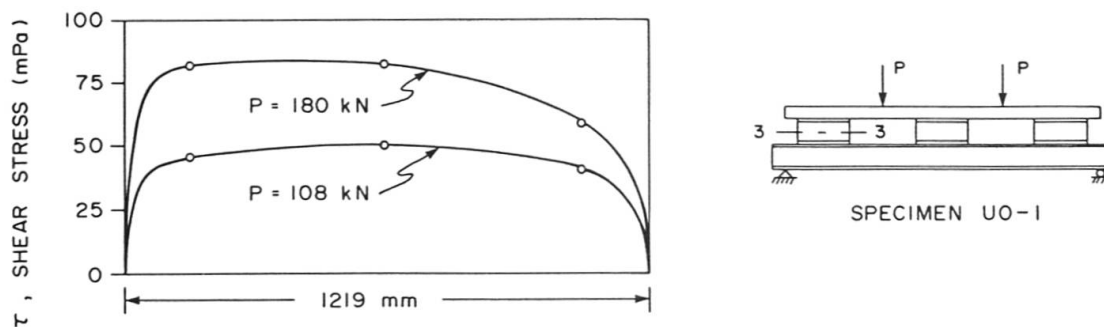
Fig.7 Shear stress distribution across section 3-3

The observed shear stress distribution across one of the end stubs is shown in Fig. 7. The deviation from the basic parabolic shape which occurs at higher loads is believed to be caused by local concrete failure at the tensile (prying) end of the stub. Localized failure could reduce the shear resistance of studs subjected to tension, giving rise to the skewed distribution in Fig. 7. The design equation for headed studs of a conventional composite beam therefore, would not seem to be applicable to the

Using the shear stress distribution across the end stubs at the ultimate load (similar to Fig. 7), the maximum horizontal shear force was calculated for both specimens. This gave an average shear resistance per stud of 26.7 kN for specimen UO-1 and 33.68 kN for specimen UO-2. The maximum capacity that can be developed in shear, based on the CSA standard CAN3-S16.1-M78 [6] for conventional composite design, is 64.2 kN for the high strength concrete used. The difference between the observed and calculated shear resistances is due to several reasons. First, the use of a single row of studs resulted in a wedge action that triggered a somewhat premature concrete splitting along the end stubs. Second, both specimens were subjected to considerable prying. Due to higher prying force induced by the larger open panel in specimen UO-1, the resistance per stud was smaller compared to that of
