Zeitschrift: IABSE proceedings = Mémoires AIPC = IVBH Abhandlungen
Band: 8 (1984)
Heft: P-74: Failure of stub-girders due to longitudinal shear

Artikel: Failure of stub-girders due to longitudinal shear
Autor: Gosselin, G.C. / Hosain, M.U.
DOI: <https://doi.org/10.5169/seals-38336>

Failure of Stub-Girders due to Longitudinal Shear

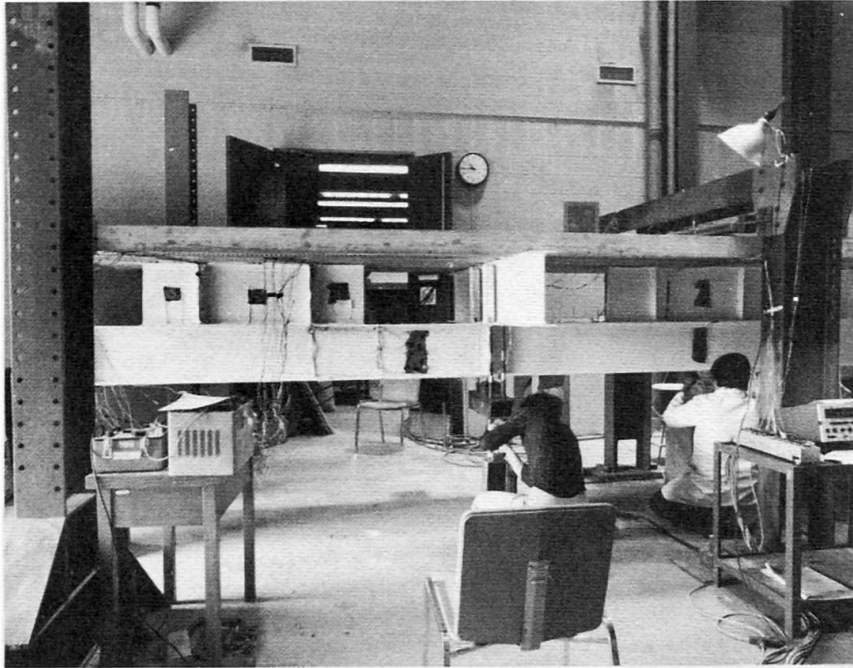
The test set-up used is shown in Fig. 4. Each stub-girder was mounted on load cells which were placed on concrete pedestals at each end of the stub-girder. The concrete slab was laterally braced at the supports and also at mid-span. The bracing system at midspan was based on Watt's mechanism [4] to permit free vertical movement. Vertical loads were applied through the floor beams in order to simulate the loading condition expected in an actual stub-girder system. This resulted in a 2-point loading arrangement for specimen UO-1 and a 3-point loading arrangement for specimen UO-2. The loads were applied by Enerpac hydraulic rams which were located below the test floor. Applied loads on each floor beam was monitored by four 25.4 mm diameter instrumented and precalibrated steel bars. Strains in the steel and in the concrete as well as deflections were recorded.

Fig.4 Test set-up

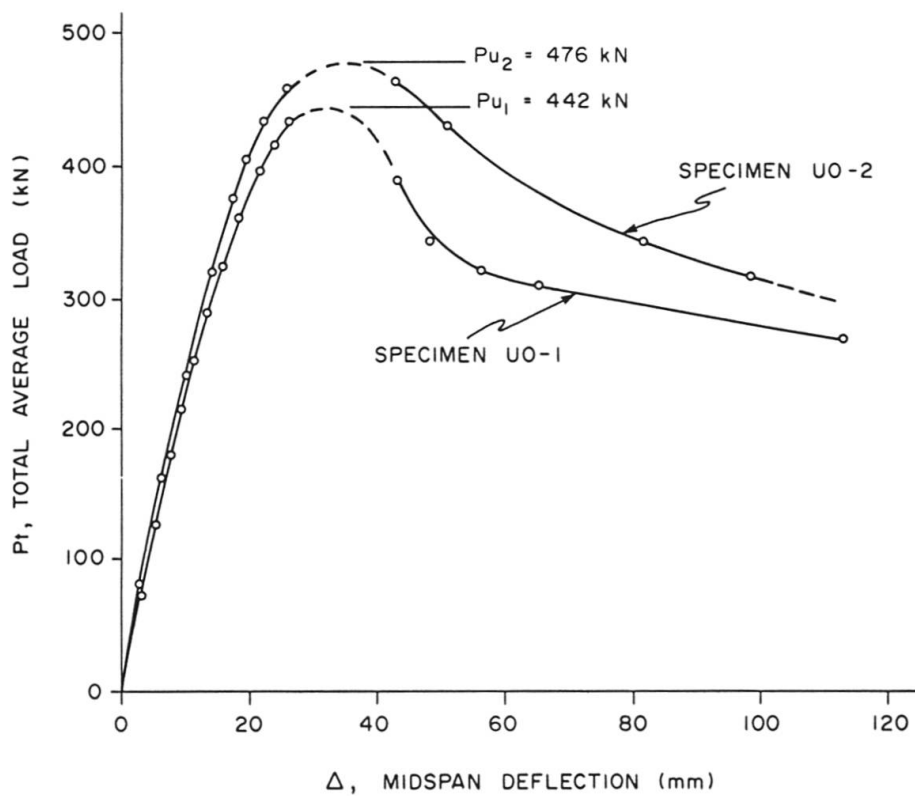
The load vs midspan deflection curves for specimens UO-1 and UO-2 are presented in Fig. 5. For both specimens, the deviation from the initial elastic behavior was due to longitudinal cracking on the underside of the concrete slab on both sides of the end stubs. With increasing load these cracks widened and, eventually, a sudden drop in the load was observed. It is believed that this rapid unloading was caused by sufficient widening of the cracks to allow bending of the headed studs.

Fig.5 Load-deflection curves

After the initial rapid drop, the load-deflection curve exhibited ductile behavior with relatively small reduction in load. This behavior is attributed to the transverse reinforcement becoming effective in restraining further splitting of the concrete. Simultaneous resistance to splitting from the concrete and transverse reinforcement steel was not achieved because the transverse reinforcement was located too high in the slab (near the head of the studs). As indicated earlier, this placement of the transverse steel was dictated by the floor deck and the clear cover requirement for the longitudinal reinforcement. This practical problem needs further study especially if the use of wire mesh is envisaged. Fig. 6 shows the slab failure region over the end stub.

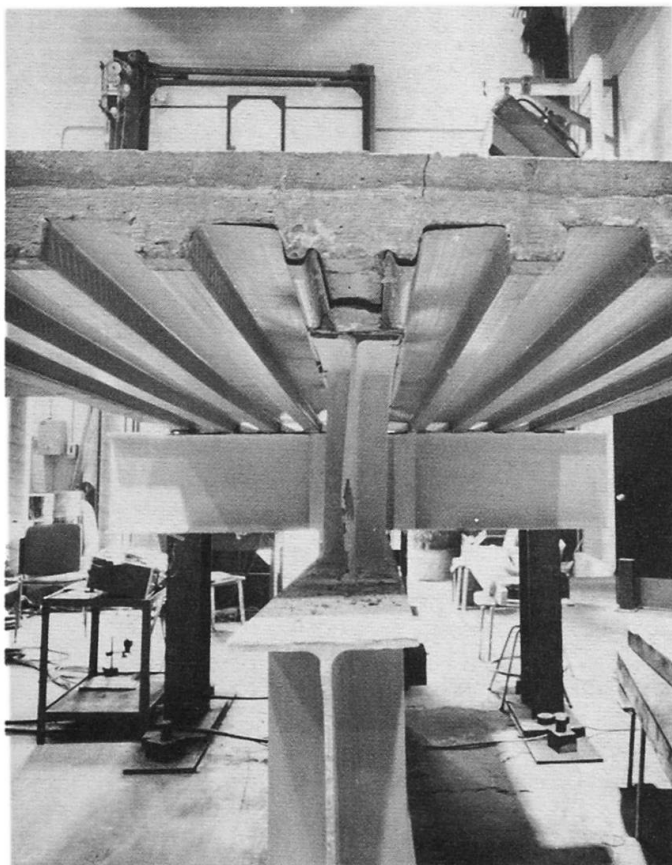
Fig.6 Slab failure region over the end stub

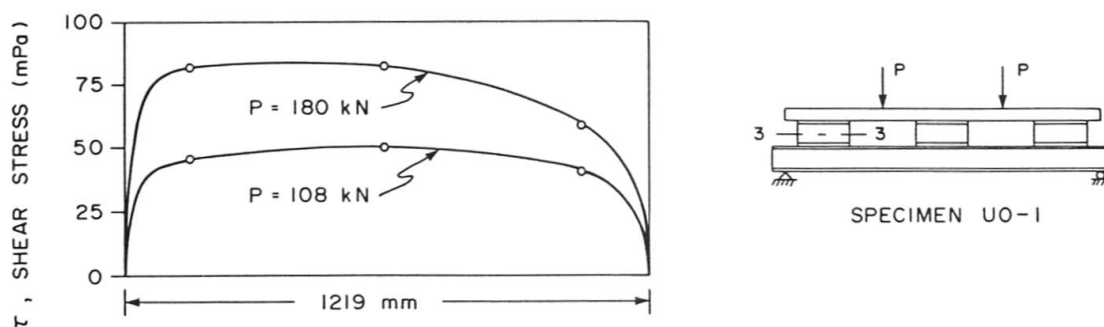
The observed shear stress distribution across one of the end stubs is shown in Fig. 7. The deviation from the basic parabolic shape which occurs at higher loads is believed to be caused by local concrete failure at the tensile (prying) end of the stub. Localized failure could reduce the shear resistance of studs subjected to tension, giving rise to the skewed distribution in Fig. 7. The design equation for headed studs of a conventional composite beam therefore, would not seem to be applicable to the

Fig.7 Shear stress distribution across section 3-3

Using the shear stress distribution across the end stubs at the ultimate load (similar to Fig. 7), the maximum horizontal shear force was calculated for both specimens. This gave an average shear resistance per stud of 26.7 kN for specimen U0-1 and 33.68 kN for specimen U0-2. The maximum capacity that can be developed in shear, based on the CSA standard CAN3-S16.1-M78 [6] for conventional composite design, is 64.2 kN for the high strength concrete used. The difference between the observed and calculated shear resistances is due to several reasons. First, the use of a single row of studs resulted in a wedge action that triggered a somewhat premature concrete splitting along the end stubs. Second, both specimens were subjected to considerable prying. Due to higher prying force induced by the larger open panel in specimen U0-1, the resistance per stud was smaller compared to that of
