Zeitschrift: **IABSE proceedings = Mémoires AIPC = IVBH Abhandlungen**

Flash Floods on Bridge Piers

Alfonso KRUMDIECK

Civil Engineer
Electrowatt Eng. Services Ltd.
Zurich, Switzerland

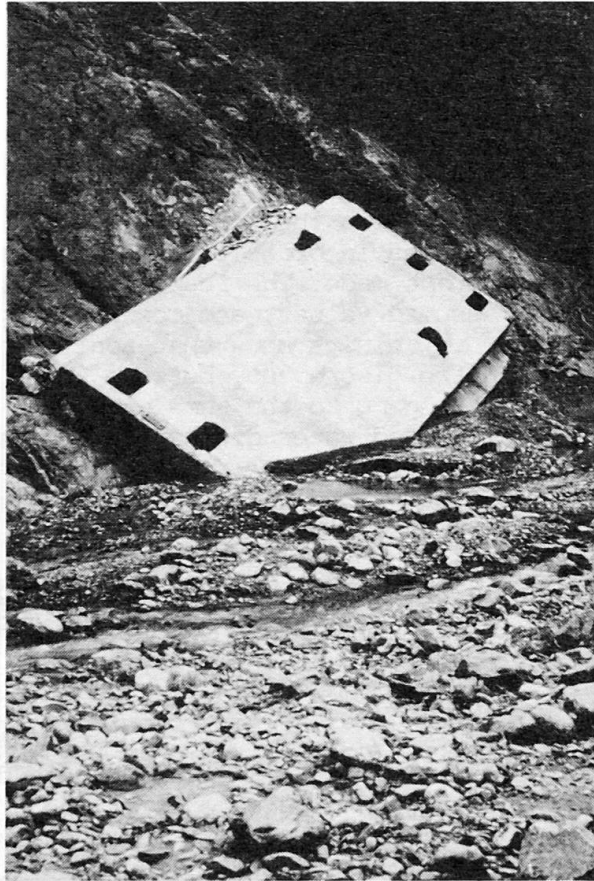
Huge quantities of bed material were reported to have been dragged along the river bed. The peak velocities which occurred during the event could not be directly measured. From eye witness accounts these were estimated to be about 30 to 60 km/h, however these must be judged critically. Taking into consideration that huge bridge slabs of 200 tons of weight or more were moved hundreds of meters downstream, it can be safely assumed, that peak velocities of approximately 50 km/h occurred, (see Fig. 2).

FIG. 2 200 Ton Bridge slab after the flash flood.
