Fatigue Crack Locations in Orthotropic Steel Decks

J. R. CUNINGHAME

C. BEALES

SUMMARY

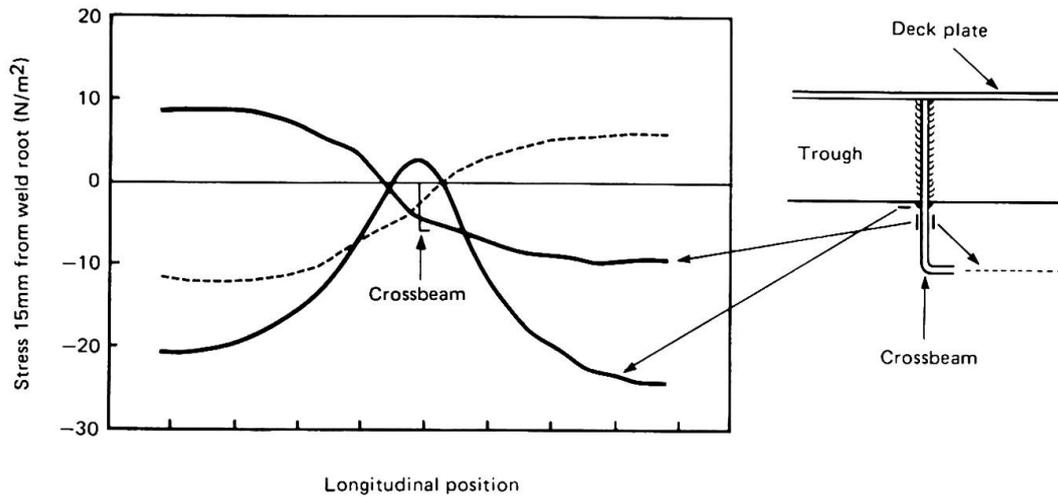
Fig.1 Stress influence lines for trough to crossbeam joint

Fatigue tests were carried out on a deck panel by loading alternately at two positions over the trough on either side of the crossbeam, coinciding with the stress peaks on the influence line. Small (1500 x 600mm) specimens were also tested.

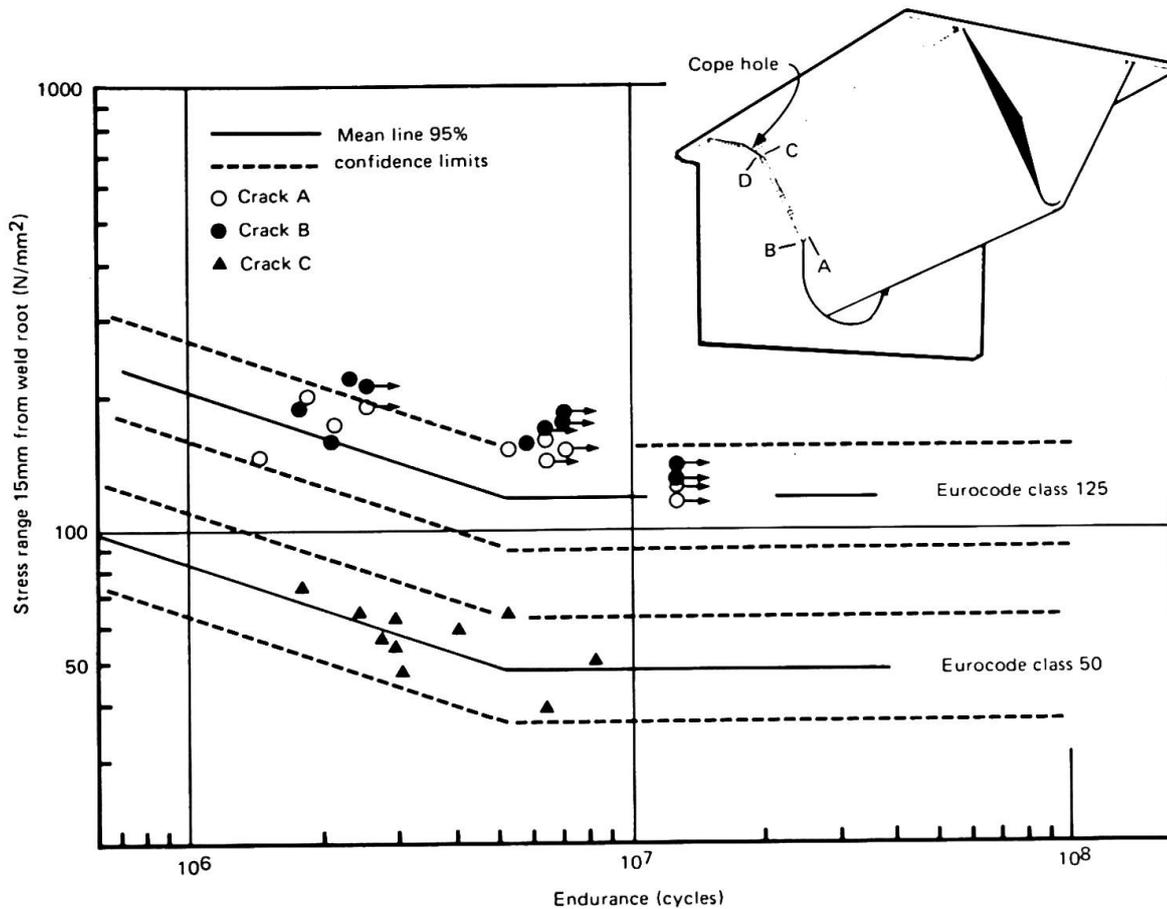
Fig.3 Crack locations and test results for trough to crossbeam joint

In two of the designs, the trough to crossbeam weld stops short of the deck plate and a cope hole is left in the crossbeam, to bridge the trough to deck plate weld. This avoids three welds meeting at a point. However, when these joints were fatigue tested cracks occurred in the trough and crossbeam at the upper end of the trough to crossbeam weld, ie at the edge of the cope hole.

The crack locations and test results are shown in figure 3. Cracks also occurred at the lower end of the weld but at much longer endurances. The fatigue strength of the cope hole detail is consistent with BS 5400 class G or Eurocode class 50 [10]. The estimated life under design traffic loading is less than 5 years. Without the cope hole detail, the fatigue strength (for cracking at the weld toe at the lower end of the weld) is much higher than expected and is consistent with BS 5400 class C, or Eurocode class 125. The design life of the joint is then greater than the 120 years required by the UK design standard.

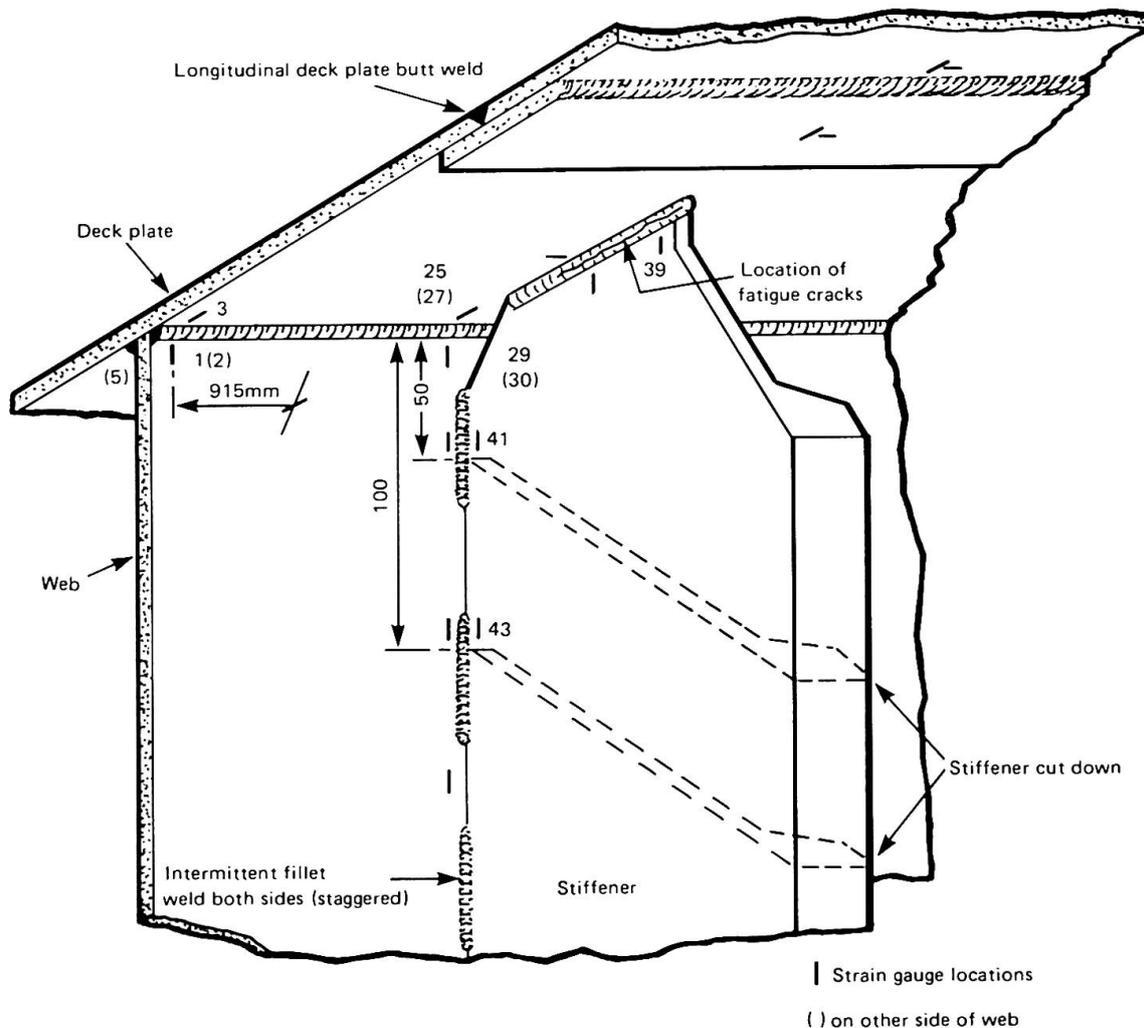
Fig.4 Web stiffener to deck joint

Cracks occurred at the joint shown in figure 4 under the nearside lane of a box girder bridge after 9 years in service.

The stiffener was then cut down, first to 50mm from the deck plate, then by a further 50mm to 100mm from the deck plate, see figure 4. The potential crack locations were then (i) the weld end at the top of the stiffener and (ii) the web to deck weld. The adjacent deck plate butt weld was also checked. Gauges were attached at all these locations and the load tests repeated.
