Surfacings on an experimental deck panel in a highway

SURFACINGS ON AN EXPERIMENTAL DECK PANEL IN A HIGHWAY

W.I.J. PRICE
Head of Bridges Section
Road Research Laboratory

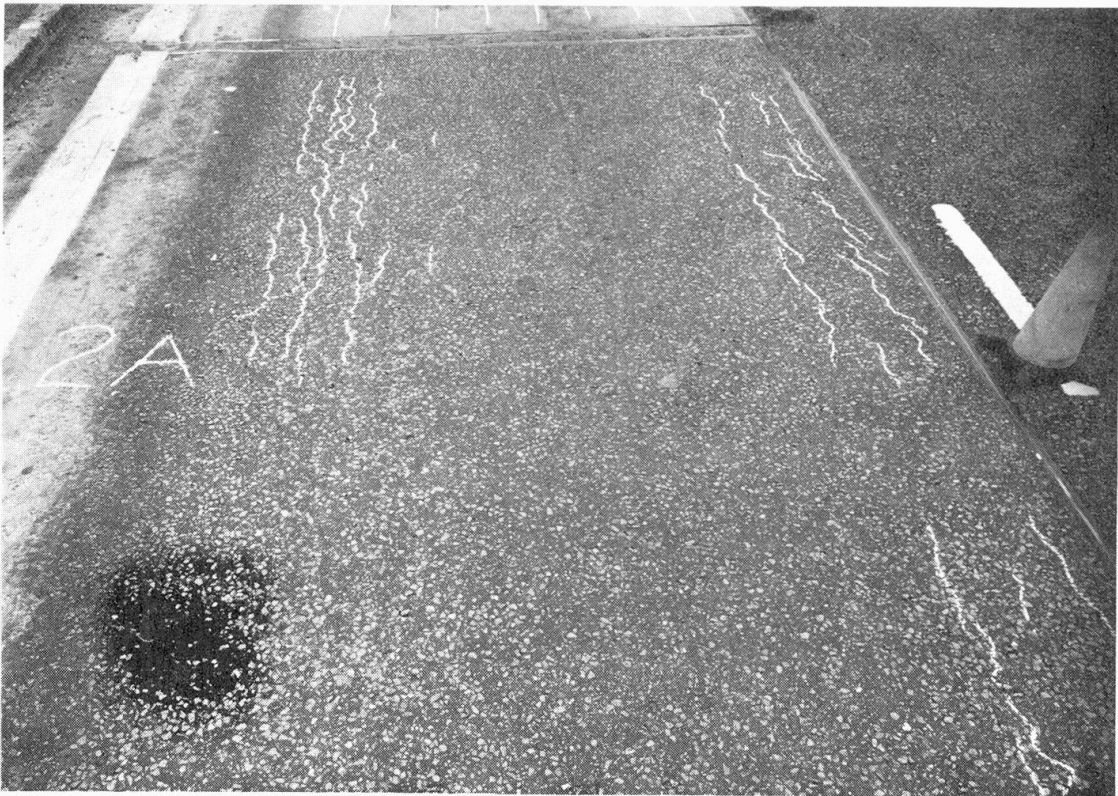
FIG. 4 CRACKING ON ROLLED ASPHALT OVER GRITTED EPOXY RESIN, NOVEMBER, 1967

A very fine crack, a few inches long, appeared during the Spring of 1964 in the nearside wheel track. It remained largely unchanged until the Winter of 1964/5 when the crack lengthened to extend almost over the length of the section by the Spring of 1965. By that time two intermittent cracks had developed in the outer wheel tracks, near the edge of the panel. During 1966, parallel cracks developed in the near side wheel track over the webs of the underlying stiffener, that is 6 in. (15 mm) on either side of the existing crack. By November, 1967, when the photograph in Fig. 4 was taken, a crazed pattern of cracks was established over a 12 in (300 mm) wide strip, with short crack appearing over the line of the next stiffener towards the centre of the panel. When last observed in July, 1968 (Fig. 5) a depression about $\frac{1}{4}$ in (6 mm) deep had formed in the centre of the strip. Cracks along the off-side wheel tracks had become more continuous, but these are not such good indicators of performance, because of the proximity of the edge of the panel. It is significant that cracks have not run over the transverse diaphragm of the deck panel, but have terminated some 9 in (225 mm) from it.

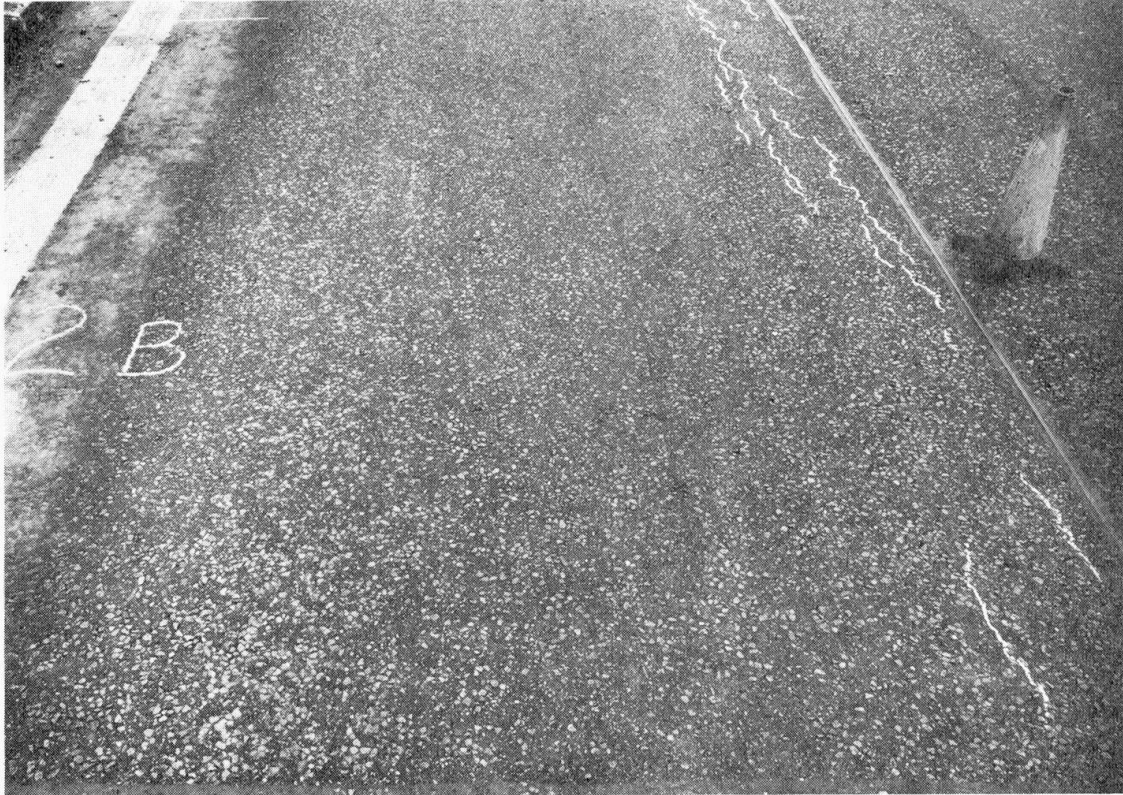
FIG. 6 CRACKING IN ROLLED ASPHALT ON FILLED RUBBER BITUMEN, NOVEMBER, 1967

In February, 1965, short intermittent cracks were noticed in the off-side wheel tracks near the edge of the panel. These cracks occur mid-way between lines of stiffeners. They have continued to develop, until in November, 1967 there were two fairly definite lines of cracks about 12 in. (300 mm) apart with some interconnecting cracks (Fig. 6). Again the cracks disappear within about 9 in (225 mm) of the position of the transverse stiffener.

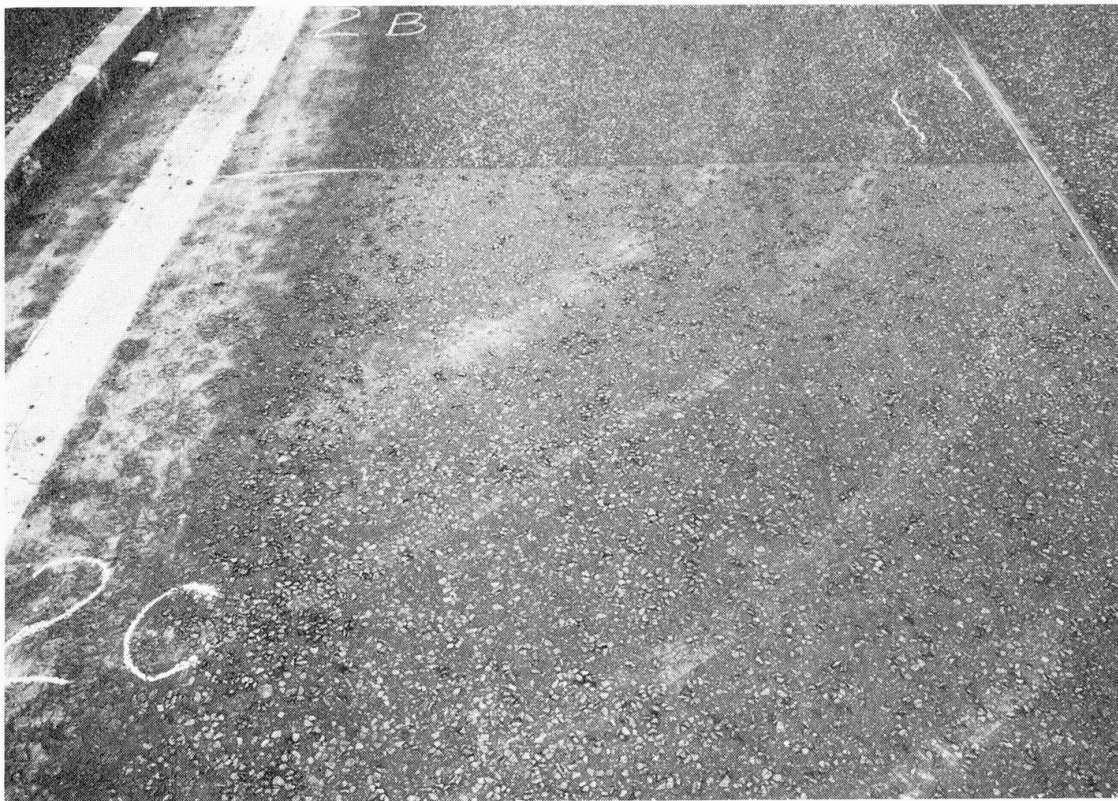
FIG. 7 MASTIC ASPHALT ON FILLED RUBBER BITUMEN, NOVEMBER, 1967

No cracking has so far occurred in this section. In the Spring of 1964, however, a blister about 9 in. to 12 in (225 to 300 mm) dia. appeared near the centre of the section, When it was cut out and repaired

in September, 1964, it was observed that separation had occurred between the layer of filled rubber bitumen and the mastic asphalt wearing course (Fig. 7).
