A FIRST GEOTECHNICAL ASSESSMENT OF THE RECENT PATTI EARTHQUAKE
(SICILY)

Michele Maugeri, Professor of Soil Mechanics Faculty of Engineering, University of Catania.

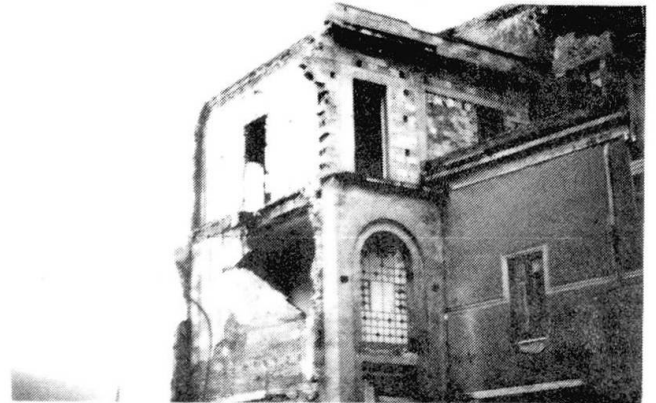
Fig. 6: Patti Cathedral: the left wing.

The worst damaged houses in Patti were those founded on sandstone, built of masonry and rarely cemented, in the old centre of the town.

On that site the sandstone formation assumes a hill configuration, which could produce an amplification on maximum ground acceleration (Maugeri, 1976), which can explain, together with the poor construction quality, the severe destruction of some houses.

In fig. 6 the damage suffered by one wing of Patti Cathedral is visible and in fig. 7, the damage at the corner of the main nave is evident.

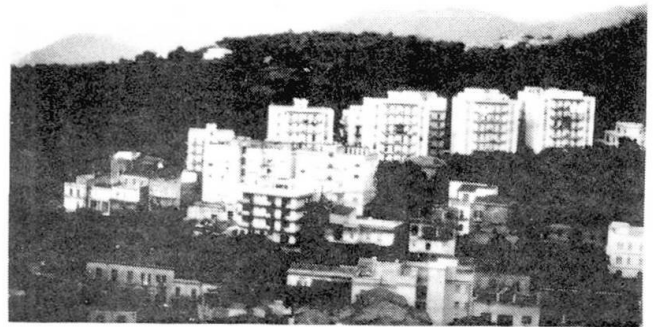
Fig. 8: Concrete buildings at Patti virtually undamaged.

The new concrete buildings in Patti, shown in fig. 8, are built on fissured clay and were apparently damaged on the buffer walls only, mainly at the lower levels.

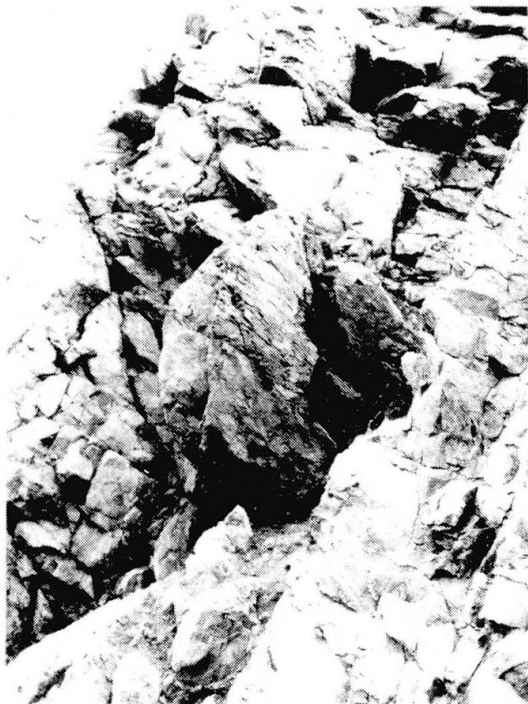
Fig. 10: Rock fall at Capo Calavà.

A landslide, consisting in a rock mass failure, was observed at Capo Calavà, whose location is on the left of the Patti gulf. The slope was high and formed of very jointed and altered rock, which has been consolidated in the past by spritz beton and anchorages.

Because of the earthquakes the rock failure was accelerated and a series of blocks, from 10 to 60 cm in diameter fell down into the road. As is clear from fig. 10 the entire cliff is at present in a dangerous limit equilibrium.
